Baseline Soil Assessment

EASTERN LEASES PROJECT

Prepared for Hansen Bailey
on behalf of South32 Pty Ltd
May 2015

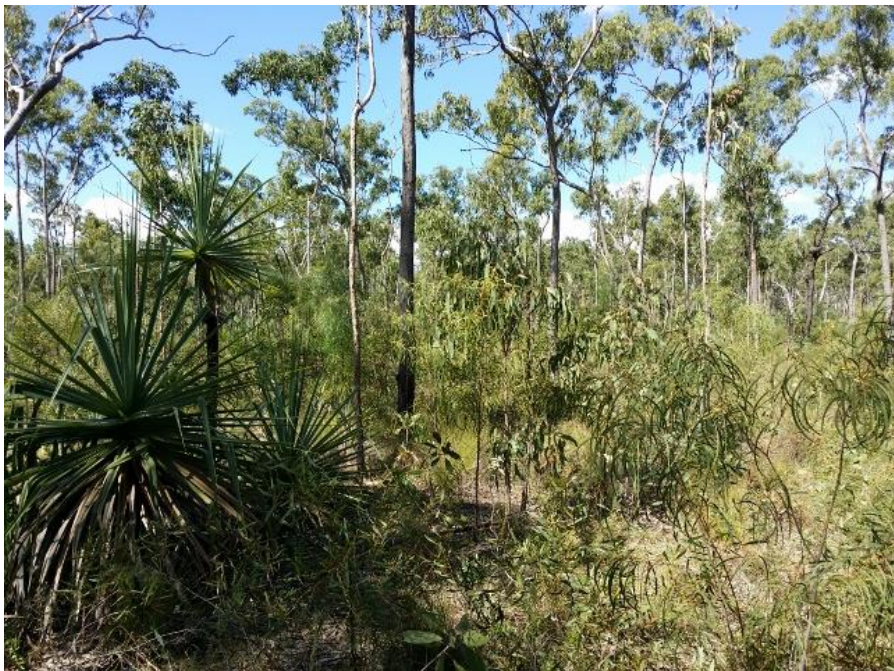
SMU	<i>B1</i>	Representative Site Number	Site 5
Representative Site photograph

Site survey type	Detailed. 50 mm hand auger.	Main vegetation	Stringybark, Darwin Woollybutt, Cypress Pine
Location	665639mE 8449753mN	Disturbance	No effective disturbance
Landform element and pattern	Gentle Undulating Plain	Micro relief	None
		Permeability	Highly permeable
Slope (%)	3.0	Drainage	Rapid drainage
Surface coarse fragments	No coarse fragment	Surface condition	Surface is firm and dry
ASC Order (s) present in SMU	Brown Tenosol	Land use	Native Vegetation
Land System (Lynch (2012))	Bundah	Substrate	Sandstone
Effective Soil Depth	1.0m+	Estimated Soil Water Storage	40mm
Erosion potential (Bourne and Tuck 1993)	The SMU is generally located on long, low-gradient sloping areas with a sandy surface. It has a low to medium water erosion hazard.		
Soil quality for mine rehabilitation	<u>Recommended Topsoil Strip Depth: 0.4m</u>

Land condition	Good condition		
Total area (ha)	3524

The recommended topsoil stripping depth for SMU *B1* is therefore 0.4m.

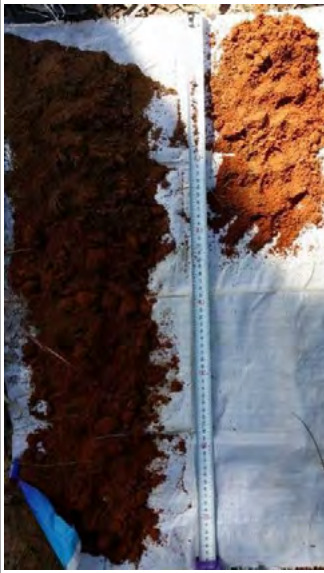
Representative Site Number: Site 5	HORIZON, DEPTH (m), BOUNDARY	COLOUR, MOTTLES, BLEACH	MOISTURE, IN SITU MEASUREMENTS DEPTH (m): pH and EC (mS)	TEXTURE, STRUCTURE, STRENGTH	COARSE FRAGMENTS, SEGREGATIONS, ROOTS

Horizon: A11 Horizon Depth: 0.0-0.40 Boundary: Diffused	Colour: 7.5YR3/4, Dark Brown Mottle: No Mottle Bleach: No Bleach	Moisture: Dry Depth 0.05m: Field pH 6.5 Meter pH 7.94 Meter EC 0.00 Depth 0.30m: Field pH 6.5 Meter pH 7.68 Meter EC 0.00	Texture: Loamy Sand Structure: Massive Strength: Loose	Coarse Fragments: <2%, 2-6mm Segregations: No segregations Roots: Fine, very few
	Horizon: A12 Horizon Depth: 0.40-1.00	Colour: 2.5YR3/4, Dark Reddish Brown Mottle: No Mottle Bleach: No Bleach	Moisture: Dry Depth 0.60m: Field pH 6.5 Meter pH 7.74 Meter EC 0.00 Depth 0.90m: Field pH 6.5 Meter pH 7.52 Meter EC 0.00	Texture: Loamy Sand Structure: Massive Strength: Loose	Coarse Fragments: <2%, 2-6mm Segregations: No segregations Roots: Fine, very few

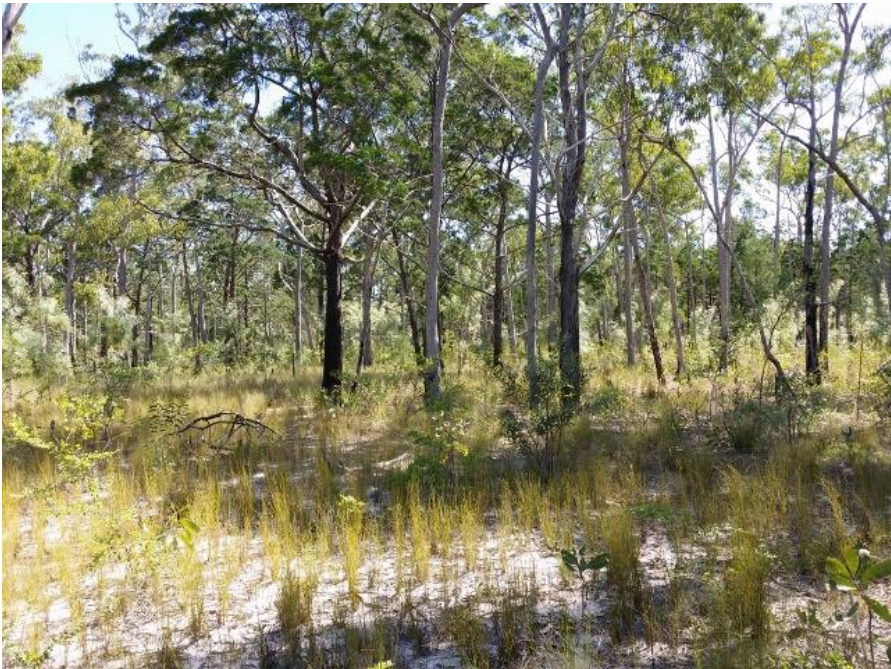
Site survey type	Detailed. 50 mm hand auger.	Main vegetation	Stringybark, Darwin Woollybutt, Cypress Pine
Location	665414mE 8449066mN	Disturbance	No effective disturbance
Landform element and pattern	Gentle Undulating Plain	Micro relief	None
		Permeability	Highly permeable
Slope (%)	1.5	Drainage	Rapid drainage
Surface coarse fragments	No coarse fragment	Surface condition	Surface is firm and dry
ASC Order (s) present in SMU	Grey Tenosol	Land use	Native Vegetation
Land System (Lynch (2012))	Bundah	Substrate	Sandstone
Effective Soil Depth	1.0m+	Estimated Soil Water Storage	42mm
Erosion potential (Bourne and Tuck 1993)	The SMU is generally located on long, low-gradient sloping areas with a sandy surface. It has a low to medium water erosion hazard.		
Soil quality for mine rehabilitation	<u>Recommended Topsoil Strip Depth: 0.20m</u>

Land condition	Good condition		
Total area (ha)	13

The recommended topsoil stripping depth for SMU *B1v* is therefore 0.2m.

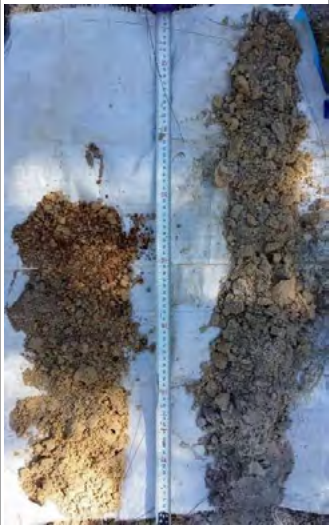
Representative Site Number: Site 6	HORIZON, DEPTH (m), BOUNDARY	COLOUR, MOTTLES, BLEACH	MOISTURE, IN SITU MEASUREMENTS DEPTH (m): pH and EC (mS)	TEXTURE, STRUCTURE, STRENGTH,	COARSE FRAGMENTS, SEGREGATIONS, ROOTS

Horizon: A11 Horizon Depth: 0.0-0.20 Boundary: Diffused	Colour: 10YR6/1, Brownish Grey Mottle: No mottle Bleach: No bleach	Moisture: Dry Depth 0.05m: Field pH 6.5 Meter pH 7.92 Meter EC 0.00	Texture: Sand Structure: Massive Strength: Loose	Coarse Fragments: No coarse fragments Segregations: No segregations Roots: Few, very fine
	Horizon: A12 Horizon Depth: 0.20-0.90 Boundary: Gradual	Colour: 10YR6/2, Greyish yellow brown Mottle: No mottle Bleach: No bleach	Moisture: Dry Depth 0.30m: Field pH 6.5 Meter pH 7.58 Meter EC 0.00 Depth 0.60m: Field pH 6.5 Meter pH 7.40 Meter EC 0.00	Texture: Loamy Sand Structure: Massive Strength: Very weak	Coarse Fragments: No coarse fragments Segregations: No segregations Roots: Few, Very fine

Horizon: A2 Horizon Depth: 0.90-1.15	Colour: 5YR6/3, Dull orange Mottle: No mottle Bleach: No bleach	Moisture: Dry Depth 0.95m: Field pH 6.5 Meter pH 7.22 Meter EC 0.00	Texture: Sandy Clay Loam Structure: Weak Strength: Very weak	Coarse Fragments: <40%, 2-6mm coarse fragments Segregations: No segregations Roots: No roots observed

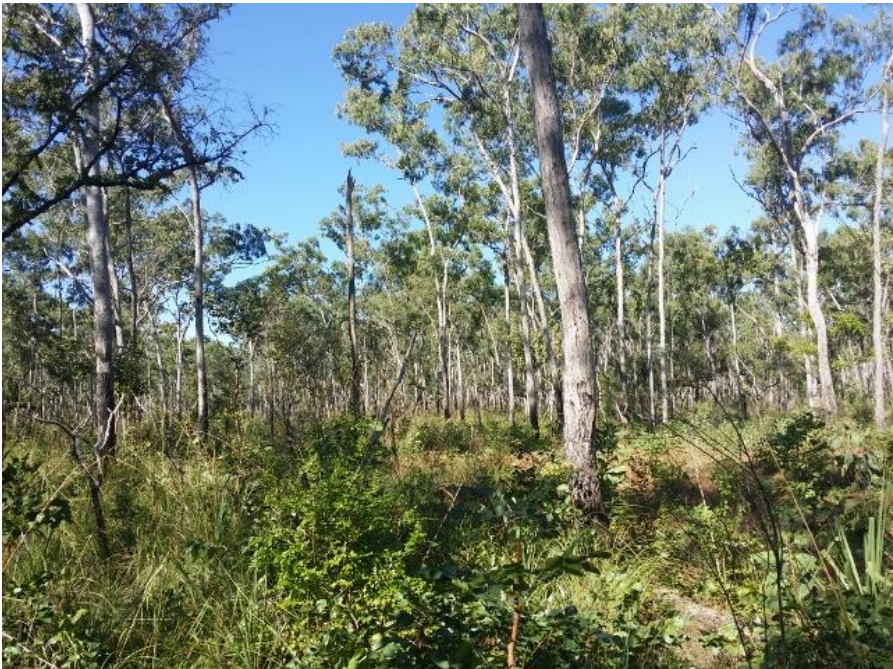
Site survey type	Detailed. 50 mm hand auger.	Main vegetation	Stringybark, Cypress Pine
Location	664316mE 8447989mN	Disturbance	No effective disturbance
Landform element and pattern	Gentle Undulating Plain	Micro relief	None
		Permeability	Highly permeable
Slope (%)	3.5	Drainage	Rapid drainage
Surface coarse fragments	<10% 2-6mm coarse fragments	Surface condition	Surface is firm and dry
ASC Order (s) present in SMU	Brown Kandosol	Land use	Native Vegetation
Land System (Lynch (2012))	Yarrowirrie	Substrate	Sandstone
Effective Soil Depth	1.0m+	Estimated Soil Water Storage	68mm
Erosion potential (Bourne and Tuck 1993)	The SMU is generally located on low-gradient sloping areas with a sandy surface. It has a low to medium water erosion hazard.		
Soil quality for mine rehabilitation	<u>Recommended Topsoil Strip Depth: 0.15m</u>		
Land condition	Good condition

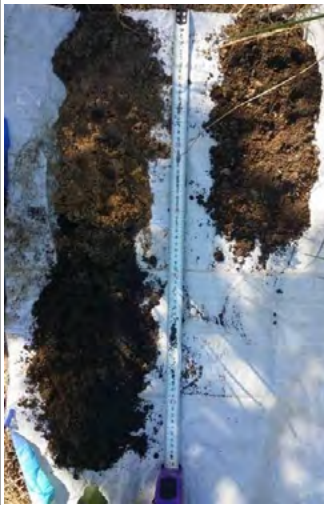
Representative site number: Site 7	HORIZON, DEPTH (m), BOUNDARY	COLOUR, MOTTLES, BLEACH	MOISTURE, IN SITU MEASUREMENTS DEPTH (m): pH and EC (mS)	TEXTURE, STRUCTURE, STRENGTH	COARSE FRAGMENTS, SEGREGATIONS, ROOTS

Horizon: A11 Horizon Depth: 0.0-0.20 Boundary: Abrupt	Colour: 10YR3/2, Brownish Black Mottle: No mottle Bleach: No Bleach	Moisture: Dry Depth 0.10m: Meter pH 7.87 Meter EC 0.00	Texture: Loamy sand Structure: Massive Strength: Loose	Coarse Fragments: No coarse fragments Segregations: No segregations Roots: Few, very fine
	Horizon: A12 Horizon Depth: 0.20-0.30 Boundary: Abrupt	Colour: 10YR4/2 , Greyish yellow brown Mottle: No mottle Bleach: No Bleach	Moisture: Dry Depth 0.30m: Meter pH 7.05 Meter EC 0.00	Texture: Loamy Sand Structure: Massive Strength: Very weak	Coarse Fragments: No coarse fragments Segregations: No segregations Roots: Few, very fine
	Horizon: B2 Horizon Depth: 0.30-1.15	Colour: 10YR2/2, Brownish black Mottle: No mottle Bleach: No bleach	Moisture: Dry Depth 0.60m: Meter pH 7.36 Meter EC 0.00 Depth 0.90m: Meter pH 7.29 Meter EC 0.00	Texture: Sandy Clay Loam Structure: Weak Strength: Very weak	Coarse Fragments: <40%, 2-6mm coarse fragments Segregations: No segregations Roots: No roots observed

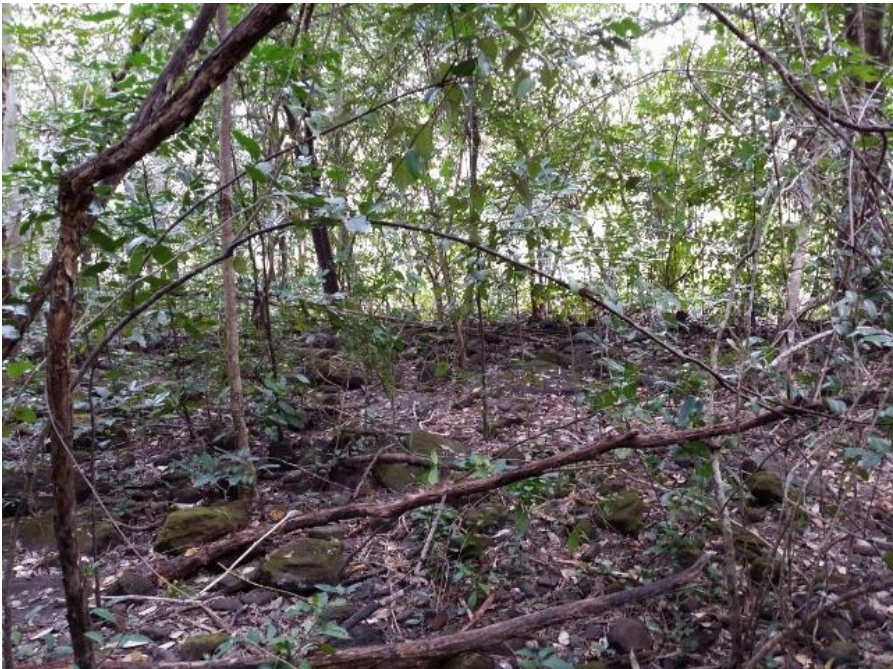
Site survey type	Detailed. Hand trowel	Main vegetation	Monsoonal Vine Thicket
Location	665359mE 8440001mN	Disturbance	No effective disturbance
Landform element and pattern	Undulating Plain	Micro relief	None
		Permeability	-
Slope (%)	6.0	Drainage	-
Surface coarse fragments	>95% 0-200mm coarse fragments and boulders	Surface condition	Organic Matter/leaf matter
ASC Order (s) present in SMU	Brown Tenosol	Land use	Native Vegetation
Land System (Lynch (2012))	Bundah	Substrate	Sandstone
Effective Soil Depth	0.0	Estimated Soil Water Storage	n/a
Erosion potential (Bourne and Tuck 1993)	-		
Soil quality for mine rehabilitation	<u>Recommended Topsoil Strip Depth: 0.00m</u>		
Land condition	Good condition		
Total area (ha)	1

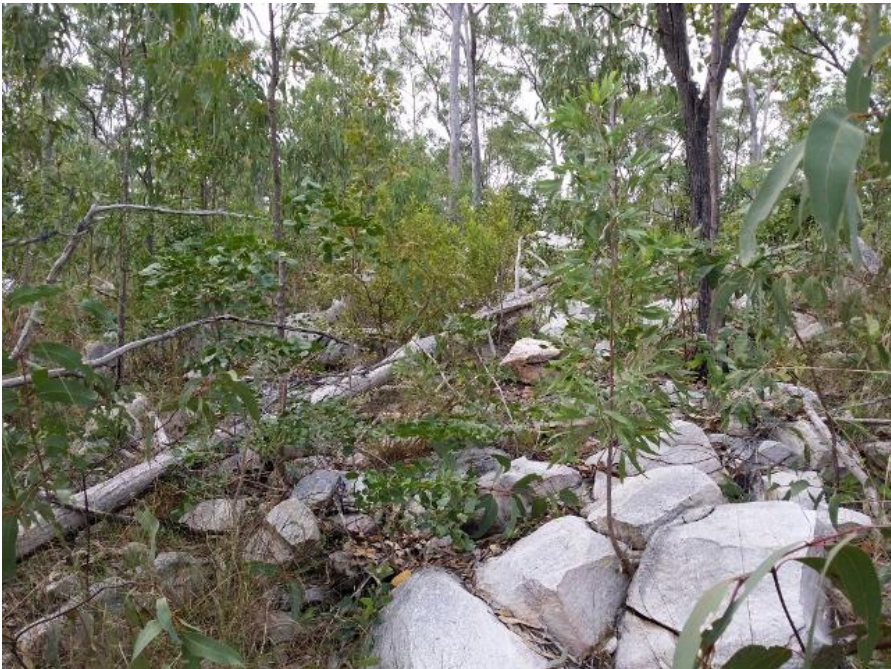
Site survey type	Detailed. Hand Trowel	Main vegetation	Stringybark, Cypress Pine
Location	659747mE 8443219mN	Disturbance	No effective disturbance
Landform element and pattern	Undulating Plains	Micro relief	None
		Permeability	Highly permeable
Slope (%)	6.5	Drainage	Rapid drainage
Surface coarse fragments	<30% <6mm <30% <20mm <20% >20mm Coarse fragments/ boulders/quartz	Surface condition	Surface is soft and dry
ASC Order (s) present in SMU	Grey Tenosol	Land use	Native Vegetation
Land System (Lynch (2012))	Groote	Substrate	Sandstone
Effective Soil Depth	<0.02m	Estimated Soil Water Storage	n/a
Erosion potential (Bourne and Tuck 1993)	This SMU generally located on low-gradient sloping areas with a sandy surface It has a low to medium water erosion hazard.		
Soil quality for mine rehabilitation	<u>Recommended Topsoil Strip Depth: 0.00m</u>

Land condition	-		
Total area (ha)	471

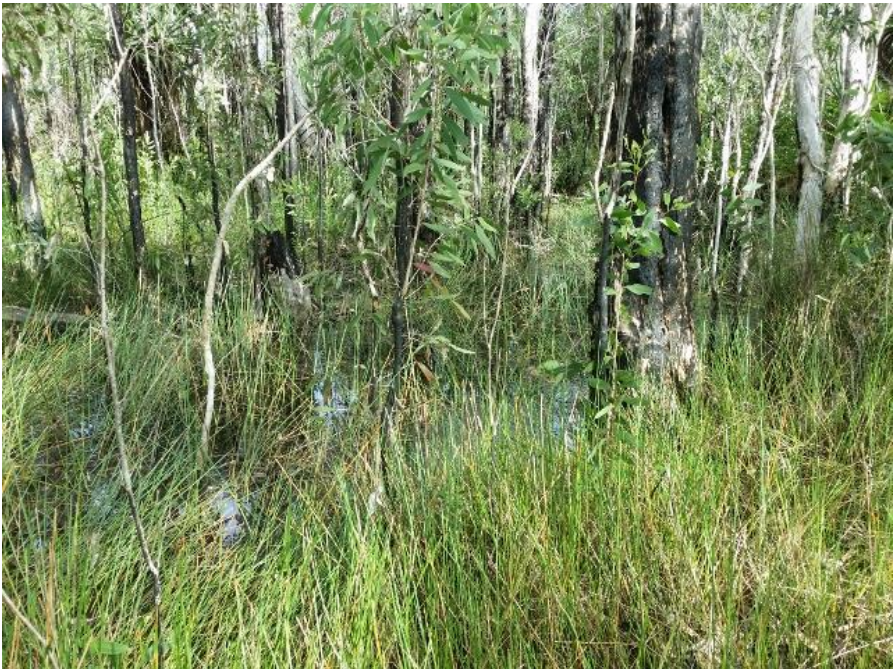
Site survey type	Detailed. 50 mm hand auger.	Main vegetation	Paperbark, Stringybark
Location	661131mE 8444231mN	Disturbance	No disturbance
Landform element and pattern	Gentle undulating plain, lower slope, gully nearby	Micro relief	Nil
		Permeability	Moderate
Slope (%)	2.0%	Drainage	Well drained
Surface coarse fragments	No coarse fragments	Surface condition	Soft, moist
ASC Order (s) present in SMU	Grey Chromosol	Land use	Native Vegetation
Land System (Lynch (2012))	Effington	Substrate	Sandstone
Effective Soil Depth	1.0m	Estimated Soil Water Storage	62mm
Erosion potential (Bourne and Tuck 1993)	This SMU has a high susceptibility to erosion if the surface is exposed.		
Soil quality for mine rehabilitation	<u>Recommended Topsoil Strip Depth: 0.15m</u>		
Land condition	Good condition		
Total area (ha)	138

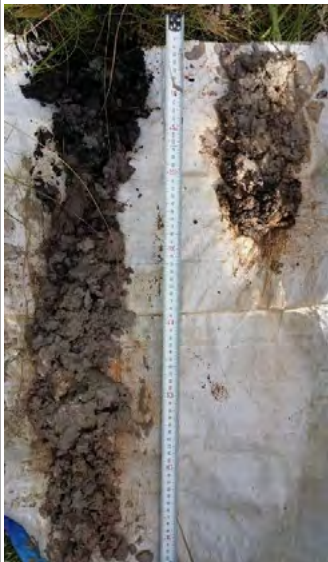
Representative site number: Site 19	HORIZON, DEPTH (m), BOUNDARY	COLOUR, MOTTLES, BLEACH	MOISTURE, IN SITU MEASUREMENTS DEPTH (m): pH and EC (mS)	TEXTURE, STRUCTURE, STRENGTH	COARSE FRAGMENTS, SEGREGATIONS, ROOTS

Horizon: A1 Horizon Depth: 0.0-0.15 Boundary: Diffuse	Colour: 10YR2/1, Black, Mottle: No mottle Bleach: No bleach	Moisture: Moist Depth 0.10m: Field pH 6.5 Meter pH 7.02 Field EC 0.00	Texture: Sandy loam Structure: Weak Strength: Weak	Coarse Fragments: No coarse fragments Segregations: No segregations Roots: Very fine, Common
	Horizon: A2 Horizon Depth: 0.15-0.48 Boundary: Abrupt	Colour: 10YR3/1, Brownish black Mottle: No mottle Bleach: No bleach	Moisture: Moist Depth 0.30m: Field pH 6.0 Meter pH 6.72 Meter EC 0.00	Texture: Loamy sand Structure: Weak Strength: Weak	Coarse Fragments: No coarse fragments Segregations: No segregations Roots: Very fine, Common
	Horizon: B21 Horizon Depth: 0.48-0.85 Boundary: Abrupt	Colour: 10YR5/1, Brownish grey Mottle <25% 2.5YR4/8 Bleach: No bleach	Moisture: Wet Depth 0.60m: Field pH 6.0 Meter pH 6.62 Meter EC 0.00	Texture: Clay loam Structure: Weak Strength: Moderate	Coarse Fragments: No coarse fragments Segregations: No segregations Roots: Very fine, Common

Horizon: B22 Horizon Depth: 0.85-1.00	Colour: 10YR3/2, Brownish black Mottle: No mottle Bleach: No bleach	Moisture: Wet Depth 0.90m: Field pH 6.0 Meter pH 6.82 Meter EC 0.00	Texture: Clay loam, Structure: Weak, Strength: Moderate	Coarse Fragments: <10% <20mm coarse fragments Segregations: No segregations Roots: No Roots

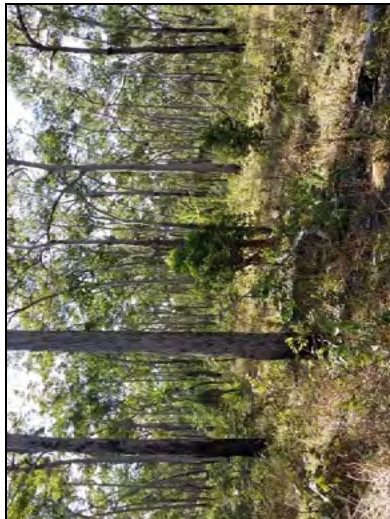
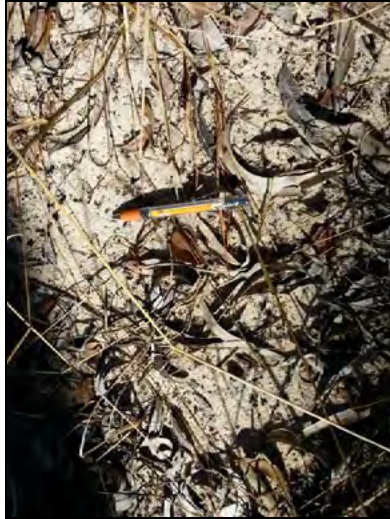
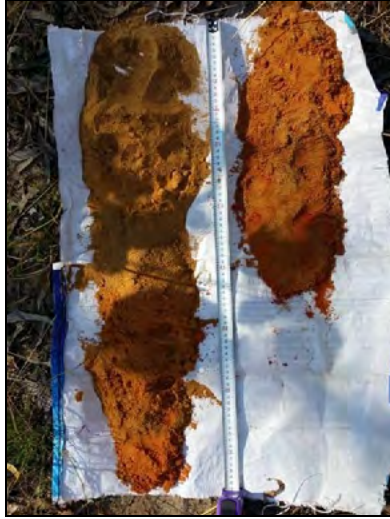
Soil Mapping Unit: B1	Land Systems, Lynch (2012): Bundah	Location (GDA ZONE 53): 659124mE 8446957mN	Aust. Soil Class.: Brown Tenosol	Site Survey Type: Detailed - 50mm hand auger	Survey Date: 13/06/2014
---------------------------------	--	--	--	--	-----------------------------------

Land use Landform Pattern, Element, Slope	Natural Vegetation	Microrelief Disturbance Erosion	Surface condition, surface rock	Soil Profile Description										Observations
				Horizon Depth (m), Boundary	Texture	Structure, Strength	Inclusions Segregations	Colour, Mottle	Moisture, Drainage	Roots	Depth (m) / Field pH	Sample (m)		
Native Vegetation Gentle Undulating Plain Midslope 3.5%	Tall open woodland including Eucalypts 20% cover Native Shrubs and grasses	Nil microrelief Nil Disturbance Nil Erosion	Soft, sandy, no coarse fragment observed	A11 0.00-0.68 Diffuse	Sand	Massive, Loose	<2% <5mm Manganese nodules	10YR4/3 Brown Nil mottle	Dry, rapid	Very fine, very few roots	0.05 - 7.0pH/ EC 0.30 - 7.0pH/ EC 0.60 - 7.0pH/ EC	0.0-0.10 0.30-0.40 0.60-0.68	-	
				A2 0.68-1.15	Loamy Sand	Massive, Very weak	<2% <5mm Manganese nodules	5YR5/8 Yellowish red Mottle ~40% 10YR4/3 Brown	Dry, rapid	No roots observed	0.90 - 7.0pH/ EC	1.0-1.10

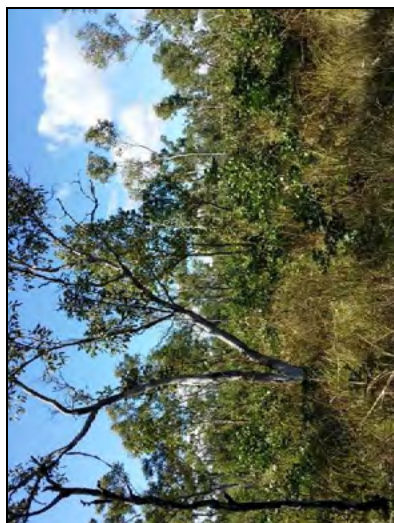
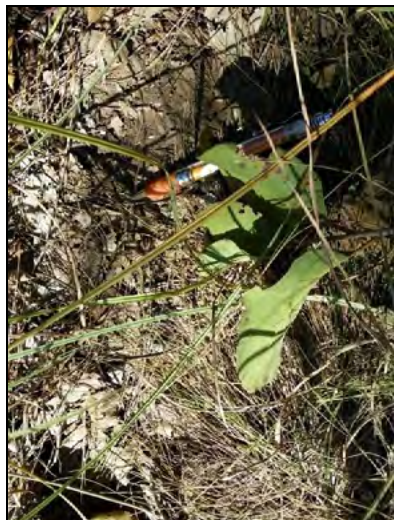
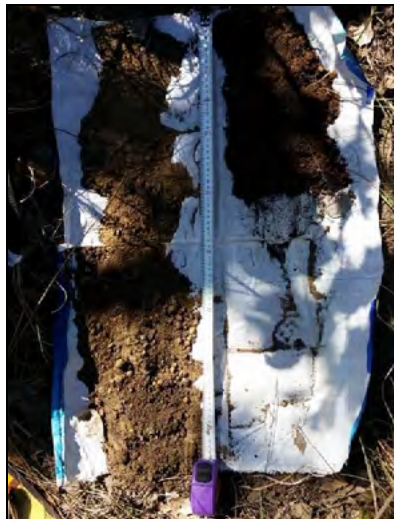
SITE 2

Soil Mapping Unit: B1	Land Systems, Lynch (2012): Bundah	Location (GDA ZONE 53): 660821mE 8446560mN	Aust. Soil Class. : Brown Tenosol	Site Survey Type: Detailed - 50mm hand auger	Survey Date: 13/06/2014
---------------------------------	--	--	---	--	-----------------------------------

Land use Landform Pattern, Element, Slope	Natural Vegetation	Microrelief Disturbance Erosion	Surface condition, surface rock	Soil Profile Description									
				Horizon Depth (m), Boundary	Texture	Structure, Strength	Inclusions Segregations	Colour, Mottle	Moisture, Drainage	Roots	Depth (m) / Field pH	Sample (m)	Observations
Native Vegetation Gentle Undulating Plain Flat Plain 0.5%	Tall open woodland including Eucalypts 20% cover Native Shrubs and grasses	Nil microrelief Nil Disturbance Nil Erosion	Firm, sandy, <5% 2-6mm coarse fragments	A11 0.0-0.40 Clear	Loamy Sand	Massive, very weak	<2% 2-6mm coarse fragments	10YR3/2 Very dark greyish brown Nil mottle	Dry, Rapid	Fine, few	0.10 - 6.5pH 0.30 - 6.5pH	0.0-0.10 0.30-0.40	-
				A12 0.40-0.70 Abrupt	Loamy Sand	Massive, very weak	<5% 5-20mm coarse fragments	10YR2/2 Very dark brown Nil mottle	Dry, Rapid	Fine, few	0.60 - 6.5pH	0.60-0.70	
				A2 0.70-1.00	Loamy Sand	Massive, very weak	<20% 0.5mm coarse fragments <20% 0.5mm Manganese	10YR2/1 Black Nil mottle	Dry, Rapid	-	0.90 - 6.5pH	0.90-1.00

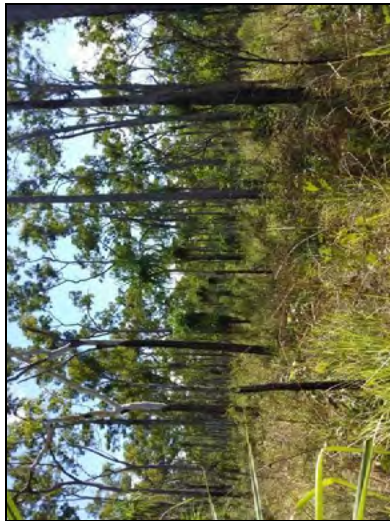
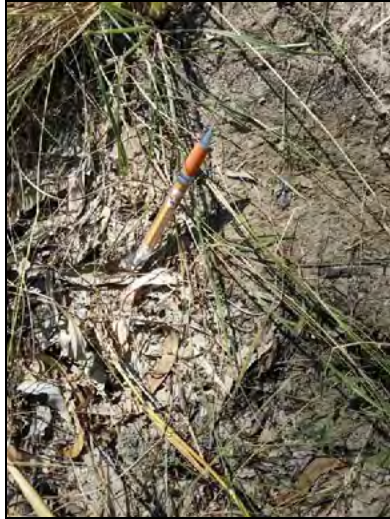
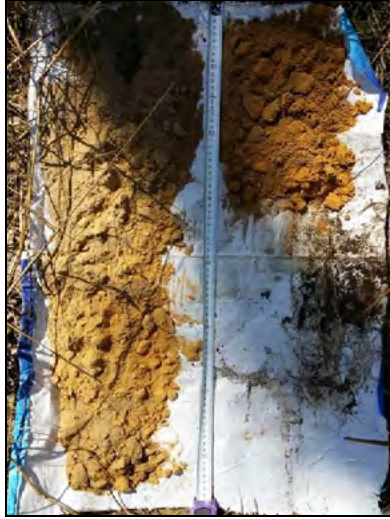
SITE 3

Soil Mapping Unit: B2	Land Systems, Lynch (2012): Yarrawirrie	Location (GDA ZONE 53): 662772mE 8448457mN	Aust. Soil Class. : Brown Kandosol	Site Survey Type: Detailed - 50mm hand auger	Survey Date: 13/06/2014
---------------------------------	---	--	--	--	-----------------------------------

Land use Landform Pattern, Element, Slope	Natural Vegetation	Microrelief Disturbance Erosion	Surface condition, surface rock	Soil Profile Description							Observations	
				Horizon Depth (m), Boundary	Texture	Structure, Strength	Inclusions Segregations	Colour, Mottle	Moisture, Drainage	Roots		Depth (m) / Field pH
Native Vegetation Gentle Undulating Plain Mid slope 3.0%	Tall open woodland including Eucalypts 20% cover Native Shrubs and grasses	Nil microrelief Nil Disturbance Nil Erosion	Soft, sandy, No coarse fragments	A1 0.0-0.20 Abrupt	Sand	Massive, loose	<2% 2-6mm coarse fragments	10YR4/1 Dark gray Nil mottle	Dry, Rapid	Very fine, few	0.05 - 7.0pH	-
				B2 0.20-1.00	Sandy Clay Loam	Massive, very weak	<2% 2-6mm coarse fragments	10YR6/4 Light yellowish brown Nil mottle	Dry, Rapid	Very fine, few	0.30 - 7.0pH 0.60 - 7.0pH 0.90 - 7.0pH	-

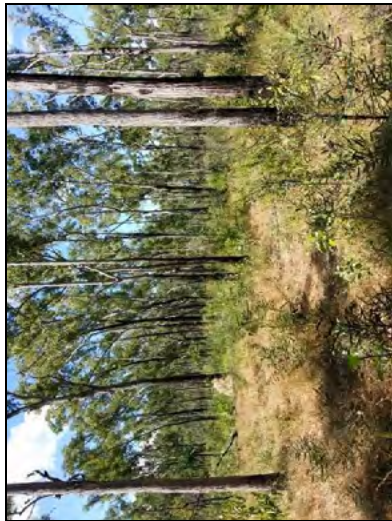
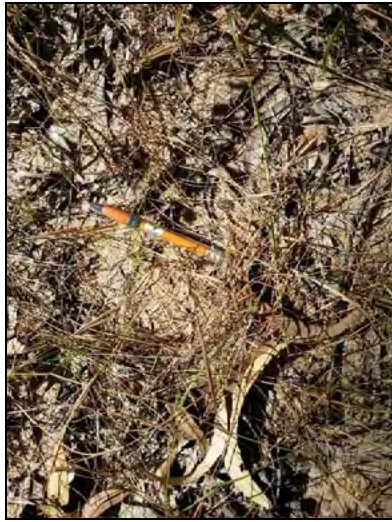
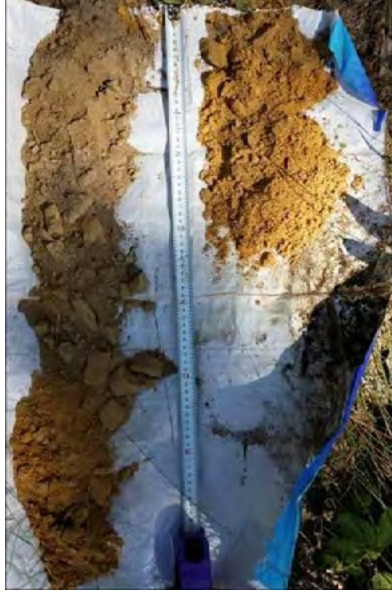
SITE 4

Soil Mapping Unit: B1	Land Systems, Lynch (2012): Bundah	Location (GDA ZONE 53): 663439mE 8449735mN	Aust. Soil Class. : Brown Tenosol	Site Survey Type: Detailed - 50mm hand auger	Survey Date: 13/06/2014
---------------------------------	--	--	---	--	-----------------------------------

Land use Vegetation Pattern, Element, Slope	Natural Vegetation	Microrelief Disturbance Erosion	Surface condition, surface rock	Soil Profile Description							Observations		
				Horizon Depth (m), Boundary	Texture	Structure, Strength	Inclusions Segregations	Colour, Mottle	Moisture, Drainage	Roots		Depth (m) / Field pH	Sample (m)
Native Vegetation Gentle Undulating Plain Mid slope 4.0%	Tall open woodland including Eucalypts 20% cover Native Shrubs and grasses	Nil microrelief Nil Disturbance Nil Erosion	Firm, sandy, No coarse fragments	A1 0.0-0.40 Abrupt	Sand	Massive, loose	-	10YR4/1 Dark gray Nil mottle	Dry, Rapid	Very fine, few	0.05 - 7.0pH 0.30 - 7.0pH	-	-
				A2 0.40-1.00	Loamy Sand	Massive, very weak	-	10YR6/4 Light yellowish brown Nil mottle	Dry, Rapid	Very fine, few	0.60 - 7.0pH 0.90 - 7.0pH	-

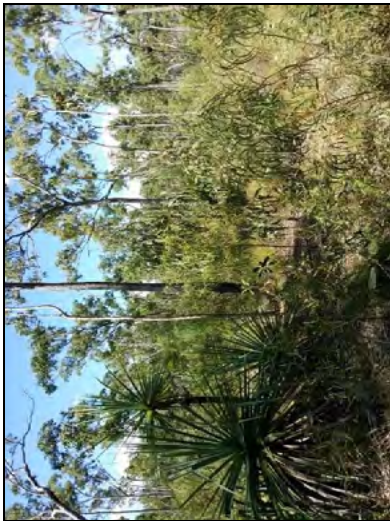
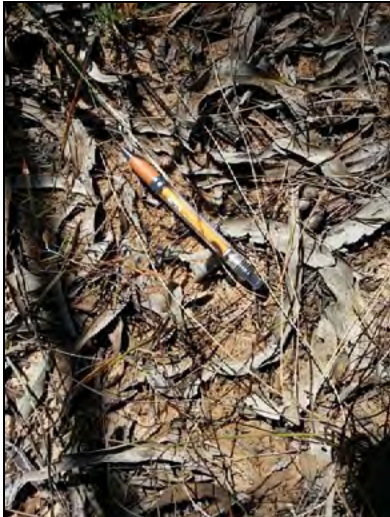
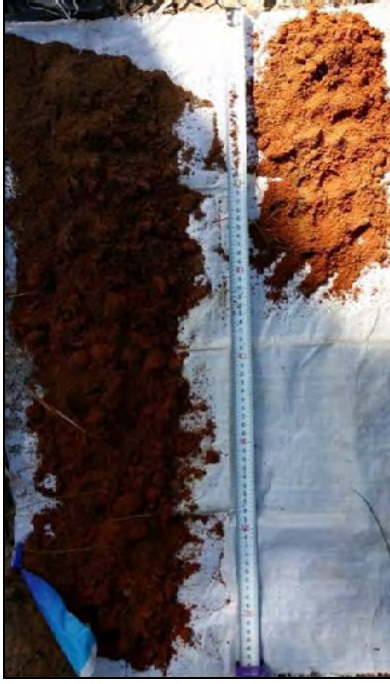
SITE 5

Soil Mapping Unit: B1	Land Systems, Lynch (2012): Bundah	Location (GDA ZONE 53): 665639mE 8449753mN	Aust. Soil Class.: Brown Tenosol	Site Survey Type: Detailed - 50mm hand auger	Survey Date: 13/06/2014
---------------------------------	--	--	--	--	-----------------------------------

Land use Landform Pattern, Element, Slope	Natural Vegetation	Microrelief Disturbance Erosion	Surface condition, surface rock	Soil Profile Description								Observations	
				Horizon Depth (m), Boundary	Texture	Structure, Strength	Inclusions Segregations	Colour, Mottle	Moisture, Drainage	Roots	Depth (m) / Field pH / Meter pH Meter / EC (mS)		Sample (m)
Native Vegetation Gentle Undulating Plain Mid slope 3.0%	Tall open woodland including Eucalypts 20% cover Native Shrubs and grasses	Nil microrelief Nil Disturbance Nil Erosion	Firm, sandy, No coarse fragments	A11	Loamy sand	Massive, loose	<2% 2-6mm coarse fragments	7.5YR3/4 Dark brown Nil mottle	Dry, Rapid	Fine, very few	0.05 - 6.5pH/ 7.94pH / 0.00 0.30 - 6.5pH/ 7.68pH / 0.00	0.0-0.10 0.30-0.40	-
				A12	Loamy Sand	Massive, loose	<2% 2-6mm coarse fragments	2.5YR3/4 Dark reddish brown Nil mottle	Dry, Rapid	Fine, very few	0.60 - 6.5pH/ 7.74pH / 0.00 0.90 - 6.5pH/ 7.52pH / 0.00	0.60-0.70 0.90-1.00

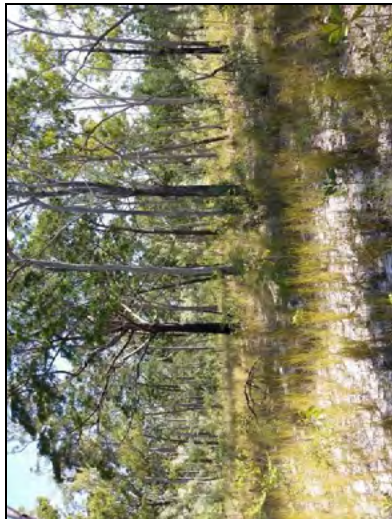
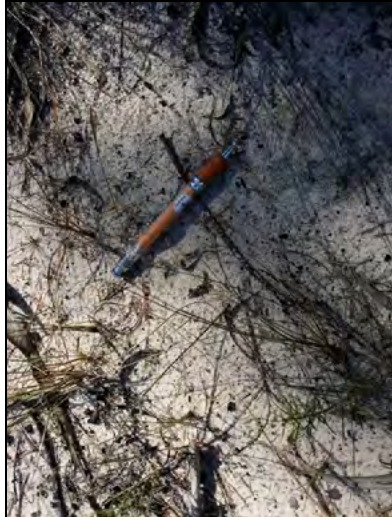
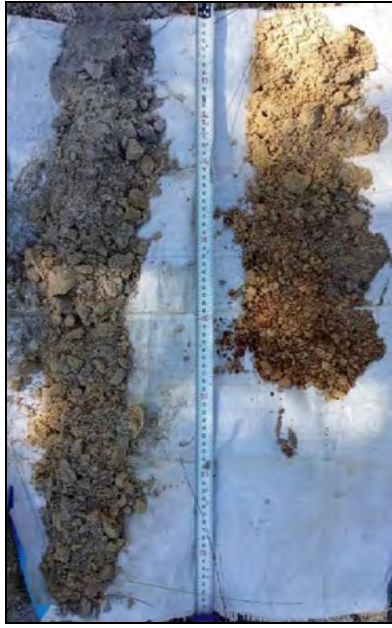
SITE 6

Soil Mapping Unit: B1v	Land Systems, Lynch (2012): Bundah	Location (GDA ZONE 53): 665414mE 8449066mN	Aust. Soil Class. : Grey Tenosol	Site Survey Type: Detailed - 50mm hand auger	Survey Date: 13/06/2014
----------------------------------	--	--	--	--	-----------------------------------

Soil Profile Description										Observations
Land use Landform Pattern, Element, Slope	Natural Vegetation	Microrelief Disturbance Erosion	Surface condition, surface rock	Horizon Depth (m), Boundary	Texture	Structure, Strength	Inclusions Segregations	Colour, Mottle	Moisture, Drainage	Roots	Depth (m) / Field pH / Meter pH Meter / EC (mS)	Sample (m)
Native Vegetation Gentle Undulating Plain Mid slope 1.5%	Tall open woodland including Eucalypts AND Casuarinas <20% cover Native Shrubs and grasses	Nil microrelief Nil Disturbance Nil Erosion	Firm, light grey sandy, No coarse fragments	A11 0.0-0.20 Diffused	Sand	Massive, loose	-	10YR6/1 Brownish Gray Nil mottle	Dry, Rapid	Very fine, few	0.05 - 6.5pH/ 7.92pH / 0.00	0.0-0.10
				A12 0.20-0.90 Gradual	Loamy Sand	Massive, very weak	-	10YR6/2 Light brownish gray Nil mottle	Dry, Rapid	Very fine, few	0.30 - 6.5pH/ 7.58pH / 0.00 0.60 - 6.5pH/ 7.40pH / 0.00	0.30-0.40 0.60-0.70

A2 0.90-1.15	Sandy Clay Loam	Weak, very weak	<40%, 2-6mm coarse fragments	5YR6/3 Dull orange Nil mottle	Dry, Rapid	-	0.95 - 6.5pH/ 7.22pH / 0.00	0.95-1.00

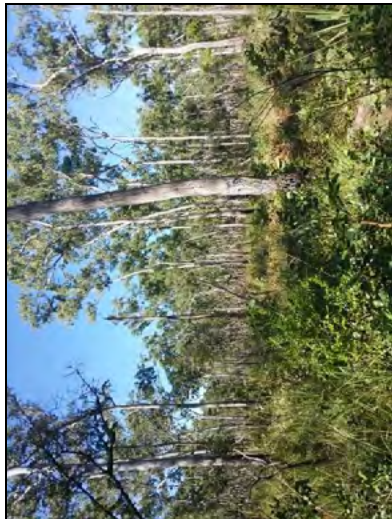
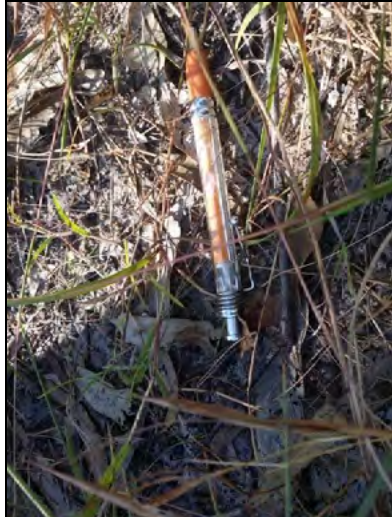
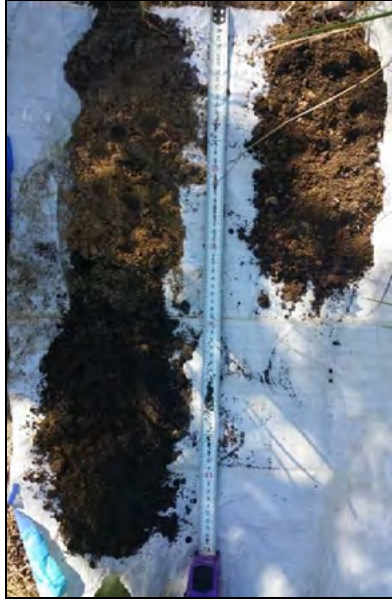
Soil Mapping Unit: B2	Land Systems, Lynch (2012): Yarrawirrie	Location (GDA ZONE 53): 664316mE 8447989mN	Aust. Soil Class. : Brown Kandosol	Site Survey Type: Detailed - 50mm hand auger	Survey Date: 13/06/2014
---------------------------------	---	--	--	--	-----------------------------------

Land use Landform Pattern, Element, Slope	Natural Vegetation	Microrelief Disturbance Erosion	Surface condition, surface rock	Soil Profile Description								Observations	
				Horizon Depth (m), Boundary	Texture	Structure, Strength	Inclusions Segregations	Colour, Mottle	Moisture, Drainage	Roots	Depth (m) Meter pH Meter / EC (mS)		Sample (m)
Native Vegetation Gentle Undulating Plain Mid slope 3.5%	Tall open woodland including Eucalypts AND Casuarinas <20% cover Native Shrubs and grasses	Nil microrelief Nil Disturbance Nil Erosion	Firm, <10% 2-6mm coarse fragments	A11 0.0-0.20 Abrupt	Loamy sand	Massive, loose	-	10YR3/2 Very dark greyish brown Nil mottle	Dry, Rapid	Very fine, few	0.10 -7.87pH / 0.00	0.0-0.10	-
				A12 0.20-0.30 Abrupt	Loamy Sand	Massive, very weak	-	10YR4/2 Dark greyish brown Nil mottle	Dry, Rapid	Very fine, very few	0.30 -7.05pH / 0.00	-	
				B2 0.30-1.15	Sandy Clay Loam	Weak, very weak	<40% 2-6mm coarse fragments	10YR2/2 Very dark brown Nil mottle	Dry, Rapid	-	0.60 -7.36pH / 0.00 0.90 -7.29pH / 0.00	0.30-0.40 0.60-0.70 0.95-1.00

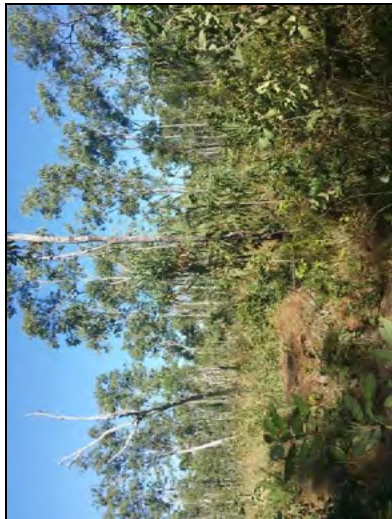
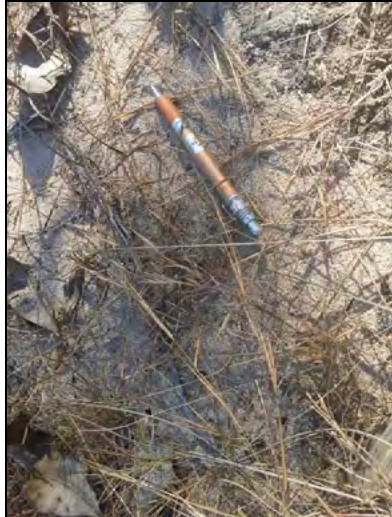
SITE 8

Soil Mapping Unit: B1	Land Systems, Lynch (2012): Bundah	Location (GDA ZONE 53): 664175mE 8446998mN	Aust. Soil Class. : Brown Tenosol	Site Survey Type: Detailed - 50mm hand auger	Survey Date: 13/06/2014
---------------------------------	--	--	---	--	-----------------------------------

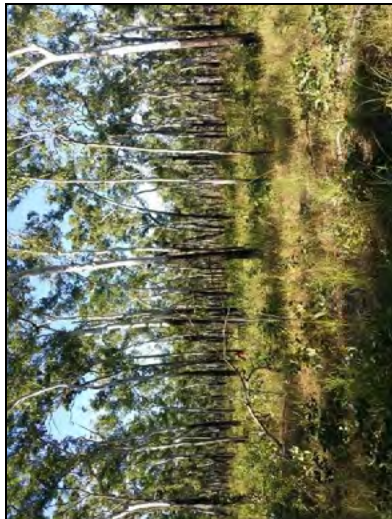
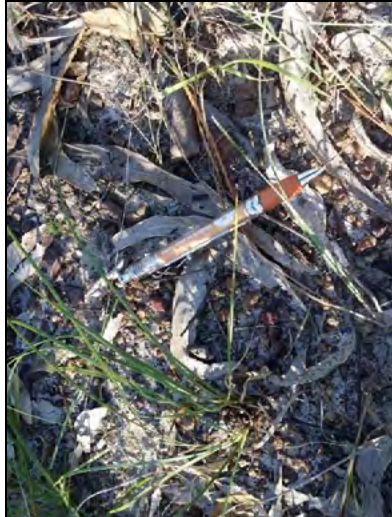
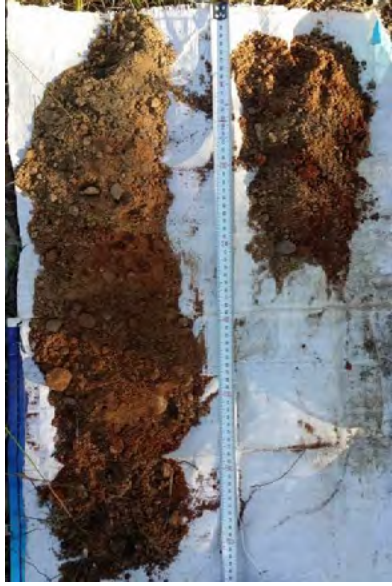
Soil Mapping Unit: B1	Land Systems, Lynch (2012): Bundah	Location (GDA ZONE 53): 665692mE 8446994mN	Aust. Soil Class. : Brown Tenosol	Site Survey Type: Detailed - 50mm hand auger	Survey Date: 13/06/2014
---------------------------------	--	--	---	--	-----------------------------------

Land use Vegetation Pattern, Element, Slope	Natural Vegetation	Microrelief Disturbance Erosion	Surface condition, surface rock	Soil Profile Description							Observations		
				Horizon Depth (m), Boundary	Texture	Structure, Strength	Inclusions Segregations	Colour, Mottle	Moisture, Drainage	Roots		Depth (m) / Field pH	Sample (m)
Native Vegetation Gentle Undulating Plain Flat Plain 2.5%	Tall open woodland including Eucalypts Native Shrubs and grasses	Nil microrelief Nil Disturbance Nil Erosion	Firm, <10% 2-6mm coarse fragments <5% 2-6mm Manganese	A11 0.0-0.30 Abrupt	Loamy sand	Massive, loose	<10%, 2-6mm coarse fragments	10YR5/3 Brown Nil mottle	Dry, Rapid	Very fine, few	0.10 - 6.5pH	0.0-0.10	-
				A12 0.30-1.00	Loamy Sand	Massive, loose	<30%, 2-6mm <2% >10mm coarse fragments	5YR5/3 Reddish brown Mottle 10YR5/3 Brown<20%	Dry, Rapid	-	0.30 - 6.5pH 0.60 - 6.5pH 0.90 - 6.5pH	0.30-0.40 0.60-0.70 0.90-1.00

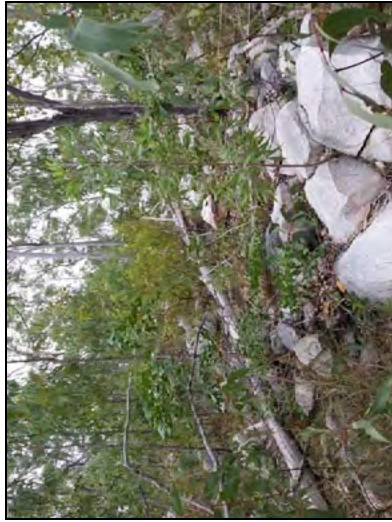
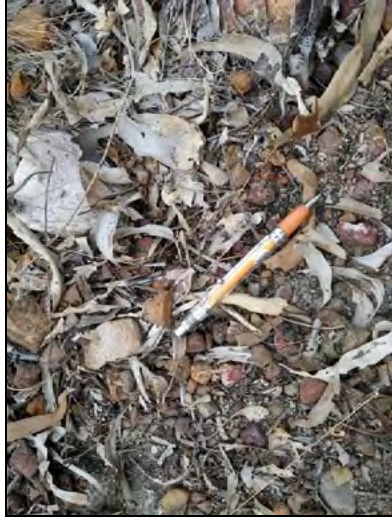
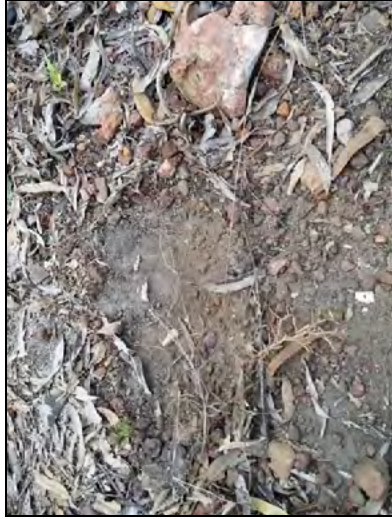
SITE 10

Soil Mapping Unit: Q1	Land Systems, Lynch (2012): Croote	Location (GDA ZONE 53): 659747mE 8443219mN	Aust. Soil Class. : Grey Tenosol	Site Survey Type: Detailed - 50mm hand auger	Survey Date: 14/06/2014
---------------------------------	--	--	--	--	-----------------------------------

Soil Profile Description													
Land use Landform Pattern, Element, Slope	Natural Vegetation	Microrelief Disturbance Erosion	Surface condition, surface rock	Horizon Depth (m), Boundary	Texture	Structure, Strength	Inclusions Segregations	Colour, Mottle	Moisture, Drainage	Roots	Depth (m) / Field pH / Meter pH Meter / EC (mS)	Sample (m)	Observations
Native Vegetation Gentle Undulating Plain Mid slope 6.5%	Tall open woodland including Eucalypts Native Shrubs and grasses	Nil microrelief Nil Disturbance Nil Erosion	Soft, <30% <6mm <30% <20mm <20% >20mm Coarse fragments/ boulders/ quartz	A1 0.0-0.02	Clayey Sand	Massive, loose	As surface	10YR7/1 Light Gray Nil mottle	Dry, Rapid	Fine, few	0.02 - 6.5pH / 6.24pH / 0.00	0.0-0.02	Rocky outcrop

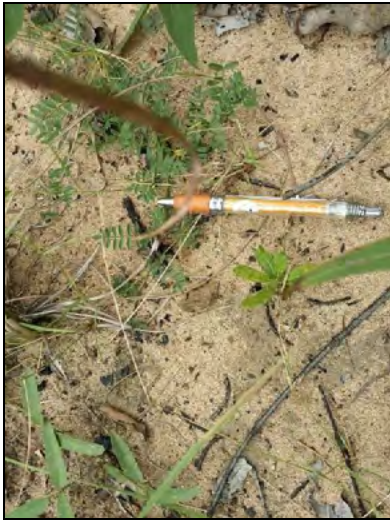
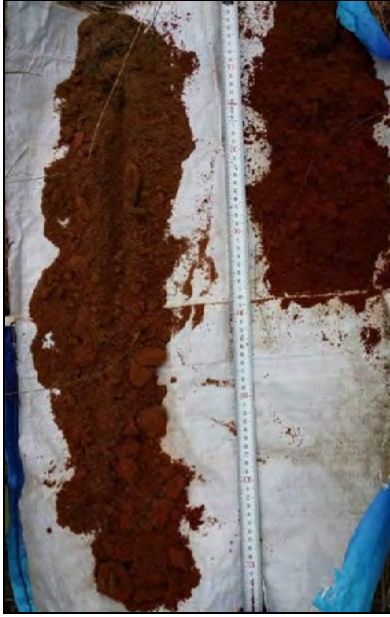
SITE 11

Land use Vegetation Pattern, Element, Slope	Natural Vegetation	Microrelief Disturbance Erosion	Surface condition, surface rock	Soil Profile Description									
				Horizon Depth (m), Boundary	Texture	Structure, Strength	Inclusions Segregations	Colour, Mottle	Moisture, Drainage	Roots	Depth (m) / Field pH	Sample (m)	Observations
Native Vegetation Gentle Undulating Plain Mid slope 3.0%	Tall open woodland including Eucalypts Native Shrubs and grasses	Nil microrelief Nil Disturbance Nil Erosion	Soft, light yellow brown, sandy, no coarse fragments	A11 0.0-0.15 Abrupt	Loamy sand	Massive, loose	-	10YR3/2 Very dark greyish brown Nil mottle	Dry, Rapid	Fine, few	0.05 - 6.5pH	0.0-0.05	-
				A12 0.15-0.53 Abrupt	Loamy Sand	Massive, weak	-	7.5YR3/4 Dark brown Nil mottle	Dry, Rapid	Very fine, few	0.30 - 6.5pH	0.30-0.40	
				A21 0.53-0.85 Abrupt	Loamy sand	Massive, weak	-	2.5YR4/4 Reddish brown Nil mottle	Dry, Rapid	-	0.60 - 6.5pH	0.60-0.70

A22 0.85-1.10	Loamy sand	Massive, weak	-	2.5YR3/4 Dark reddish brown Nil mottle	Dry, Rapid	-	0.90 - 6.5pH	0.90-1.00

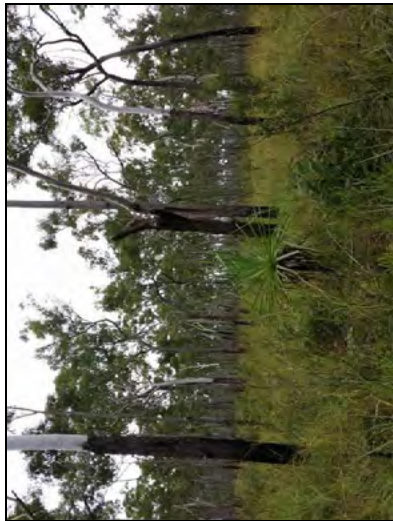
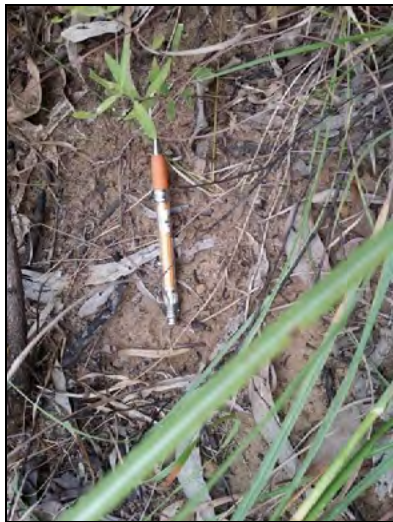
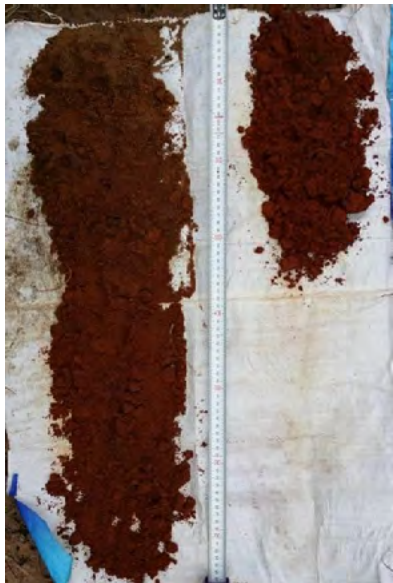
Soil Mapping Unit: B1	Land Systems, Lynch (2012): Bundah	Location (GDA ZONE 53): 663470mE 8441043mN	Aust. Soil Class. : Brown Tenosol	Site Survey Type: Detailed - 50mm hand auger	Survey Date: 14/06/2014
---------------------------------	--	--	---	--	-----------------------------------

Soil Profile Description													
Land use Landform Pattern, Element, Slope	Natural Vegetation	Microrelief Disturbance Erosion	Surface condition, surface rock	Horizon Depth (m), Boundary	Texture	Structure, Strength	Inclusions Segregations	Colour, Mottle	Moisture, Drainage	Roots	Depth (m) / Field pH	Sample (m)	Observations
Native Vegetation Gentle Undulating Plain Flat plain <0.5%	Tall open woodland including Eucalypts Native Shrubs and grasses	Nil microrelief Nil Disturbance Nil Erosion	Soft, light yellow brown, sandy, no coarse fragments	A11 0.0-0.15 Abrupt	Loamy sand	Massive, loose	-	10YR3/2 Very dark greyish brown Nil mottle	Dry, Rapid	Fine, few	0.05 - 6.5pH	-	-
				A12 0.15-0.40 Abrupt	Loamy Sand	Massive, weak	-	10YR3/4 Dark yellowish brown Nil mottle	Dry, Rapid	Very fine, few	0.30 - 6.5pH	-	-
				A21 0.40-0.80 Abrupt	Loamy sand	Massive, weak	-	2.5YR4/4 Reddish brown Nil mottle	Dry, Rapid	-	0.60 - 6.5pH	-	-

A22 0.80-1.00	Loamy sand	Massive, weak	-	2.5YR3/4 Dark reddish brown Nil mottle	Dry, Rapid	-	0.90 - 6.5pH	-	-

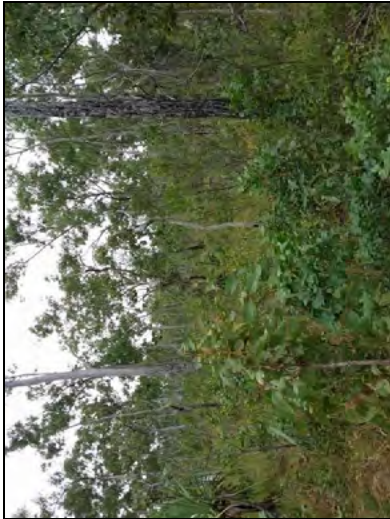
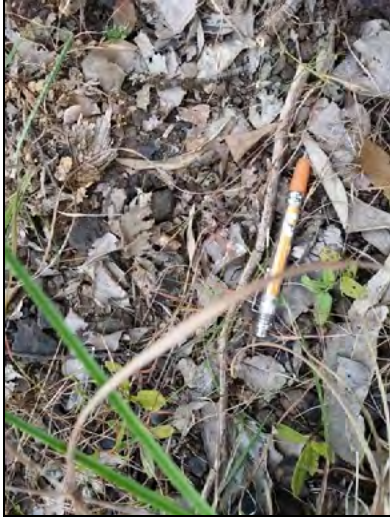
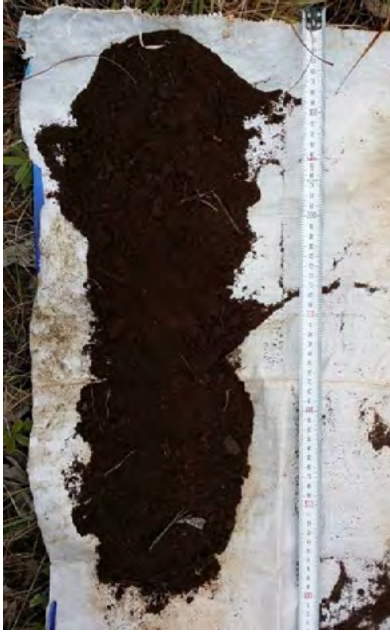
Soil Mapping Unit: B1	Land Systems, Lynch (2012): Bundah	Location (GDA ZONE 53): 66850mE 8440234mN	Aust. Soil Class. : Brown Tenosol	Site Survey Type: Detailed - 50mm hand auger	Survey Date: 14/06/2014
---------------------------------	--	---	---	--	-----------------------------------

Soil Profile Description											
Land use Landform Pattern, Element, Slope	Natural Vegetation	Microrelief Disturbance Erosion	Surface condition, surface rock	Horizon Depth (m), Boundary	Texture	Structure, Strength	Inclusions Segregations	Colour, Mottle	Moisture, Drainage	Roots	Depth (m) / Field pH	Sample (m)	Observations
Native Vegetation Gentle Undulating Plain Midslope 5.0%	Tall open woodland including Narrow trunk Eucalypts Native Shrubs and grasses	Nil microrelief Nil Disturbance Minor sheet erosion observed	Firm, sandy, <30% 10-50mm coarse fragments	A11 0.0-0.40 Abrupt	Loamy sand	Massive, loose	<5% 5-10mm coarse fragments	10YR2/2 Very dark brown Nil mottle	Dry, Rapid	Fine, few	0.10 - 6.5pH 0.30 - 6.5pH	0.0-0.10	Manganese outcrops nearby. Five borehole attempts. Refusal at 0.20-0.30m at four locations.
				A12 0.40-0.60 Abrupt	Loamy Sand	Massive, loose	<10% 5-10mm coarse fragments	10YR2/2 Very dark brown Nil mottle	Dry, Rapid	Fine, few	0.50 - 6.5pH	0.40-0.50

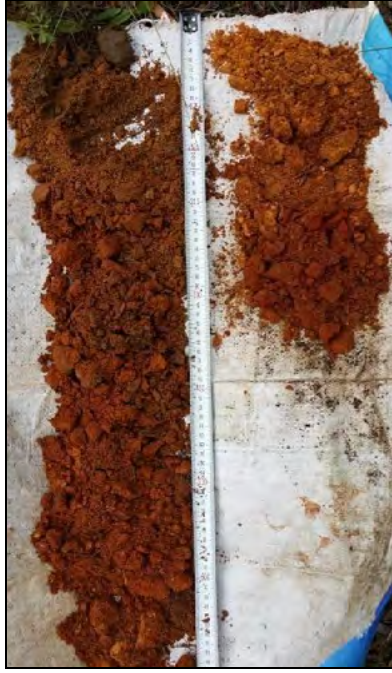
Land use Landform Pattern, Element, Slope	Natural Vegetation	Microrelief Disturbance Erosion	Surface condition, surface rock	Soil Profile Description								Observations	
				Horizon Depth (m), Boundary	Texture	Structure, Strength	Inclusions Segregations	Colour, Mottle	Moisture, Drainage	Roots	Depth (m) / Field pH		Sample (m)
Native Vegetation Gentle Undulating Plain Midslope 3.0%	Tall open woodland including Eucalypts Native Shrubs and grasses	Nil microrelief Nil disturbance Nil erosion	Sandy, <2% 2-6mm Manganese nodules	A11 0.0-0.07 Abrupt (Ab)	Loamy sand	Massive, loose	-	10YR4/2 Dark grayish brown Nil mottle	Dry, Rapid	Very fine, very few	0.05 - 7.0pH	-	-
				A12 0.07-0.40 Ab	Loamy Sand	Massive, loose	-	10YR5/4 Yellowish brown Nil mottle	Dry, Rapid	Very fine, very few	0.30 - 7.0pH	-	-
				A21 0.40-0.70 Ab	Loamy Sand	Weak, polyhedral	-	5YR5/6 Yellowish red Mottle <5% 10YR3/2 Very dark greyish brown	Dry, Rapid	Very fine, very few	0.60 - 6.5pH	-	-

A22 0.70-0.90 Ab	Loamy Sand	Weak, polyhedral	<2% 2-6mm Manganese nodules	7.5YR5/6 Yellowish red Nil mottle	Dry, Rapid	-	0.80 - 6.5pH	-	-
				A23 0.90-1.00	Loamy Sand	Weak, polyhedral	<2% 2-6mm Mg nodules	5YR4/6 Yellowish red Nil mottle	Dry, Rapid	-	1.00 - 6.5pH	-	-

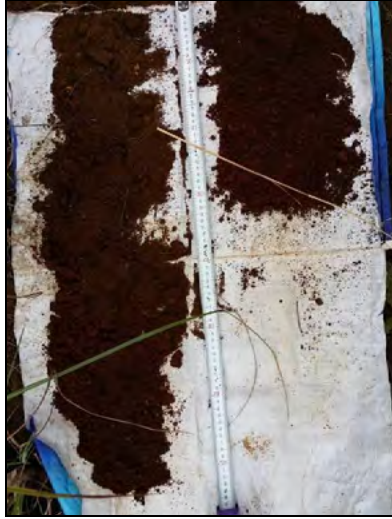
Land use Vegetation Pattern, Element, Slope	Natural Vegetation	Microrelief Disturbance Erosion	Surface condition, surface rock	Soil Profile Description								Observations	
				Horizon Depth (m), Boundary	Texture	Structure, Strength	Inclusions Segregations	Colour, Mottle	Moisture, Drainage	Roots	Depth (m) / Field pH		Sample (m)
Native Vegetation Gentle Undulating Plain Midslope 1.0%	Tall open woodland including Eucalypts Native Shrubs and grasses	Nil microrelief Nil disturbance Nil erosion	Firm, Sandy, <2% 2-6mm Coarse Manganese nodules	A1	Loamy sand	Weak, very weak	<2% 2-6mm Manganese	10YR2/2 Very dark brown Nil mottle	Dry, Rapid	Very fine, very few	0.10 – 6.5pH	0.00-0.10	Site similar to site 13 however no Mg outcrops observed
				A2	Clayey sand	Weak, weak	<2% 2-6mm Manganese	5YR3/3 Dark reddish brown Nil mottle	Dry, Rapid	Very fine, very few	0.30 – 6.5pH	0.30-0.40	
				A3	Loamy Sand	Weak, Very weak	<10% 2-6mm Manganese	5YR3/3 Dark reddish brown Nil mottle	Dry, Rapid	-	0.90 – 6.5pH	0.60-0.70

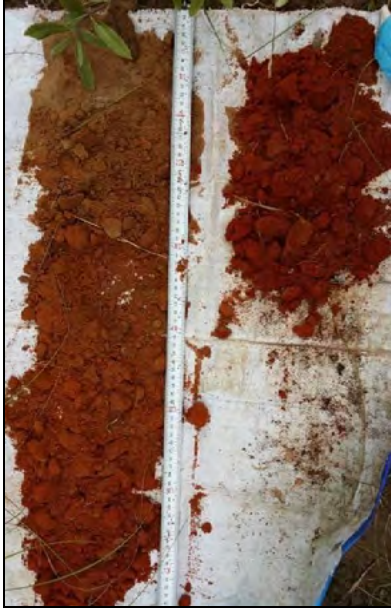
Soil Profile Description											
Land use Landform Pattern, Element, Slope	Natural Vegetation	Microrelief Disturbance Erosion	Surface condition, surface rock	Horizon Depth (m), Boundary	Texture	Structure, Strength	Inclusions Segregations	Colour, Mottle	Moisture, Drainage	Roots	Depth (m) / Field pH	Sample (m)	Observations
Native Vegetation Gentle Undulating Plain Upper slope 3.0%	Tall open woodland including Eucalypts Native Shrubs and grasses	Nil microrelief Nil disturbance Nil erosion	Firm, Sandy, <2% 2-6mm Coarse fragments and manganese nodules	A11 0.0-0.12 Abrupt	Loamy sand	Massive, weak	<2% 2-6mm Manganese nodules	10YR4/2 Dark grayish brown Nil mottle	Dry, Rapid	Very fine, very few	0.05 - 7.0pH	-	-
				A12 0.12-0.40 Diffuse	Loamy sand	Weak, polyhedral very weak	<2% 2-6mm Manganese nodules	7.5YR5/4 Brown Nil mottle	Dry, Rapid	Very fine, very few	0.30 - 7.0pH	-	-
				A21 0.40-0.70 Abrupt	Clayey sand	Weak, polyhedral very weak	-	2.5YR5/6 Yellowish red Nil mottle	Dry, Rapid	-	0.60 - 7.0pH	-	-

A22 0.70-1.00	Clayey sand	Weak, polyhedral very weak	-	2.5YR4/6 Yellowish red Nil mottle	Dry, Rapid	-	0.90 - 7.0pH	-	-

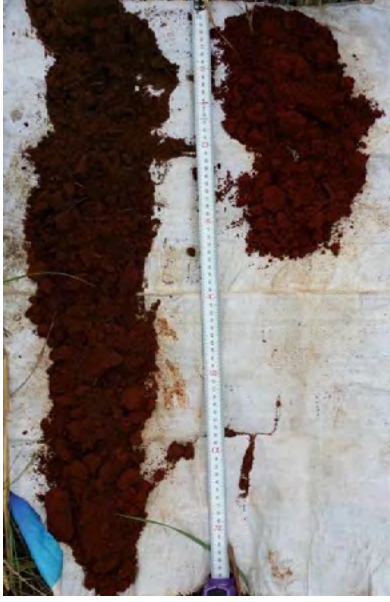
Land use Vegetation Pattern, Element, Slope	Natural Vegetation	Microrelief Disturbance Erosion	Surface condition, surface rock	Soil Profile Description										Observations
				Horizon Depth (m), Boundary	Texture	Structure, Strength	Inclusions Segregations	Colour, Mottle	Moisture, Drainage	Roots	Depth (m) / Field pH	Sample (m)		
Native Vegetation Gentle Undulating Plain Flat plain 0.5%	Tall open woodland including narrow trunk Eucalypts Native Shrubs and grasses	Nil microrelief Nil disturbance Nil erosion	Firm, Sandy, No coarse fragments	A1	Loamy sand	Weak, very weak	<2% 2-6mm Manganese	10YR2/2 Very dark brown Nil mottle	Dry, Rapid	Very fine, very few	0.10 – 6.5pH	-	Site similar to Site 15	
				A2 0.20-0.50 Abrupt	Clayey sand	Weak, weak	<2% 2-6mm Manganese	5YR3/3 Dark reddish brown Nil mottle	Dry, Rapid	Very fine, very few	0.30 – 6.5pH			
				A3 0.50-1.00	Loamy Sand	Weak, Very weak	<10% 2-6mm Manganese	5YR3/3 Dark reddish brown Nil mottle	Dry, Rapid	-	0.60 – 6.5pH 0.90 – 6.5pH

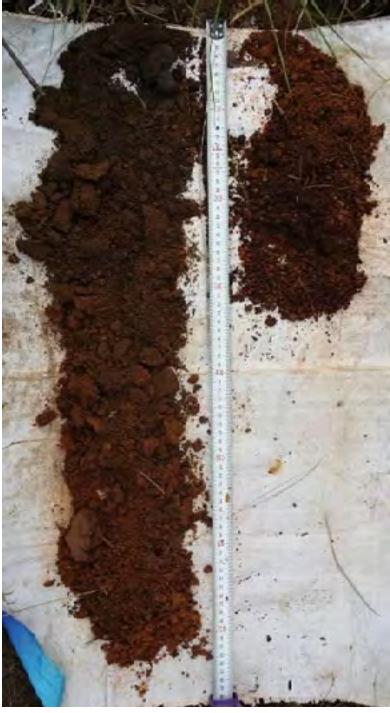
Soil Profile Description													
Land use Landform Pattern, Element, Slope	Natural Vegetation	Microrelief Disturbance Erosion	Surface condition, surface rock	Horizon Depth (m), Boundary	Texture	Structure, Strength	Inclusions Segregations	Colour, Mottle	Moisture, Drainage	Roots	Depth (m) / Field pH	Sample (m)	Observations
Native Vegetation Gentle Undulating Plain Mid slope 2.0%	Tall open woodland including narrow trunk Eucalypts Native Shrubs and grasses	Nil microrelief Nil disturbance Nil erosion	Soft, Sandy, No coarse fragments	A1 0.0-0.35 Clear	Loamy sand	Massive, very weak	-	10YR3/2 Very dark greyish brown Nil mottle	Dry, Rapid	Very fine, very few	0.05 – 7.0pH 0.30 – 6.5pH	-	-
				A21 0.35-0.80 Abrupt	Clayey sand	Weak, weak	<5% <10mm Manganese nodules	10YR4/2 Brown Nil mottle	Dry, Rapid	Very fine, very few	0.60 – 7.0pH	-	-
				A22 0.80-1.00	Clayey sand	Massive, Very weak	<30% <10mm Manganese nodules	10YR4/2 Dark greyish brown Nil mottle	Dry, Rapid	-	0.90 – 6.5pH	-	-
