Baseline Soil Assessment

EASTERN LEASES PROJECT

Prepared for Hansen Bailey
on behalf of South32 Pty Ltd
May 2015

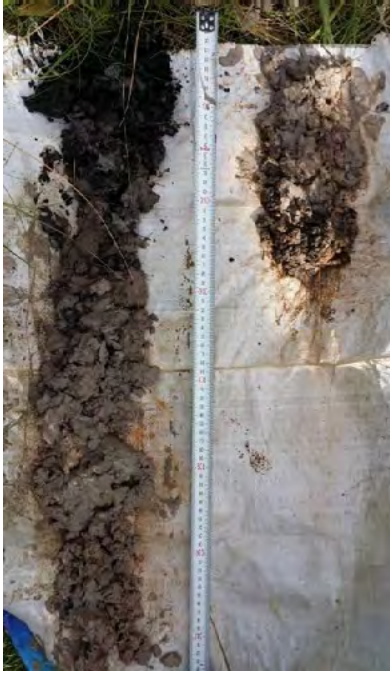
Soil Profile Description											
Land use Landform Pattern, Element, Slope	Natural Vegetation	Microrelief Disturbance Erosion	Surface condition, surface rock	Horizon Depth (m), Boundary	Texture	Structure, Strength	Inclusions Segregations	Colour, Mottle	Moisture, Drainage	Roots	Depth (m) / Field pH / Meter pH Meter / EC (mS)	Sample (m)	Observations
Native Vegetation Gentle Undulating Plain Lower slope, Gully depression nearby 2.0%	Tall open woodland including Eucalypts Native Shrubs and grasses Area recently submerged	Nil microrelief Nil disturbance Nil erosion	Soft, moist No coarse fragments	A1 0.0-0.15 Diffuse	Sandy loam	Weak, weak	-	10YR2/1 Black Black Nil mottle	Moist, Rapid	Very fine, common	0.10 – 6.5pH / 7.02pH / 0.00	-	Water table observed at 0.45m
				A2 0.15-0.48 Abrupt	Loamy sand	Weak, weak	-	10YR3/1 Brownish black Nil mottle	Moist, Rapid	Very fine, common	0.30 – 6.0pH / 6.72pH / 0.00

B21 0.48-0.85 Abrupt	Clay loam	Weak, moderate	-	10YR5/1 Brownish gray Mottle <25% 2.5YR4/8 Red	Wet, Moderate	Very fine, common	0.60 – 6.0pH / 6.62pH / 0.00		
				B22 0.85-1.00	Clay loam	Weak, moderate	<10% <20mm Coarse fragments	10YR3/2 Very dark greyish brown Nil mottle	Wet, moderate	-	0.90 – 6.0pH / 6.82pH / 0.00

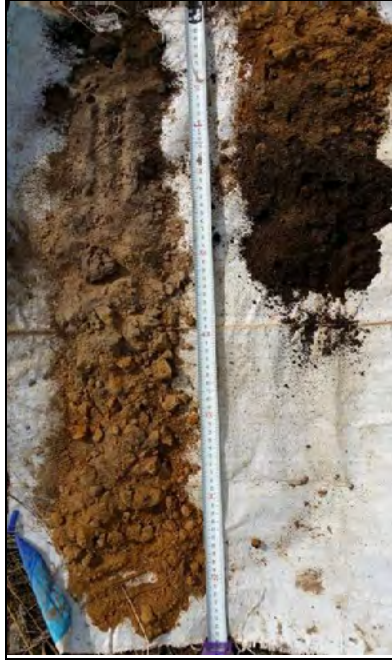
Soil Profile Description											
Land use Landform Pattern, Element, Slope	Natural Vegetation	Microrelief Disturbance Erosion	Surface condition, surface rock	Horizon Depth (m), Boundary	Texture	Structure, Strength	Inclusions Segregations	Colour, Mottle	Moisture, Drainage	Roots	Depth (m) / Field pH	Sample (m)	Observations
Native Vegetation Gentle Undulating Plain Wide ridge 2.0%	Tall open woodland including Eucalypts and Pandanus Native Shrubs and grasses	Nil microrelief Nil disturbance Nil erosion	Firm No coarse fragments	A11 0.0-0.08 Abrupt	Loamy sand	Massive, weak	-	10YR3/2 Very dark greyish brown Nil mottle	Dry, Rapid	Few, fine	0.10 – 6.5pH	-	-
				A12 0.08-0.40 Abrupt	Loamy sand	Massive, weak	-	10YR5/2 Grayish brown Nil mottle	Dry, Rapid	Few, fine	0.30 – 6.0pH	-	-
				A13 0.40-0.80 Abrupt	Loamy sand	Weak polyhedral	-	10YR5/3 Brown Nil mottle	Dry, Rapid	Few, very fine	0.60 – 6.0pH	-	-

A2 0.80-1.00	Loamy sand	Massive, moderate	-	10YR3/1 Very dark gray Nil mottle	Dry, Rapid	-	0.90 – 6.0pH	-	-

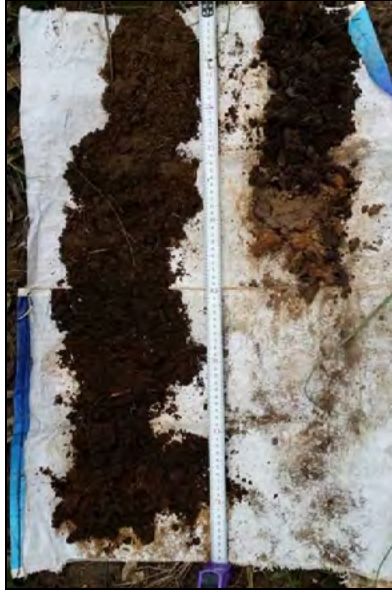
Land use Landform Pattern, Element, Slope	Natural Vegetation	Microrelief Disturbance Erosion	Surface condition, surface rock	Soil Profile Description									
				Horizon Depth (m), Boundary	Texture	Structure, Strength	Inclusions Segregations	Colour, Mottle	Moisture, Drainage	Roots	Depth (m) pH/EC	Sample (m)	Observations
Native Vegetation Gully depression, creek nearby	Tall open woodland including Eucalypts and Pandanus Native Shrubs and grasses	Nil microrelief Nil disturbance Nil erosion	Firm No coarse fragments	A11 0.0-0.20 Abrupt	Sandy Loam	Massive, weak	-	10YR3/2 Very dark greyish brown Nil mottle	Moist, Rapid	Common, fine	-	-	-
				A12 0.20-0.90 Abrupt	Sandy Loam	Massive, weak	-	10YR2/1 Black Nil mottle	Humid, Rapid	Few, fine	-	-	-
				A2 0.90-1.00	Sandy Loam	Weak, very weak	-	10YR4/2 Dark greyish brown Mottle <20% 10YR5/4 Yellowish brown	Humid, Rapid	Few, very fine	-	-	-

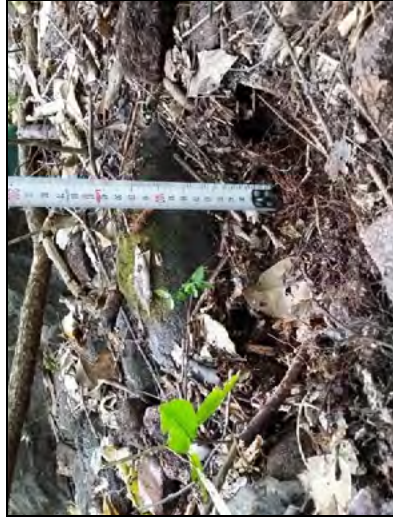
Soil Profile Description											
Land use Landform Pattern, Element, Slope	Natural Vegetation	Microrelief Disturbance Erosion	Surface condition, surface rock	Horizon Depth (m), Boundary	Texture	Structure, Strength	Inclusions Segregations	Colour, Mottle	Moisture, Drainage	Roots	Depth (m) / Field pH / Meter pH Meter / EC (mS)	Sample (m)	Observations
Native Vegetation Gentle Undulating Plain Lower slope 6.0%	Monsoonal Vine Thicket	Nil microrelief Nil disturbance Nil erosion	Organic Matter/leaf matter >95% 0- 2000mm coarse fragments and boulders	O1 0.0-0.02	Organic Matter	-	As per surface	-	Humid, moderate	Common, fine	0.02 -7.17pH / 0.05 EC	0.00-0.02	No borehole was able to be augered due to the density of the surface rock.

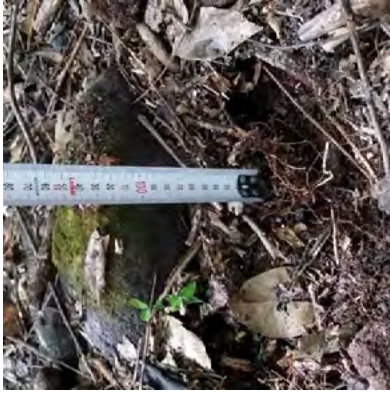
Soil Profile Description													
Land use Landform Pattern, Element, Slope	Natural Vegetation	Microrelief Disturbance Erosion	Surface condition, surface rock	Horizon Depth (m), Boundary	Texture	Structure, Strength	Inclusions Segregations	Colour, Mottle	Moisture, Drainage	Roots	Depth (m) / pH/EC	Sample (m)	Observations
Native Vegetation Gentle Undulating Plain Lower slope 6.0%	Monsoonal Vine Thicket	Nil microrelief Nil disturbance Nil erosion	Organic Matter/leaf matter >90% 0- 2000mm coarse fragments and boulders	O1 0.0-0.02	Organic Matter	-	As per surface	-	Humid, moderate	Common, fine	-	-	No borehole was able to be augered due to the density of the surface rock.

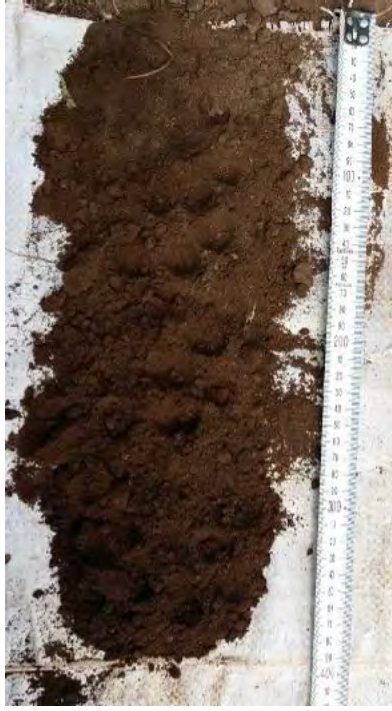
Land use Vegetation Pattern, Element, Slope	Natural Vegetation	Microrelief Disturbance Erosion	Surface condition, surface rock	Soil Profile Description								Observations	
				Horizon Depth (m), Boundary	Texture	Structure, Strength	Inclusions Segregations	Colour, Mottle	Moisture, Drainage	Roots	Depth (m) / pH / EC		Sample (m)
Native Vegetation Gentle Undulating Plain Midslope 2.0%	Tall open woodland including Eucalypts and Pandanus Native Shrubs and grasses	Nil microrelief Nil disturbance Nil erosion	Hard setting, <2% <10mm No coarse fragments	A1 0.0-0.20 Abrupt	Loamy sand	Massive, weak	<2% <10mm coarse fragments	5YR4/3 Reddish brown Nil mottle	Dry, Rapid	Few, fine	-	0.0-0.10	First borehole refusal at 0.40m
				A2 0.20-0.40 Abrupt	Loamy sand	Massive, weak	-	5YR4/3 Reddish brown Nil mottle	Dry, Rapid	Few, fine	-	0.30-0.40	Second borehole refusal at 0.18m Third borehole refusal at 0.40m and sampled

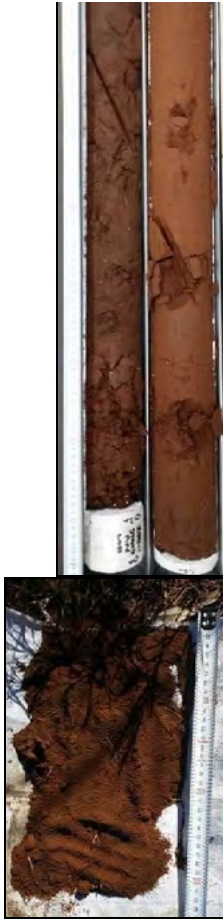
Soil Profile Description													
Land use Vegetation Pattern, Element, Slope	Natural Vegetation	Microrelief Disturbance Erosion	Surface condition, surface rock	Horizon Depth (m), Boundary	Texture	Structure, Strength	Inclusions Segregations	Colour, Mottle	Moisture, Drainage	Roots	Depth (m) / Field pH	Sample (m)	Observations
Native Vegetation Gentle Undulating Plain Midslope 2.0%	Tall open woodland including Eucalypts and Pandanus Native Shrubs and grasses	Nil microrelief Nil disturbance Nil erosion	Soft No coarse fragments	A11 0.0-0.20 Abrupt	Loamy sand	Massive, weak	-	5YR4/3 Reddish brown Nil mottle	Dry, Rapid	Very few, very fine	-	-	GEMCO Geo Borehole profile GTE conducted site surface check.
				A12 0.20-0.40 Abrupt	Loamy sand	Weak, very weak	-	5YR4/3 Reddish brown Nil mottle	Humid, Rapid	Very few, very fine	0.30 – 7.0pH		
				A13 0.40-1.00	Loamy sand	Weak, very weak	-	5YR3/3 Dark reddish brown Nil mottle	Moist, Rapid	Very few, very fine	0.60 – 7.0pH 0.90 – 7.0pH

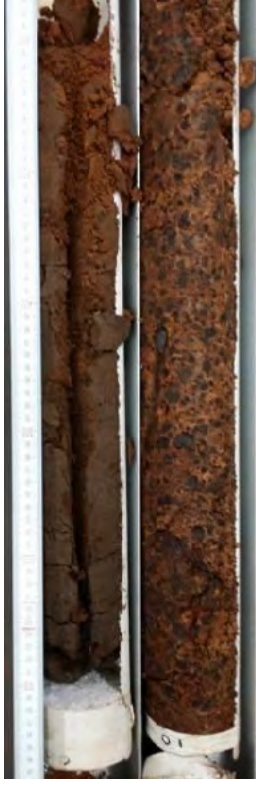
Soil Profile Description													
Land use Pattern, Element, Slope	Natural Vegetation	Microrelief Disturbance Erosion	Surface condition, surface rock	Horizon Depth (m), Boundary	Texture	Structure, Strength	Inclusions Segregations	Colour, Mottle	Moisture, Drainage	Roots	Depth (m) / Field pH	Sample (m)	Observations
Native Vegetation Gentle Undulating Plain Midslope 2.0%	Tall open woodland including Eucalypts and Pandanus Native Shrubs and grasses	Nil microrelief Nil disturbance Nil erosion	Soft No coarse fragments	A11 0.0-0.08 Abrupt	Sandy Loam	Massive, weak	-	10YR3/2 Very dark greyish brown Nil mottle	Dry, Rapid	Very few, very fine	-	-	GEMCO Geo Borehole profile GTE conducted site surface check.
				A12 0.08-0.15 Abrupt	Sandy Loam	Weak, polyhedral	-	10YR3/2 Very dark greyish brown Nil mottle	Humid, Rapid	Few, medium	0.10 – 6.5pH		
				A21 0.15-0.30 Abrupt	Loamy sand	Weak, very weak	<2% <6mm manganese nodules	7.5YR3/2 Dark brown Nil mottle	Humid, Rapid	Very few, very fine	0.30 – 6.5pH

A22 0.30-0.60	Loamy sand	Weak, very weak	<2% <6mm coarse fragments	7.5YR4/3 Reddish brown Nil mottle	Humid, Rapid	Very few, very fine	0.60 – 7.0pH

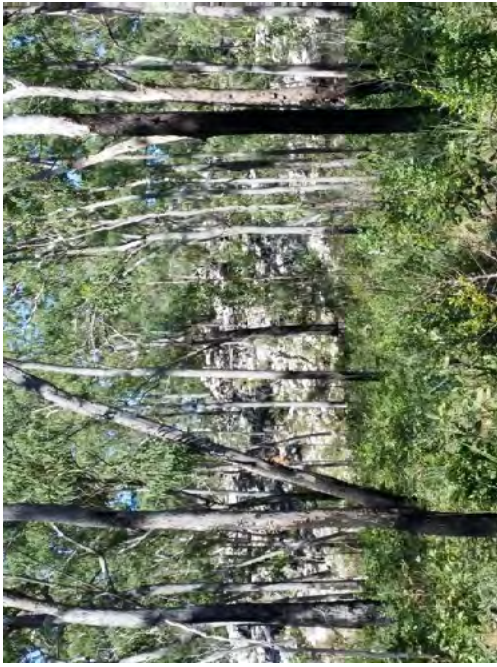
Site No.	Location (GDA94 Zone 53)	Soil Mapping Unit	Surface	Landform	Comments / Pictures
Ob8	666243mE 8449493mN	B1	Firm, sandy, No coarse fragments	Gentle Undulating Plain	Tall open woodland including Eucalypts 20% cover
Ob9	666300mE 8448780mN	Q1	Rocky outcrops, 100% cover	Ridge	-
Ob10	665174mE 8449100mN	B1v	Soft, sandy, No coarse fragments, light grey colour	Flat plain	Tall open woodland including Eucalypts <10% cover, immediate (B1v) area less overall vegetation cover than nearby (b1) areas with Eucalypt density, as per picture 'Ob12'
Ob11	665656mE 8448890mN	Boundary B1/Q1	Increasing quartz rocky outcrops, 50%+cover	Lower slope

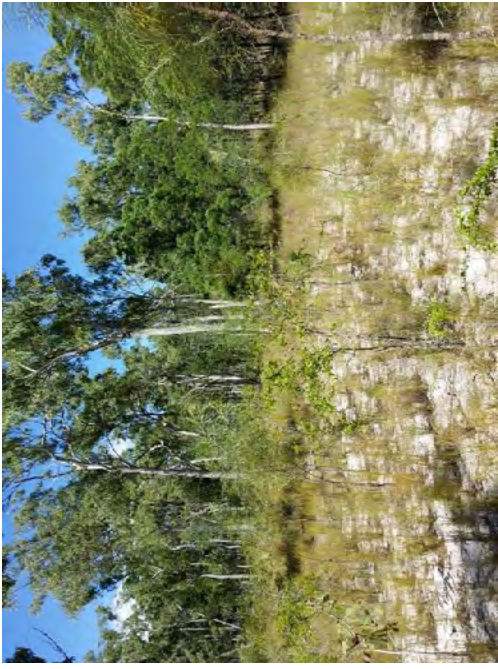
Site No.	Location (GDA94 Zone 53)	Soil Mapping Unit	Surface	Landform	Comments / Pictures
Ob12	665597mE 8448963mN	Boundary B1/B1v	Sandy with no coarse fragments, light grey to the west, light yellow/brown to the east	Gentle Undulating Plain, slope <0.5%

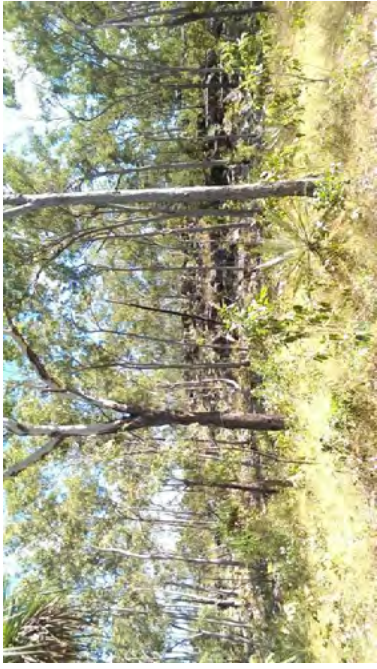
Site No.	Location (GDA94 Zone 53)	Soil Mapping Unit	Surface	Landform	Comments / Pictures
Ob39	661291mE 8442859mN	B1	Sandy, yellow/grey surface, no coarse fragments or rocks	Gentle Undulating Plain Lower slope 3%	Tall open woodland including Eucalypts 30% cover
Ob40	662184mE 8442507mN	Boundary B1/Q1	Increasing quartz rocky outcrops, 80%+cover	Lower slope, ridge

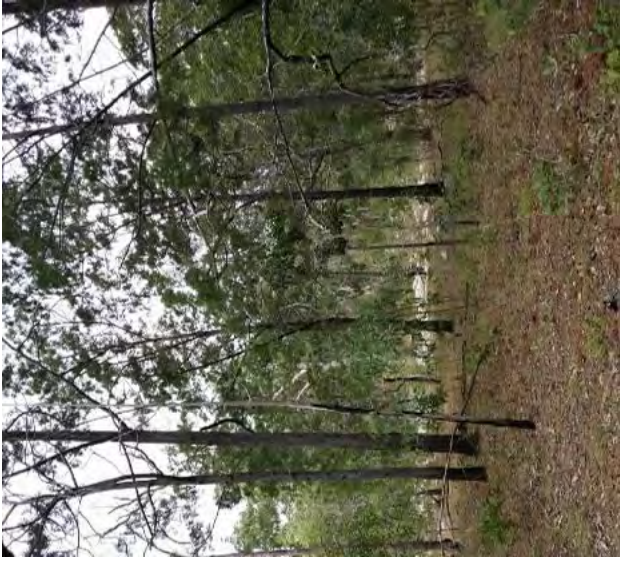
Site No.	Location (GDA94 Zone 53)	Soil Mapping Unit	Surface	Landform	Comments / Pictures
Ob51	668890mE 8440758mN	B1 (nearby Q1 boundary)	Light grey sandy surface, 20%+ rocks – manganese, quartz	Light grey rocky outcrop nearby to the south east

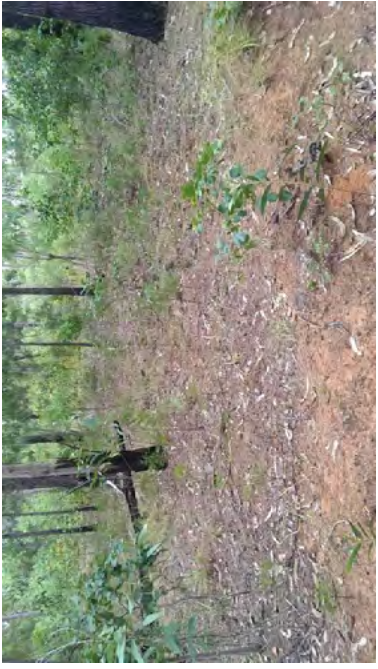
Site No.	Location (GDA94 Zone 53)	Soil Mapping Unit	Surface	Landform	Comments / Pictures
Ob54	669583mE 8440511mN	B1	Firm, light brown/red surface, no coarse fragments or rocks	Gentle Undulating Plain Mid slope 1.5%

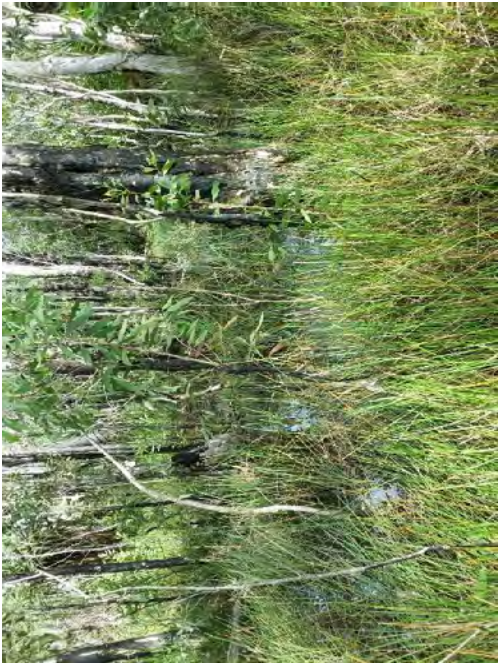
Site No.	Location (GDA94 Zone 53)	Soil Mapping Unit	Surface	Landform	Comments / Pictures
Ob57	668834mE 8441249mN	A1	Medium brown colour, sandy, soft, moist adjacent to creek	Active creek line

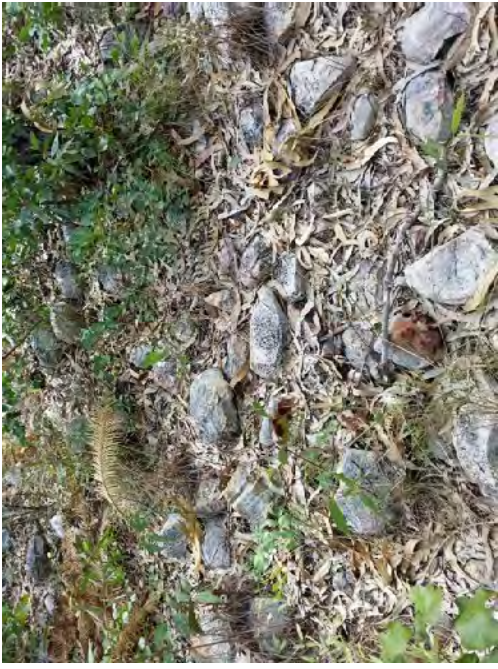
Site No.	Location (GDA94 Zone 53)	Soil Mapping Unit	Surface	Landform	Comments / Pictures
Ob63	668146mE 8442291mN	Q1	80% rock/quartz cover	Mid slope 6+%

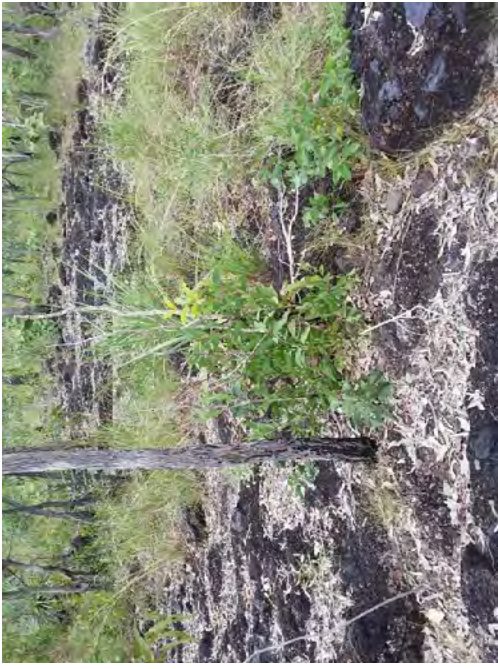
Site No.	Location (GDA94 Zone 53)	Soil Mapping Unit	Surface	Landform	Comments / Pictures
Ob67	666867mE 8440256mN	B1	Manganese outcrops	Upper slope 4%

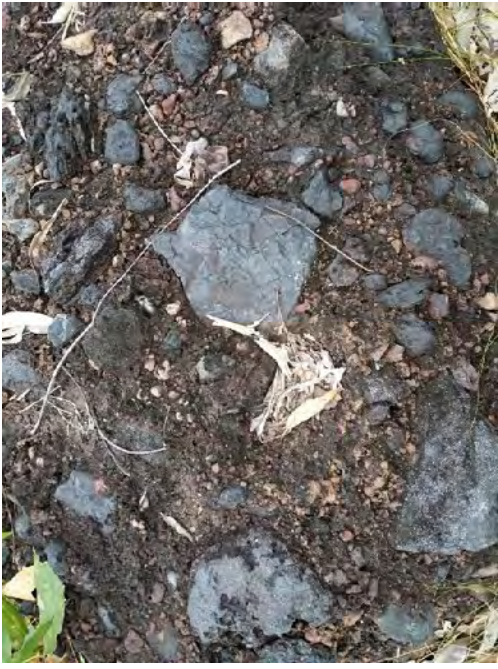
Site No.	Location (GDA94 Zone 53)	Soil Mapping Unit	Surface	Landform	Comments / Pictures
Ob71	664403mE 8441239mN	B2	Manganese 50-200mm, 20%+ cover	-

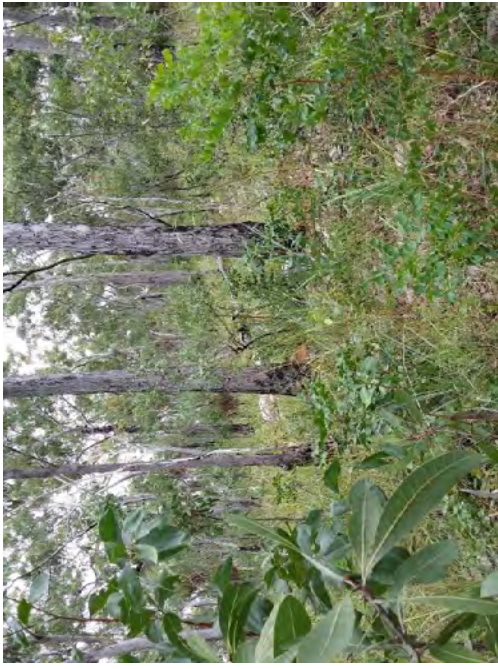
Site No.	Location (GDA94 Zone 53)	Soil Mapping Unit	Surface	Landform	Comments / Pictures
Ob74	664926mE 8443217mN	Boundary B1/Q1	Increasing Quartz rock cover at Q1 boundary	Mid slope 6%+

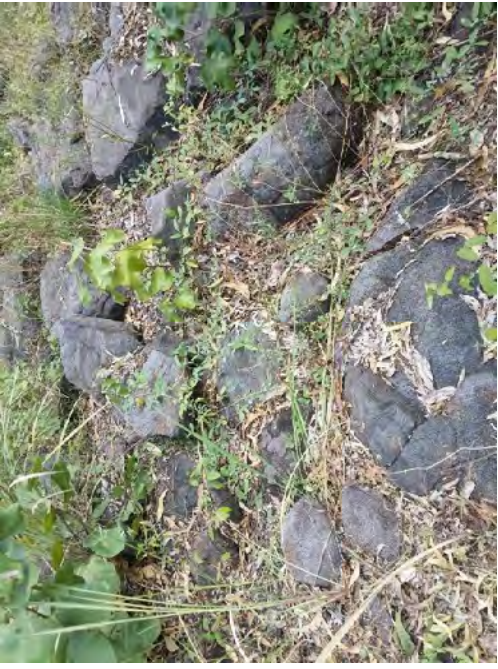
Site No.	Location (GDA94 Zone 53)	Soil Mapping Unit	Surface	Landform	Comments / Pictures
Ob89	665368mE 8439944mN	B1	Rocky outcrops throughout area, 80% cover	Upper slope / crest from 5% slope, 15m outside monsoonal vine thicket	 
Ob90	665353mE 8439946mN	B1	Rocky outcrops throughout area, 80% cover	Mid slope 4%, 4m outside monsoonal vine thicket

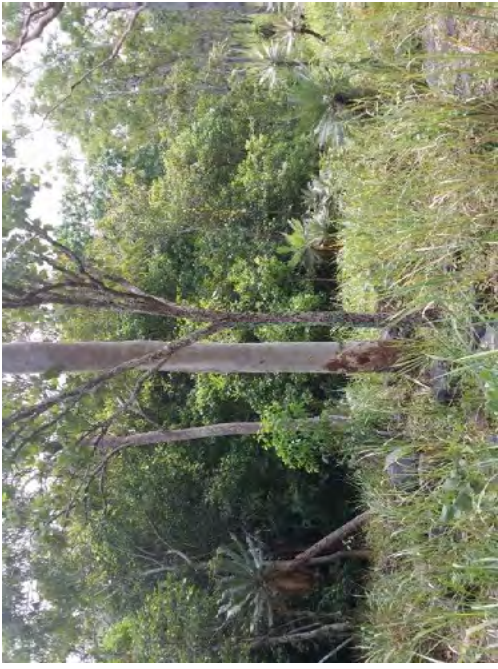
Site No.	Location (GDA94 Zone 53)	Soil Mapping Unit	Surface	Landform	Comments / Pictures
Ob91	665256mE 8440007mN	B1	20% rock cover	Mid slope 3%, 4m outside monsoonal vine thicket
