**EASTERN LEASES PROJECT**

# **BASELINE SURFACE WATER MONITORING REPORT**

for  
**South32 Pty Ltd**  
May 2015

**HANSEN BAILEY**  
215 Adelaide Street  
Brisbane QLD 4000

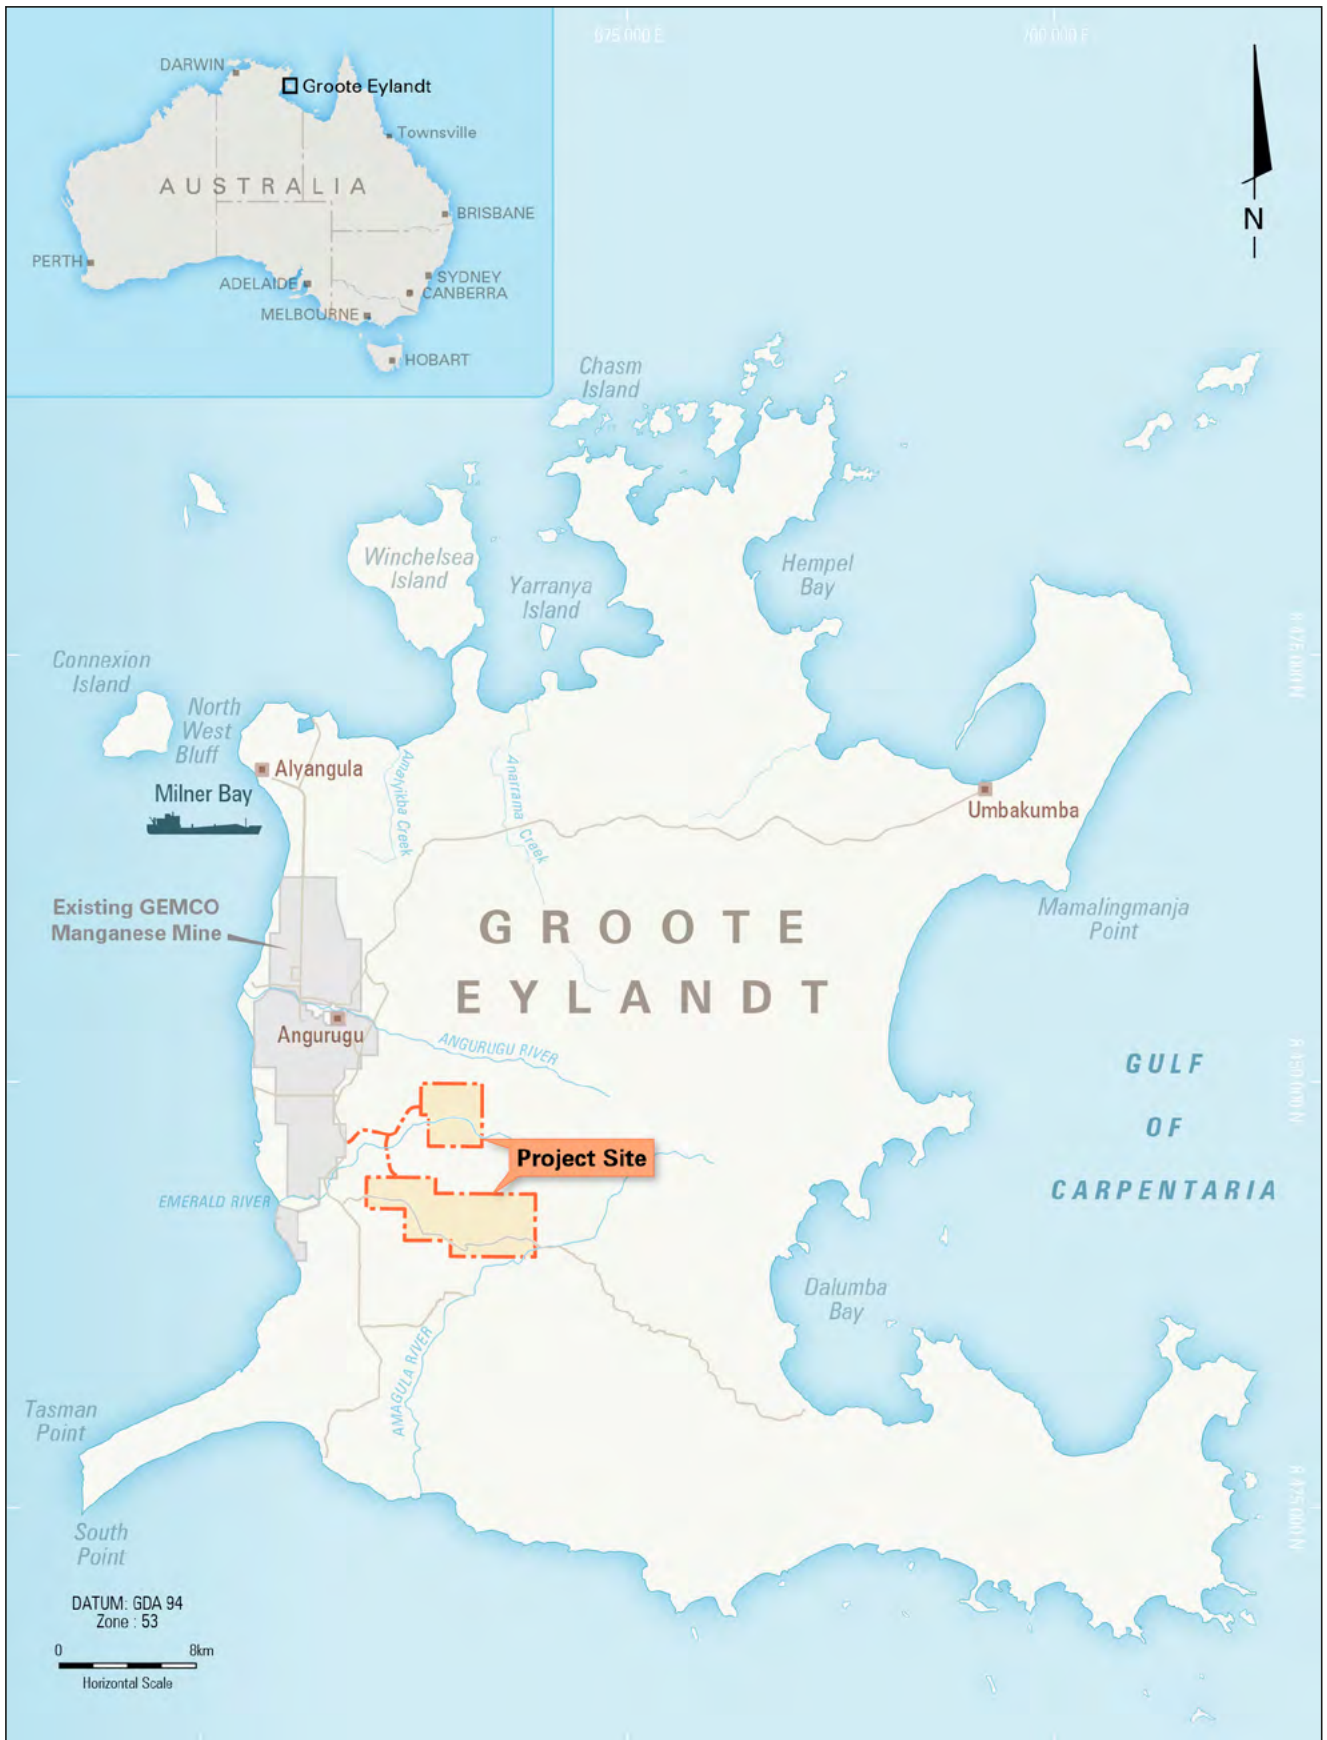
**FIGURE 3**

Regional Catchment Setting

The project site is located on Groote Eylandt, a 2,285 km<sup>2</sup> island in the Gulf of Carpentaria. The central areas of the island are characterised by elevated rocky outcrops that form hills and escarpments with limited vegetation and soil cover. The rocky outcrops limit the vegetation and soil cover within this centre portion of the island. Between these hills and escarpments, the low-lying topography forms densely vegetated, gently sloping valleys that open into flat coastal plains. These hills and escarpments define the surface water catchments across the majority of the island. The relief of the landscape in the area surrounding the project site is shown in Figure 3.

The project site is located in the upper catchments of the Amagula, Emerald and Angurugu Rivers (Figure 3). The Emerald River and its tributary watercourses drain the majority of the Northern EL and the western area of the Southern EL. The Amagula River drains the eastern area of the Southern EL via the main channel and two tributary watercourses. The main channel of the Angurugu River does not traverse the project site.

The Amagula River rises in the eastern part of Groote Eylandt and flows in a south-westerly direction. It discharges to the sea on the southern coast of the island, approximately 21 km south of the Southern EL (Figure 3). The Amagula River has a catchment area of 24,300 ha.

The Emerald River rises in the central area of Groote Eylandt and flows in a westward direction toward the south-western coast of the island. It discharges into the sea approximately 12.6 km downstream of the Northern EL and 7 km downstream of the Southern EL (Figure 3). The Emerald River has a catchment area of 9,500 ha.

The Angurugu River rises in the central area of Groote Eylandt and flows in a westward direction toward the western coast of the island. The Amagula River has a catchment area of 16,300 ha. An area of 181 ha in the north-east of the Northern EL drains to the Angurugu River via minor drainage lines and overland sheetflow (Figure 3). This area will not be disturbed by project activities.

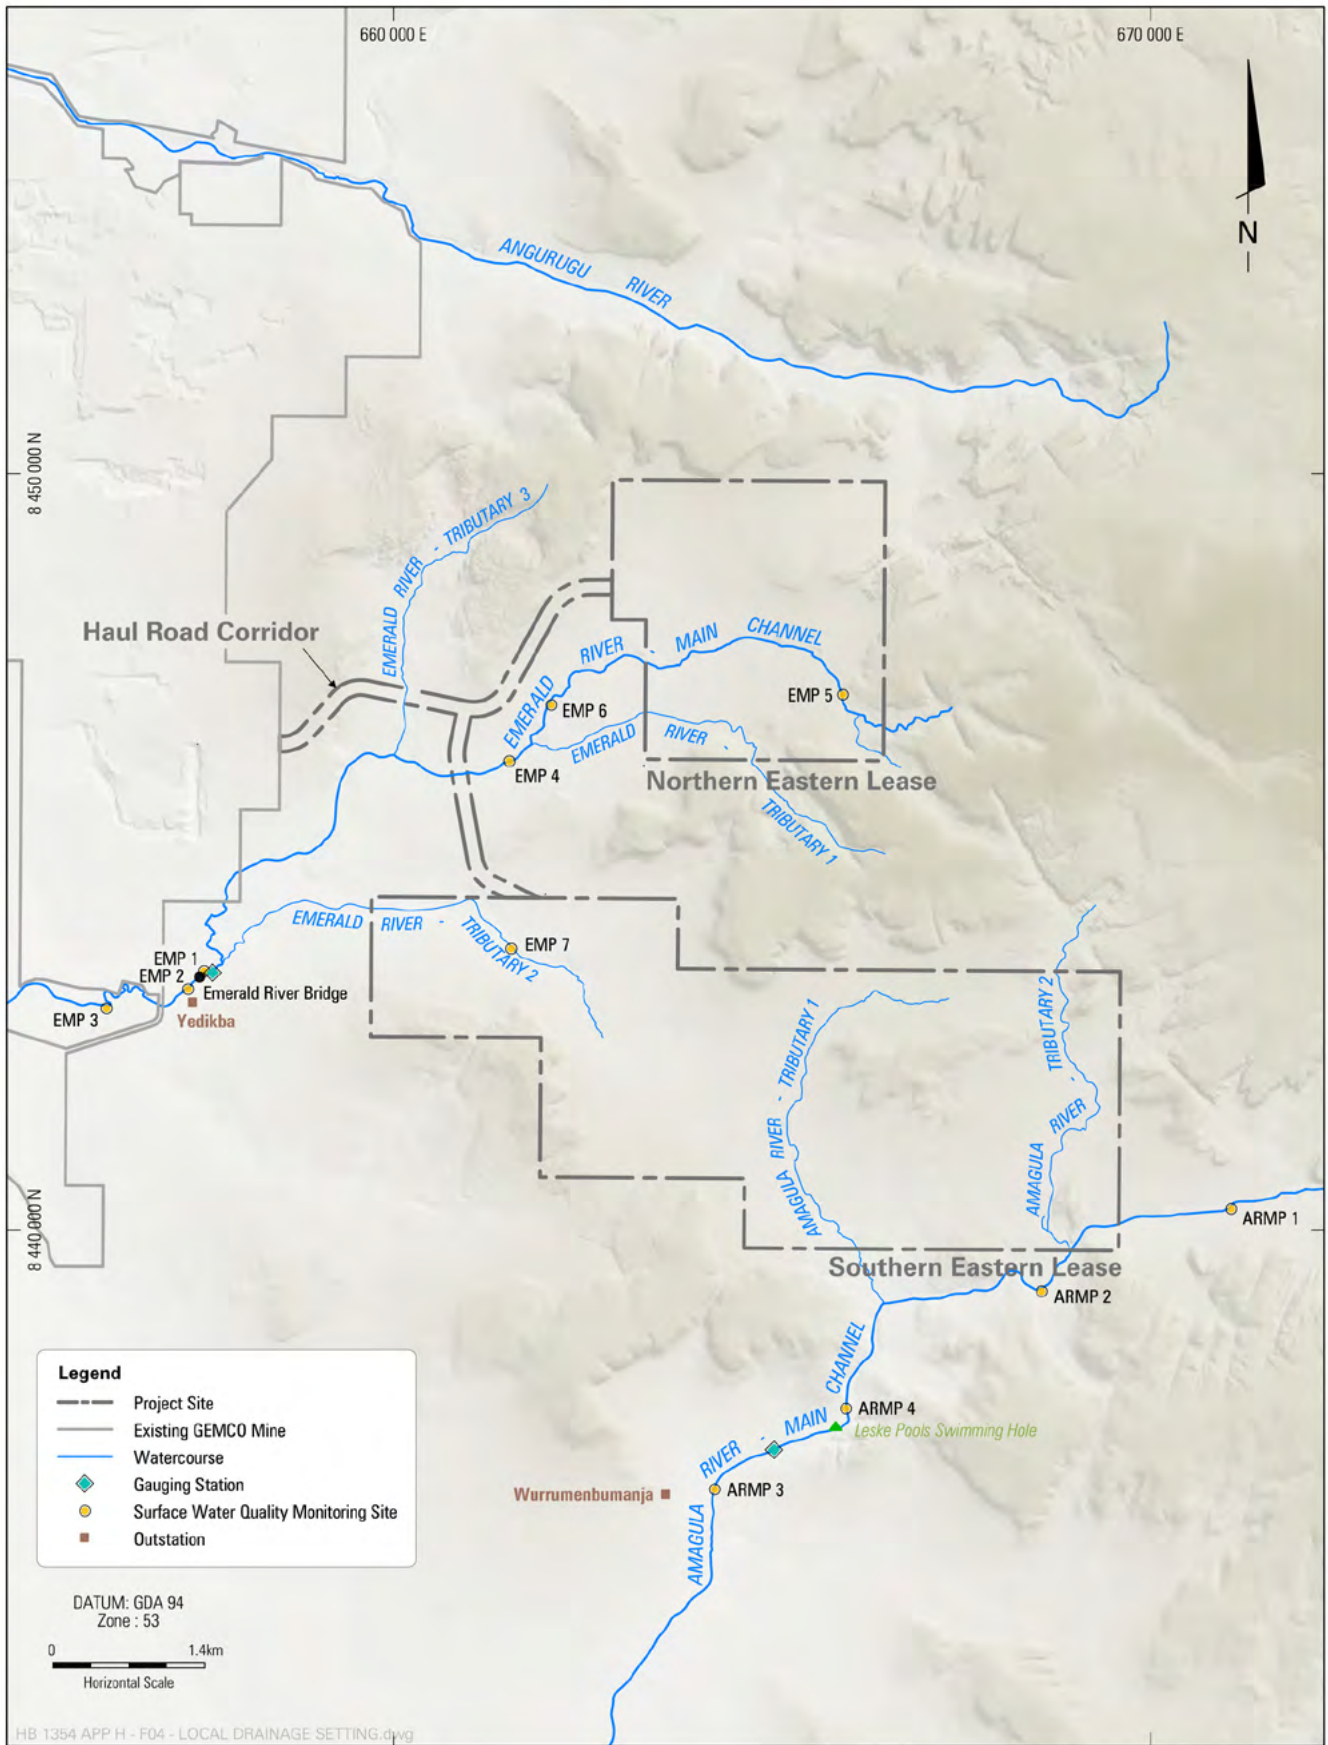
Local Drainage Setting

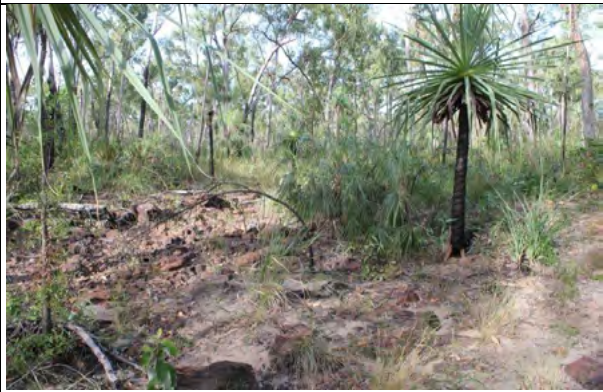
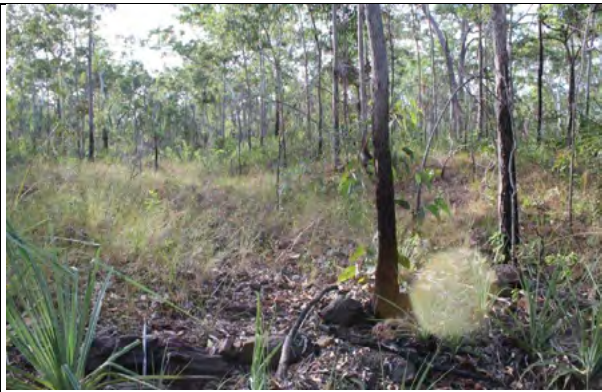
<b>FIGURE ID</b>	003	<b>Monitoring Date</b>	1/07/2014
<b>Figure Reference</b>	Figure A-2	<b>Coordinates</b>	-14.044651
<b>Location ID</b>	ER-ERMC-01		136.538584
<b>Catchment</b>	Emerald River	<b>Coordinate System</b>	Decimal degrees
<b>Drainage Feature</b>	Emerald River – Main Channel		
<b>Relative Location</b>	Upper reaches of Emerald River		
<b>Physical Assessment</b>			
Valley Shape	Asymmetrical	Local Influences	None
Floodplain Width (m)	N/A	Landuse (left bank)	Native Forest
Floodplain Features	No features	Landuse (right bank)	Native Forest
<b>Physical Barriers</b>			
Type of Bars	None	Large Woody Debris	5%
Extent of Bars (%)	None	Artificial Features	None
Particle Size on Bars	N/A	Channel Modifications	None
<b>Channel Shape &amp; Banks</b>			
Bank Shape	Convex	Bank Height (m)	2
Bank Slope	Low	Bank Width (m)	10
Factors Affecting Bank Stability	None	Bank Material	Fines over bedrock
Artificial Bank Protection	None	Substrate Composition	Fines over bedrock

<b>Water Observations</b>			
Water Level	No Flow	Water Surface Width (m)	0
Water Depth (m)	0	Turbidity (Visual)	None
Water Oils	None	Water Odours	None
Sediment Oils	None	Sediment Odours	None
<b>Stream Bed</b>			
Extent of Bedform Features	Riffle	Bedrock Outcrops	Yes
Bed Compaction	Low	Sediment Angularity	Angular
Sediment Matrix	Gravel and bedrock	Bed Stability Rating	Bed stable
<b>Photographs</b>

Upstream showing defined channel with rock controlled bed and in channel vegetation		Downstream showing defined channel with rock controlled bed and in channel vegetation

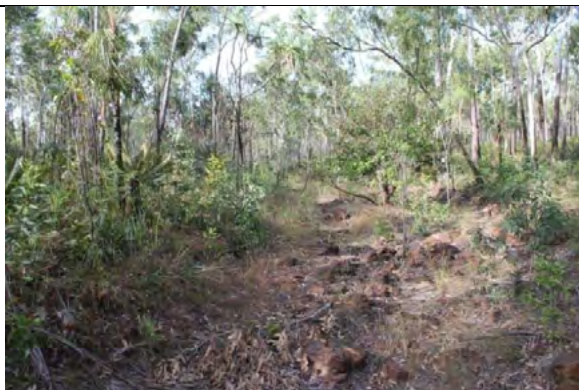
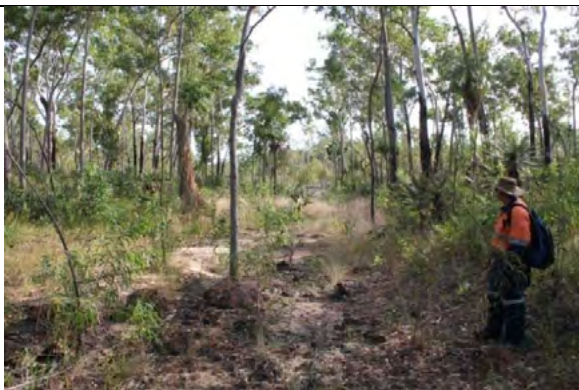
<b>FIGURE ID</b>	004	<b>Monitoring Date</b>	01/07/2014
<b>Figure Reference</b>	Figure A-2	<b>Coordinates</b>	-14.042551
<b>Location ID</b>	ER-ERMC-02		136.536689
<b>Catchment</b>	Emerald River	<b>Coordinate System</b>	Decimal degrees
<b>Drainage Feature</b>	Emerald River – Main Channel		
<b>Relative Location</b>	Upstream of confluence with Emerald River – Tributary 1		
<b>Physical Assessment</b>			
Valley Shape	Asymmetrical	Local Influences	None
Floodplain Width (m)	N/A	Landuse (left bank)	Native Forest
Floodplain Features	No features	Landuse (right bank)	Native Forest
<b>Physical Barriers</b>			
Type of Bars	None	Large Woody Debris	5%
Extent of Bars (%)	None	Artificial Features	None
Particle Size on Bars	N/A	Channel Modifications	None
<b>Channel Shape &amp; Banks</b>			
Bank Shape	Convex	Bank Height (m)	2
Bank Slope	Low	Bank Width (m)	5
Factors Affecting Bank Stability	None	Bank Material	Fines over bedrock

Artificial Bank Protection	None	Substrate Composition	Fines over bedrock
<b>Water Observations</b>			
Water Level	No Flow	Water Surface Width (m)	0
Water Depth (m)	0	Turbidity (Visual)	None
Water Oils	None	Water Odours	None
Sediment Oils	None	Sediment Odours	None
<b>Stream Bed</b>			
Extent of Bedform Features	Riffle	Bedrock Outcrops	Yes
Bed Compaction	Low	Sediment Angularity	Angular
Sediment Matrix	Gravel and bedrock	Bed Stability Rating	Bed stable
<b>Photographs</b>

Upstream showing undefined channel with rock controlled bed		Downstream showing undefined channel with rock controlled bed

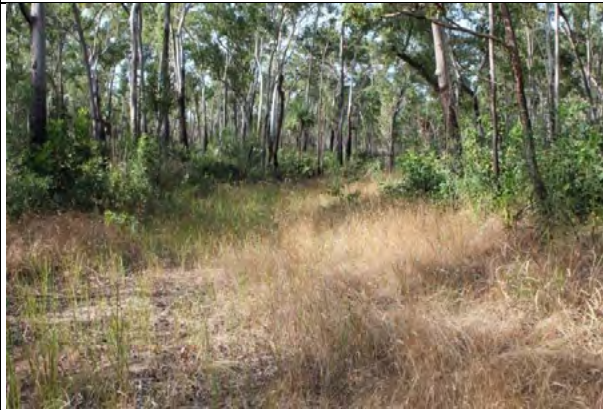
Artificial Bank Protection	None	Substrate Composition	Fines over bedrock
<b>Water Observations</b>			
Water Level	No Flow	Water Surface Width (m)	0
Water Depth (m)	0	Turbidity (Visual)	None
Water Oils	None	Water Odours	None
Sediment Oils	None	Sediment Odours	None
<b>Stream Bed</b>			
Extent of Bedform Features	Riffle and glide	Bedrock Outcrops	Yes
Bed Compaction	Low	Sediment Angularity	Angular
Sediment Matrix	Fines and bedrock	Bed Stability Rating	Bed stable
<b>Photographs</b>

Upstream showing undefined channel with in channel vegetation		Downstream showing defined channel with rock controlled bed.

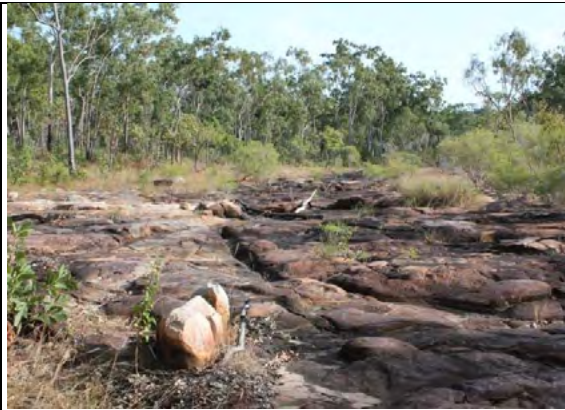
<b>FIGURE ID</b>	005	<b>Monitoring Date</b>	01/07/2014
<b>Figure Reference</b>	Figure A-2	<b>Coordinates</b>	-14.041765
<b>Location ID</b>	ER-ERMC-03		136.536548
<b>Catchment</b>	Emerald River	<b>Coordinate System</b>	Decimal degrees
<b>Drainage Feature</b>	Emerald River – Main Channel		
<b>Relative Location</b>	Upstream of confluence with Emerald River – Tributary 1		
<b>Physical Assessment</b>			
Valley Shape	Asymmetrical	Local Influences	None
Floodplain Width (m)	N/A	Landuse (left bank)	Native Forest
Floodplain Features	No features	Landuse (right bank)	Native Forest
<b>Physical Barriers</b>			
Type of Bars	None	Large Woody Debris	<5%
Extent of Bars (%)	None	Artificial Features	None
Particle Size on Bars	N/A	Channel Modifications	None
<b>Channel Shape &amp; Banks</b>			
Bank Shape	Convex, lower bench	Bank Height (m)	2
Bank Slope	Low	Bank Width (m)	5
Factors Affecting Bank Stability	None	Bank Material	Fines over bedrock

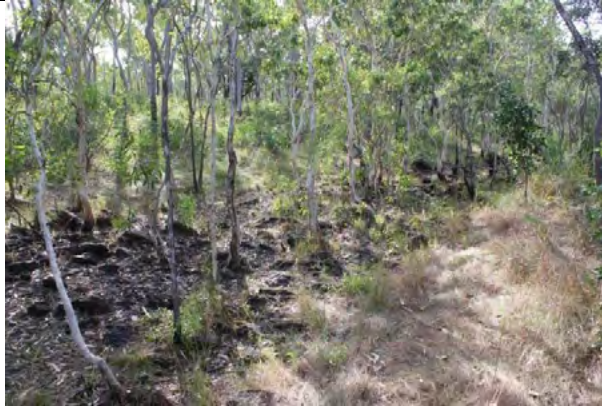
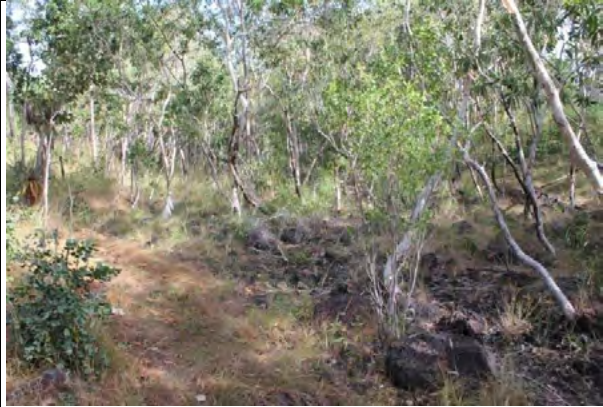
Artificial Bank Protection	None	Substrate Composition	Fines over bedrock
<b>Water Observations</b>			
Water Level	No Flow	Water Surface Width (m)	0
Water Depth (m)	0	Turbidity (Visual)	None
Water Oils	None	Water Odours	None
Sediment Oils	None	Sediment Odours	None
<b>Stream Bed</b>			
Extent of Bedform Features	Riffle and glide	Bedrock Outcrops	Yes
Bed Compaction	Low	Sediment Angularity	Angular
Sediment Matrix	Sand and bedrock	Bed Stability Rating	Bed stable
<b>Photographs</b>

Upstream showing defined channel with rock controlled bed and in channel vegetation		Downstream showing defined channel with rock controlled bed and in channel vegetation

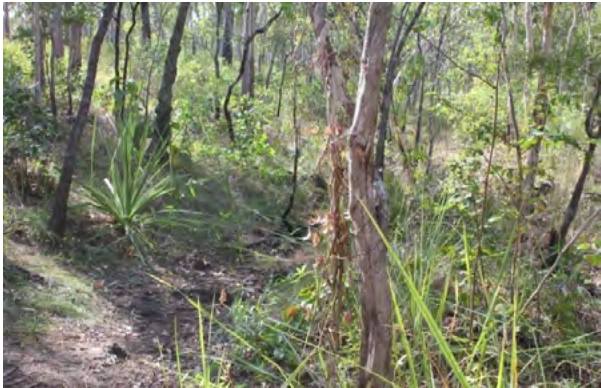
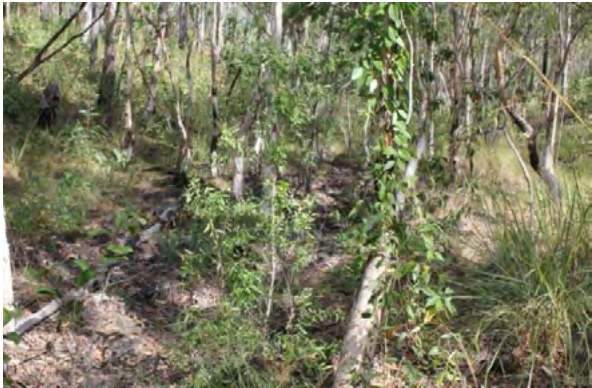
<b>FIGURE ID</b>	015	<b>Monitoring Date</b>	01/07/2014
<b>Figure Reference</b>	Figure A-2	<b>Coordinates</b>	-14.035568
<b>Location ID</b>	ER-ERMC-05		136.526352
<b>Catchment</b>	Emerald River	<b>Coordinate System</b>	Decimal degrees
<b>Drainage Feature</b>	Emerald River – Main Channel		
<b>Relative Location</b>	Upstream of confluence with Emerald River – Tributary 1		
<b>Physical Assessment</b>			
Valley Shape	Shallow Valley	Local Influences	None
Floodplain Width (m)	N/A	Landuse (left bank)	Native Forest
Floodplain Features	No features	Landuse (right bank)	Native Forest
<b>Physical Barriers</b>			
Type of Bars	None	Large Woody Debris	<5%
Extent of Bars (%)	None	Artificial Features	None
Particle Size on Bars	N/A	Channel Modifications	None
<b>Channel Shape &amp; Banks</b>			
Bank Shape	Convex	Bank Height (m)	4
Bank Slope	Moderate to low	Bank Width (m)	12
Factors Affecting Bank Stability	None	Bank Material	Sand and mud over bedrock

Artificial Bank Protection	None	Substrate Composition	Sand and mud over bedrock
<b>Water Observations</b>			
Water Level	No flow	Water Surface Width (m)	0
Water Depth (m)	0	Turbidity (Visual)	None
Water Oils	None	Water Odours	None
Sediment Oils	None	Sediment Odours	None
<b>Stream Bed</b>			
Extent of Bedform Features	Riffle and glide	Bedrock Outcrops	Yes
Bed Compaction	Moderate	Sediment Angularity	Sub-angular
Sediment Matrix	Sand and mud over bedrock	Bed Stability Rating	Bed stable
<b>Photographs</b>

Upstream showing overland flow path and no defined channel with in channel vegetation		Downstream showing overland flow path and no defined channel with in channel vegetation

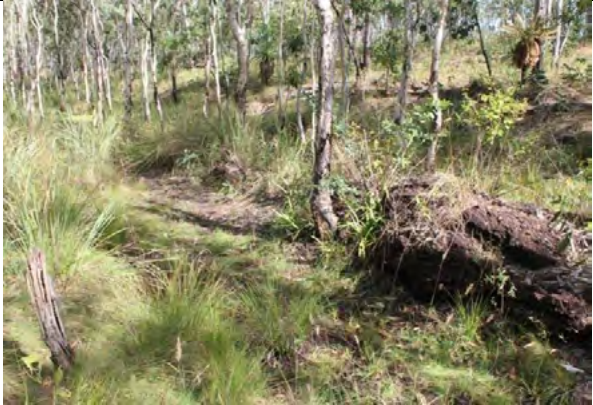
<b>FIGURE ID</b>	013	<b>Monitoring Date</b>	U01/07/2014
<b>Figure Reference</b>	Figure A-2	<b>Coordinates</b>	-14.035693
<b>Location ID</b>	ER-ERMC-07		136.523675
<b>Catchment</b>	Emerald River	<b>Coordinate System</b>	Decimal degrees
<b>Drainage Feature</b>	Emerald River – Main Channel		
<b>Relative Location</b>	Upstream of confluence with Emerald River – Tributary 1		
<b>Physical Assessment</b>			
Valley Shape	Shallow Valley	Local Influences	None
Floodplain Width (m)	N/A	Landuse (left bank)	Native Forest
Floodplain Features	No features	Landuse (right bank)	Native Forest
<b>Physical Barriers</b>			
Type of Bars	Mid channel rock bar	Large Woody Debris	20%
Extent of Bars (%)	5%	Artificial Features	None
Particle Size on Bars	N/A	Channel Modifications	None
<b>Channel Shape &amp; Banks</b>			
Bank Shape	Convex	Bank Height (m)	4
Bank Slope	Moderate to low	Bank Width (m)	10
Factors Affecting Bank Stability	None	Bank Material	Sand and mud over bedrock

Artificial Bank Protection	None	Substrate Composition	Sand and mud over bedrock
<b>Water Observations</b>			
Water Level	No flow	Water Surface Width (m)	0
Water Depth (m)	0	Turbidity (Visual)	None
Water Oils	None	Water Odours	None
Sediment Oils	None	Sediment Odours	None
<b>Stream Bed</b>			
Extent of Bedform Features	Riffle and glide	Bedrock Outcrops	Yes
Bed Compaction	Moderate	Sediment Angularity	Sub-angular
Sediment Matrix	Sand and mud over bedrock	Bed Stability Rating	Bed stable
<b>Photographs</b>

Upstream showing defined channel with in channel vegetation.

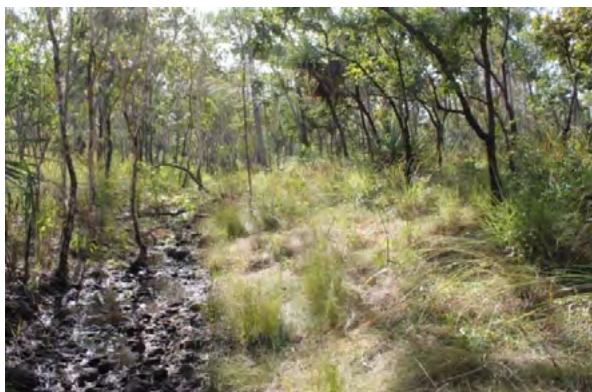
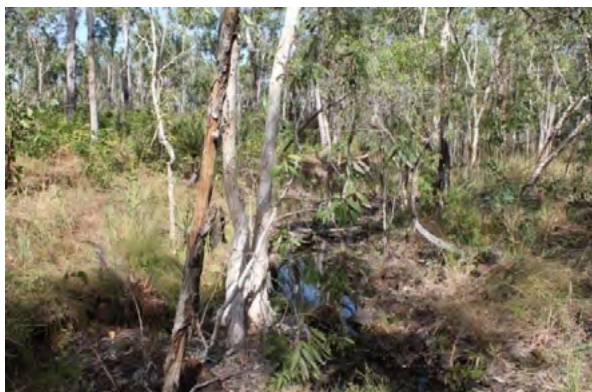
<b>FIGURE ID</b>	011	<b>Monitoring Date</b>	01/07/2014
<b>Figure Reference</b>	Figure A-2	<b>Coordinates</b>	-14.03675
<b>Location ID</b>	ER-ERMC-08		136.5215
<b>Catchment</b>	Emerald River	<b>Coordinate System</b>	Decimal degrees
<b>Drainage Feature</b>	Emerald River – Main Channel		
<b>Relative Location</b>	Upstream of confluence with Emerald River – Tributary 1		
<b>Physical Assessment</b>			
Valley Shape	Shallow Valley	Local Influences	None
Floodplain Width (m)	N/A	Landuse (left bank)	Native Forest
Floodplain Features	No features	Landuse (right bank)	Native Forest
<b>Physical Barriers</b>			
Type of Bars	None	Large Woody Debris	5%
Extent of Bars (%)	None	Artificial Features	None
Particle Size on Bars	N/A	Channel Modifications	None
<b>Channel Shape &amp; Banks</b>			
Bank Shape	Convex	Bank Height (m)	1
Bank Slope	Low	Bank Width (m)	2
Factors Affecting Bank Stability	None	Bank Material	Sand over bedrock

Artificial Bank Protection	None	Substrate Composition	Sand over bedrock
<b>Water Observations</b>			
Water Level	Low	Water Surface Width (m)	0.5
Water Depth (m)	0.1	Turbidity (Visual)	None
Water Oils	None	Water Odours	None
Sediment Oils	None	Sediment Odours	None
<b>Stream Bed</b>			
Extent of Bedform Features	Riffle and glide	Bedrock Outcrops	Yes
Bed Compaction	Moderate	Sediment Angularity	Sub-angular
Sediment Matrix	Sand and mud	Bed Stability Rating	Bed stable
<b>Photographs</b>

Upstream showing defined channel with pooled water and rock controlled bed.		Downstream showing defined channel with pooled water and rock controlled bed.

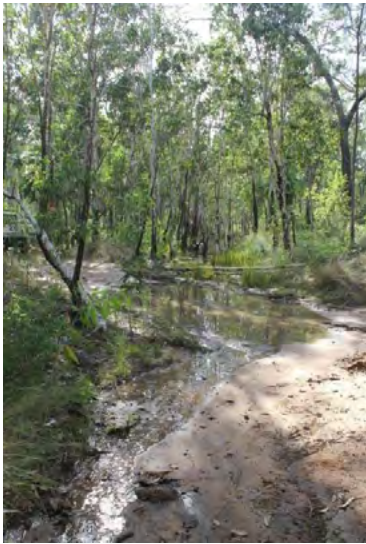
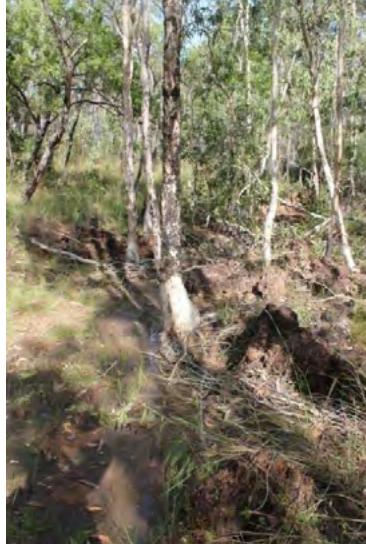
<b>FIGURE ID</b>	010	<b>Monitoring Date</b>	01/07/2014
<b>Figure Reference</b>	Figure A-2	<b>Coordinates</b>	-14.03675
<b>Location ID</b>	ER-ERMC-09		136.5215
<b>Catchment</b>	Emerald River	<b>Coordinate System</b>	Decimal degrees
<b>Drainage Feature</b>	Emerald River – Main Channel		
<b>Relative Location</b>	upstream of confluence with Emerald River – Tributary 1		
<b>Physical Assessment</b>			
Valley Shape	Shallow Valley	Local Influences	None
Floodplain Width (m)	N/A	Landuse (left bank)	Native Forest
Floodplain Features	No features	Landuse (right bank)	Native Forest
<b>Physical Barriers</b>			
Type of Bars	None	Large Woody Debris	5%
Extent of Bars (%)	None	Artificial Features	Road crossing
Particle Size on Bars	N/A	Channel Modifications	Road crossing
<b>Channel Shape &amp; Banks</b>			
Bank Shape	Stepped	Bank Height (m)	3
Bank Slope	Moderate to low	Bank Width (m)	25
Factors Affecting Bank Stability	None	Bank Material	Fines over bedrock

Artificial Bank Protection	None	Substrate Composition	Fines over bedrock
<b>Water Observations</b>			
Water Level	Low	Water Surface Width (m)	1
Water Depth (m)	0.2	Turbidity (Visual)	None
Water Oils	None	Water Odours	None
Sediment Oils	None	Sediment Odours	None
<b>Stream Bed</b>			
Extent of Bedform Features	Pool and riffle	Bedrock Outcrops	No
Bed Compaction	Moderate	Sediment Angularity	Sub-angular
Sediment Matrix	Fines and bedrock	Bed Stability Rating	Bed stable
<b>Photographs</b>

Upstream showing defined channel with pooled water and road crossing		Upstream showing defined channel with pooled water and in channel vegetation

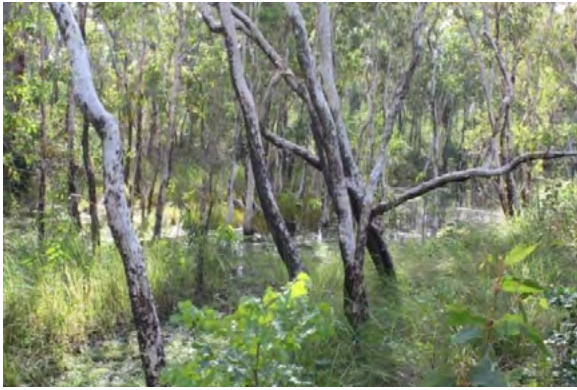
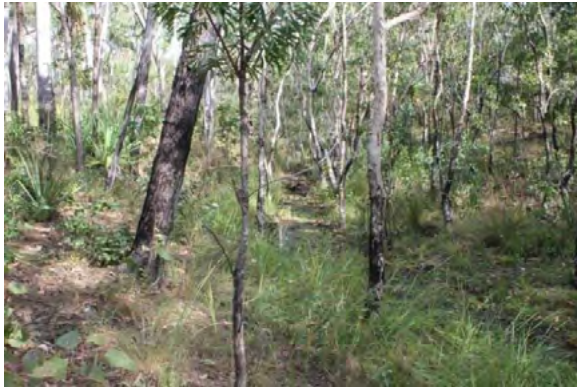
<b>FIGURE ID</b>	009	<b>Monitoring Date</b>	01/07/2014
<b>Figure Reference</b>	Figure A-2	<b>Coordinates</b>	-14.037218
<b>Location ID</b>	ER-ERMC-10		136.519247
<b>Catchment</b>	Emerald River	<b>Coordinate System</b>	Decimal degrees
<b>Drainage Feature</b>	Emerald River – Main Channel		
<b>Relative Location</b>	Upstream of confluence with Emerald River – Tributary 1		
<b>Physical Assessment</b>			
Valley Shape	Shallow Valley	Local Influences	None
Floodplain Width (m)	N/A	Landuse (left bank)	Native Forest
Floodplain Features	No features	Landuse (right bank)	Native Forest
<b>Physical Barriers</b>			
Type of Bars	None	Large Woody Debris	<5%
Extent of Bars (%)	None	Artificial Features	None
Particle Size on Bars	N/A	Channel Modifications	None
<b>Channel Shape &amp; Banks</b>			
Bank Shape	Stepped	Bank Height (m)	3
Bank Slope	Moderate to low	Bank Width (m)	25
Factors Affecting Bank Stability	None	Bank Material	Mud and sand

Artificial Bank Protection	None	Substrate Composition	Mud and sand
<b>Water Observations</b>			
Water Level	No Flow	Water Surface Width (m)	0
Water Depth (m)	0	Turbidity (Visual)	None
Water Oils	None	Water Odours	None
Sediment Oils	None	Sediment Odours	None
<b>Stream Bed</b>			
Extent of Bedform Features	Pool and riffle	Bedrock Outcrops	No
Bed Compaction	Moderate	Sediment Angularity	Sub-angular
Sediment Matrix	Sand and mud	Bed Stability Rating	Bed stable
<b>Photographs</b>

Upstream showing overland flow path and defined channel with pooled.		Downstream showing overland flow path and defined channel with pooled.

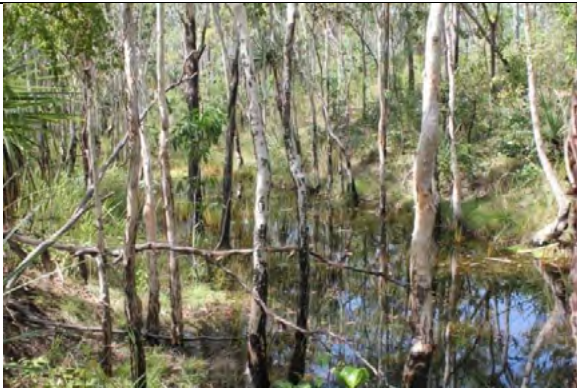
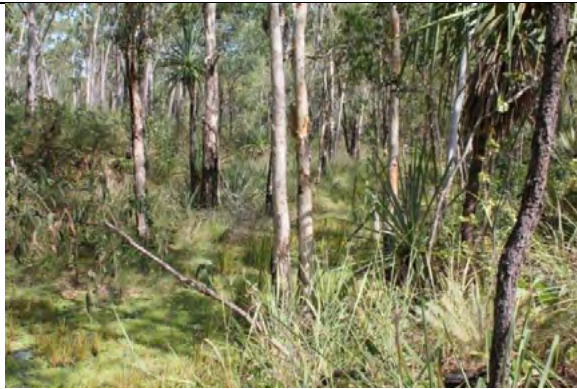
<b>FIGURE ID</b>	026	<b>Monitoring Date</b>	01/07/2014
<b>Figure Reference</b>	Figure A-2	<b>Coordinates</b>	-14.037569
<b>Location ID</b>	ER-ERMC-11		136.510446
<b>Catchment</b>	Emerald River	<b>Coordinate System</b>	Decimal degrees
<b>Drainage Feature</b>	Emerald River – Main Channel		
<b>Relative Location</b>	Upstream of confluence with Emerald River – Tributary 1		
<b>Physical Assessment</b>			
Valley Shape	Broad Valley	Local Influences	None
Floodplain Width (m)	N/A	Landuse (left bank)	Native Forest
Floodplain Features	No features	Landuse (right bank)	Native Forest
<b>Physical Barriers</b>			
Type of Bars	None	Large Woody Debris	<10%
Extent of Bars (%)	None	Artificial Features	None
Particle Size on Bars	N/A	Channel Modifications	None
<b>Channel Shape &amp; Banks</b>			
Bank Shape	Convex	Bank Height (m)	4 to 5
Bank Slope	Moderate to low	Bank Width (m)	10
Factors Affecting Bank Stability	None	Bank Material	Sand and mud over bedrock

Artificial Bank Protection	None	Substrate Composition	Sand and mud over bedrock
<b>Water Observations</b>			
Water Level	Low	Water Surface Width (m)	2
Water Depth (m)	0.5	Turbidity (Visual)	None
Water Oils	None	Water Odours	None
Sediment Oils	None	Sediment Odours	None
<b>Stream Bed</b>			
Extent of Bedform Features	Pool and glide	Bedrock Outcrops	No
Bed Compaction	Moderate	Sediment Angularity	Sub-angular
Sediment Matrix	Sand and mud over bedrock	Bed Stability Rating	Bed stable
<b>Photographs</b>

Upstream showing defined channel with pooled water		Downstream showing defined channel with pooled water

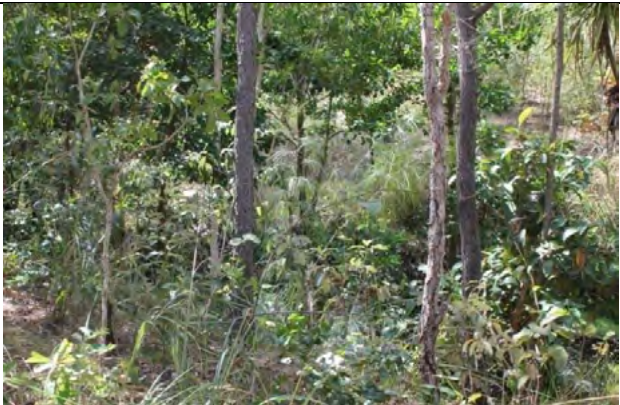
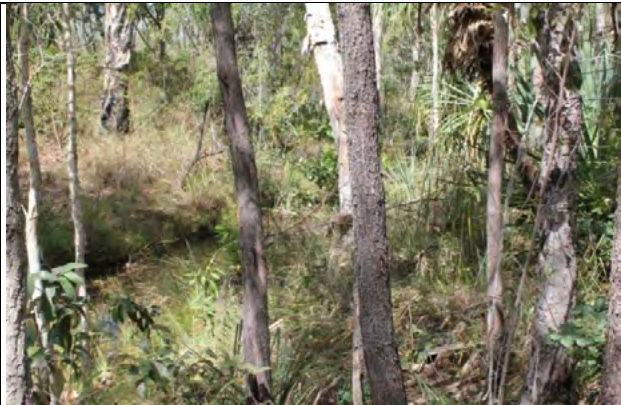
Artificial Bank Protection	None	Substrate Composition	Sand and mud over bedrock
<b>Water Observations</b>			
Water Level	Low	Water Surface Width (m)	2
Water Depth (m)	0.5	Turbidity (Visual)	None
Water Oils	None	Water Odours	None
Sediment Oils	None	Sediment Odours	None
<b>Stream Bed</b>			
Extent of Bedform Features	Pool and glide	Bedrock Outcrops	No
Bed Compaction	Moderate	Sediment Angularity	Sub-angular
Sediment Matrix	Sand and mud over bedrock	Bed Stability Rating	Bed stable
<b>Photographs</b>

Upstream showing defined channel with in channel vegetation		Downstream showing defined channel with pooled water

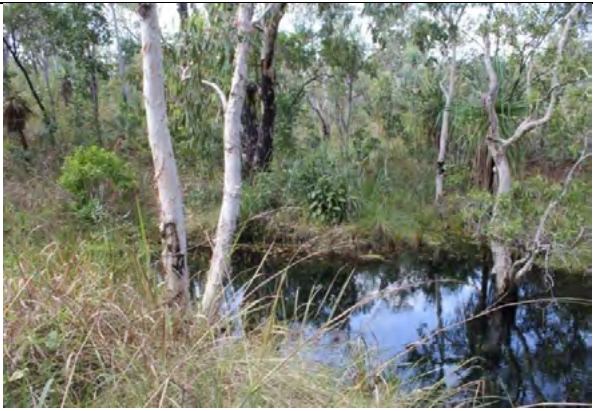
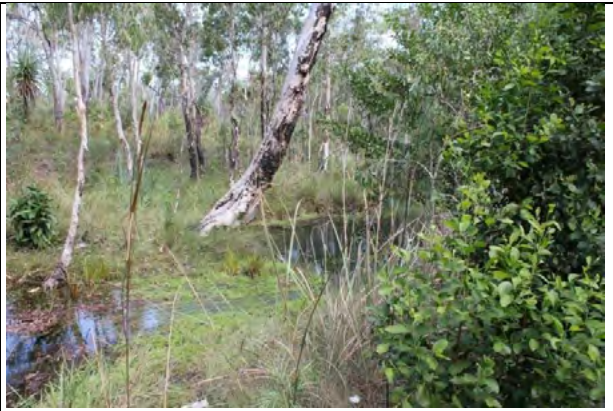
<b>Water Observations</b>			
Water Level	Low	Water Surface Width (m)	4
Water Depth (m)	0.5 to 1	Turbidity (Visual)	Plant leachate
Water Oils	None	Water Odours	Organic
Sediment Oils	None	Sediment Odours	Organic
<b>Stream Bed</b>			
Extent of Bedform Features	Pool and glide	Bedrock Outcrops	No
Bed Compaction	Moderate	Sediment Angularity	Sub-angular
Sediment Matrix	Sand and mud over bedrock	Bed Stability Rating	Bed stable
<b>Photographs</b>

Upstream showing defined channel with pooled water		Downstream showing defined channel with pooled water

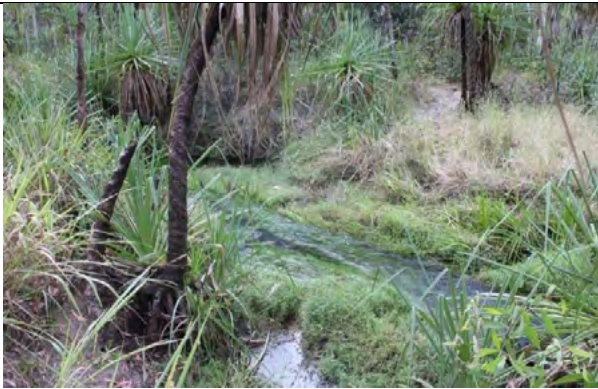
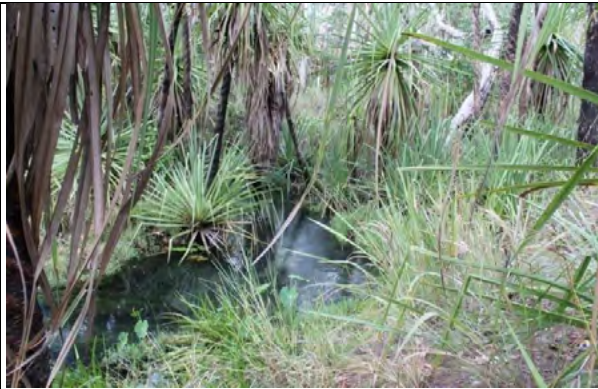
<b>FIGURE ID</b>	039	<b>Monitoring Date</b>	01/07/2014
<b>Figure Reference</b>	Figure A-3	<b>Coordinates</b>	-14.075912
<b>Location ID</b>	ER-ERMC-15		136.459724
<b>Catchment</b>	Emerald River	<b>Coordinate System</b>	Decimal degrees
<b>Drainage Feature</b>	Emerald River – Main Channel		
<b>Relative Location</b>	Downstream of confluence with Emerald River – Tributary 2		
<b>Physical Assessment</b>			
Valley Shape	Broad Valley	Local Influences	Road Crossing
Floodplain Width (m)	N/A	Landuse (left bank)	Native Forest
Floodplain Features	No features	Landuse (right bank)	Native Forest
<b>Physical Barriers</b>			
Type of Bars	Point, vegetated	Large Woody Debris	10%
Extent of Bars (%)	40	Artificial Features	Bridge in vicinity
Particle Size on Bars	Sand and silt	Channel Modifications	None
<b>Channel Shape &amp; Banks</b>			
Bank Shape	Convex	Bank Height (m)	2
Bank Slope	Low	Bank Width (m)	5
Factors Affecting Bank Stability	None	Bank Material	Sand and mud over bedrock

Artificial Bank Protection	None	Substrate Composition	Sand and mud over bedrock
<b>Water Observations</b>			
Water Level	Low	Water Surface Width (m)	2
Water Depth (m)	0.5	Turbidity (Visual)	Plant leachate
Water Oils	None	Water Odours	Organic
Sediment Oils	None	Sediment Odours	Organic
<b>Stream Bed</b>			
Extent of Bedform Features	Runs and backwaters	Bedrock Outcrops	No
Bed Compaction	Moderate	Sediment Angularity	Sub-angular
Sediment Matrix	Sand and mud over bedrock	Bed Stability Rating	Bed stable
<b>Photographs</b>

Upstream showing defined channel with pooled water		Downstream showing defined channel with pooled water

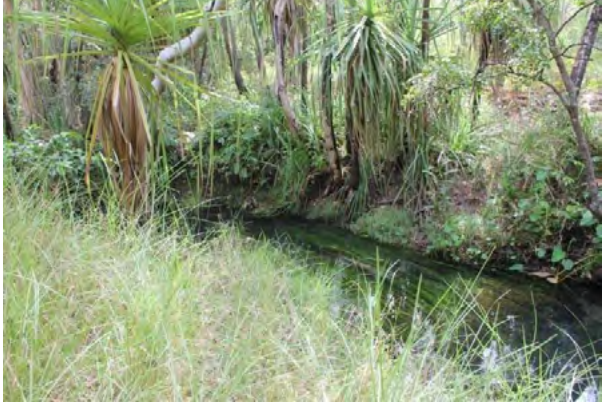
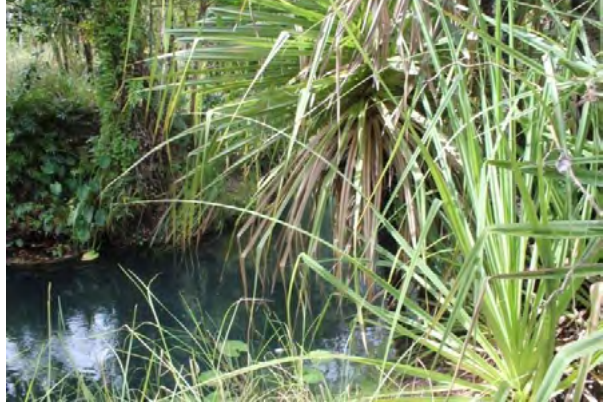
Artificial Bank Protection	None	Substrate Composition	Sand and mud over bedrock
<b>Water Observations</b>			
Water Level	Low	Water Surface Width (m)	2
Water Depth (m)	0.5	Turbidity (Visual)	Plant leachate
Water Oils	None	Water Odours	Organic
Sediment Oils	None	Sediment Odours	Organic
<b>Stream Bed</b>			
Extent of Bedform Features	Runs and backwaters	Bedrock Outcrops	No
Bed Compaction	Moderate	Sediment Angularity	Sub-angular
Sediment Matrix	Sand and mud over bedrock	Bed Stability Rating	Bed stable
<b>Photographs</b>

Upstream showing defined channel with backwaters		Downstream showing defined channel with backwaters

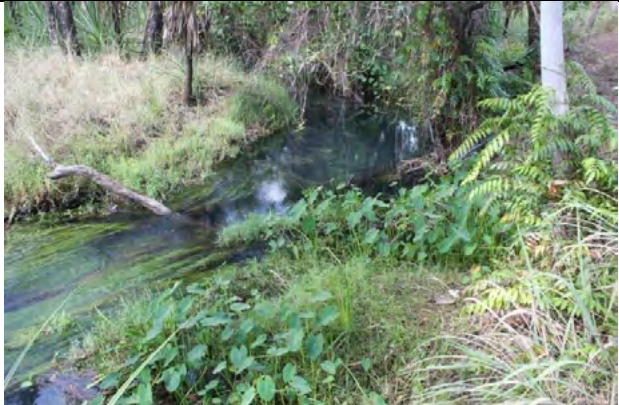
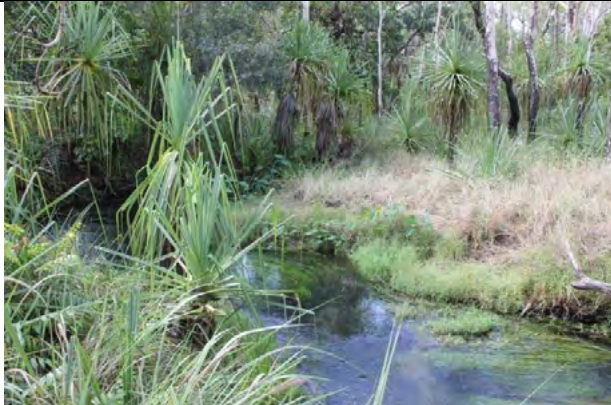
Artificial Bank Protection	None	Substrate Composition	Sand and mud over bedrock
<b>Water Observations</b>			
Water Level	Low	Water Surface Width (m)	2 to 3
Water Depth (m)	0.5	Turbidity (Visual)	Plant leachate
Water Oils	None	Water Odours	Organic
Sediment Oils	None	Sediment Odours	Organic
<b>Stream Bed</b>			
Extent of Bedform Features	Runs and backwaters	Bedrock Outcrops	No
Bed Compaction	Moderate	Sediment Angularity	Sub-angular
Sediment Matrix	Sand and mud over bedrock	Bed Stability Rating	Bed stable
<b>Photographs</b>

Upstream showing defined channel with backwaters		Downstream showing defined channel with backwaters

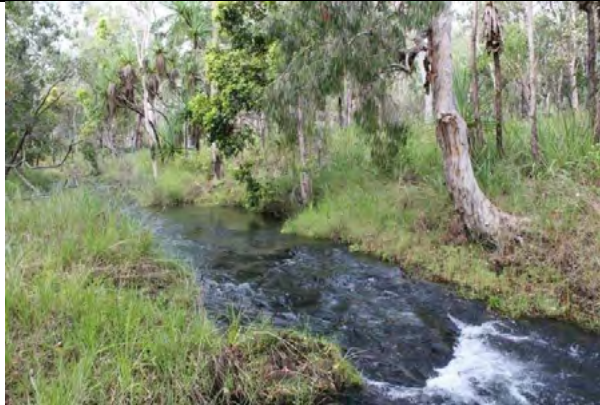
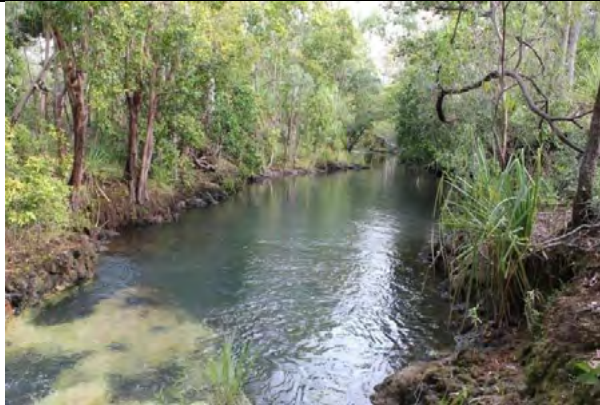
Artificial Bank Protection	None	Substrate Composition	Sand and mud over bedrock
<b>Water Observations</b>			
Water Level	Low	Water Surface Width (m)	2 to 5
Water Depth (m)	0.1 to 1	Turbidity (Visual)	Plant leachate, silt
Water Oils	None	Water Odours	Organic
Sediment Oils	None	Sediment Odours	Organic
<b>Stream Bed</b>			
Extent of Bedform Features	Glide and riffle	Bedrock Outcrops	Yes
Bed Compaction	Moderate	Sediment Angularity	Sub-angular
Sediment Matrix	Sand and mud over bedrock	Bed Stability Rating	Bed stable
<b>Photographs</b>

Upstream showing defined channel with flowing water		Downstream showing defined channel with pooled water

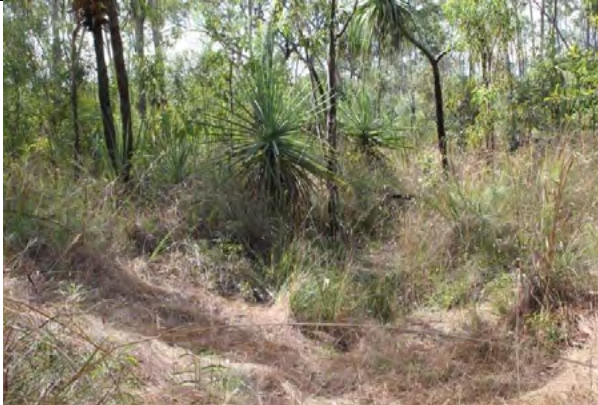
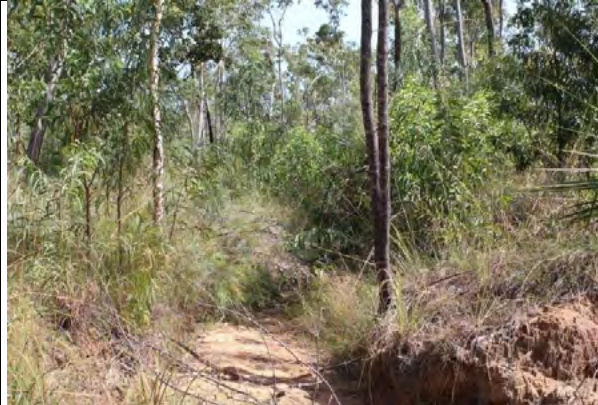
Artificial Bank Protection	None	Substrate Composition	Sand and gravel over bedrock
<b>Water Observations</b>			
Water Level	No flow	Water Surface Width (m)	0
Water Depth (m)	0	Turbidity (Visual)	None
Water Oils	None	Water Odours	None
Sediment Oils	None	Sediment Odours	None
<b>Stream Bed</b>			
Extent of Bedform Features	Riffle	Bedrock Outcrops	Yes
Bed Compaction	Moderate to low	Sediment Angularity	Sub-Angular
Sediment Matrix	Sand and gravel	Bed Stability Rating	Bed Stable
<b>Photographs</b>

Upstream showing overland flow path and no defined channel		Downstream showing defined channel with sandy bed

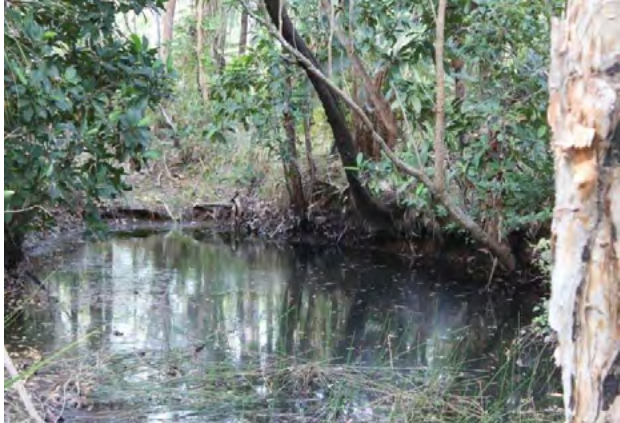
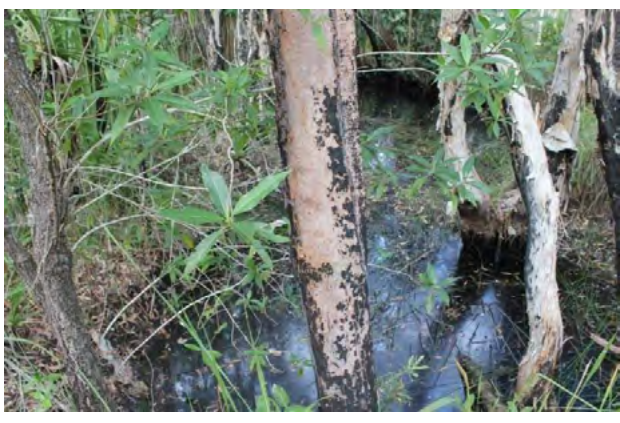
<b>Water Observations</b>			
Water Level	Low	Water Surface Width (m)	0.5 (inflow) to 2 (pool)
Water Depth (m)	0.5	Turbidity (Visual)	Black, plant leachate
Water Oils	None	Water Odours	Organic
Sediment Oils	None	Sediment Odours	Organic
<b>Stream Bed</b>			
Extent of Bedform Features	Backflows and pools	Bedrock Outcrops	No
Bed Compaction	Low to moderate	Sediment Angularity	Sub-Angular
Sediment Matrix	Fines over bedrock	Bed Stability Rating	Bed Stable
<b>Photographs</b>

Upstream showing pooled water		Downstream pooled water

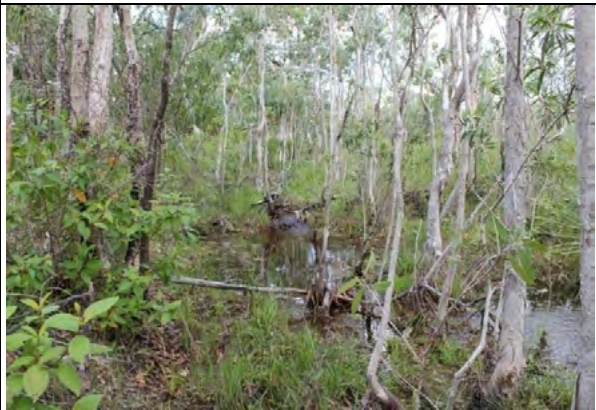
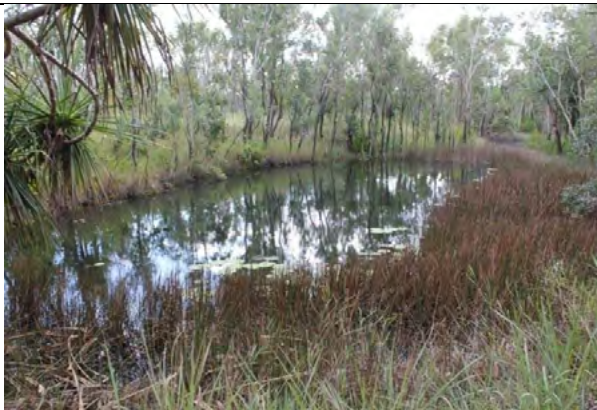
<b>Water Observations</b>			
Water Level	Low	Water Surface Width (m)	1 (inflow) to 4 (pool)
Water Depth (m)	0.5	Turbidity (Visual)	Turbid, plant leachate
Water Oils	None	Water Odours	Organic
Sediment Oils	None	Sediment Odours	Organic
<b>Stream Bed</b>			
Extent of Bedform Features	Backflows and pools	Bedrock Outcrops	No
Bed Compaction	Low to moderate	Sediment Angularity	Sub-Angular
Sediment Matrix	Fines over bedrock	Bed Stability Rating	Bed Stable
<b>Photographs</b>

Upstream showing inlet and pooled water		Downstream showing pooled water

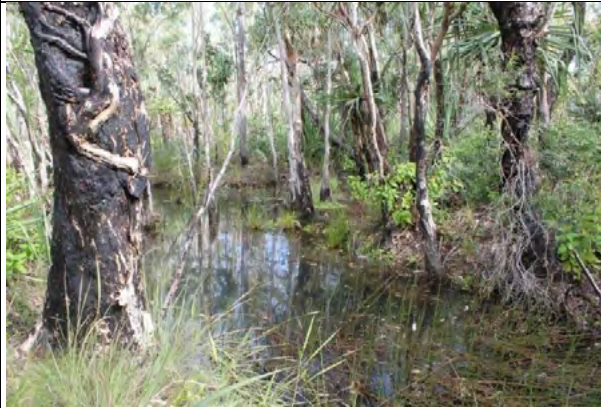
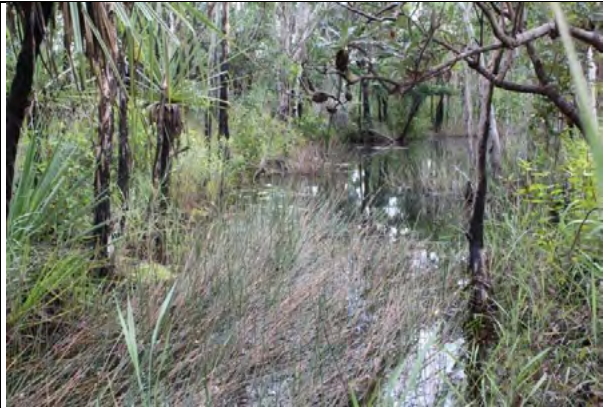
<b>Water Observations</b>			
Water Level	Low	Water Surface Width (m)	1 (inflow) to 4 (pool)
Water Depth (m)	1	Turbidity (Visual)	Clear
Water Oils	None	Water Odours	None
Sediment Oils	None	Sediment Odours	None
<b>Stream Bed</b>			
Extent of Bedform Features	Pool and riffles	Bedrock Outcrops	No
Bed Compaction	Low to moderate	Sediment Angularity	Sub-Angular
Sediment Matrix	Fines over bedrock	Bed Stability Rating	Bed Stable
<b>Photographs</b>

Upstream showing defined channel with pooled water		Downstream showing defined channel with pooled water and in stream vegetation

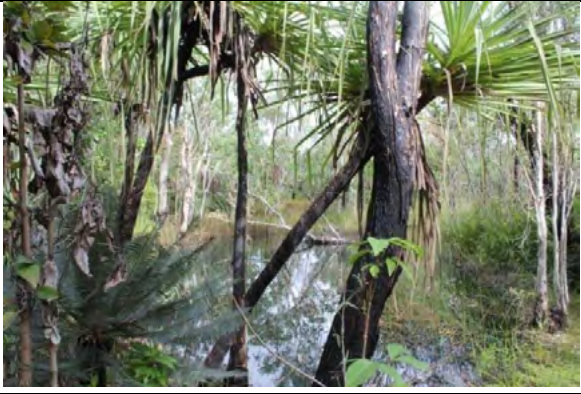
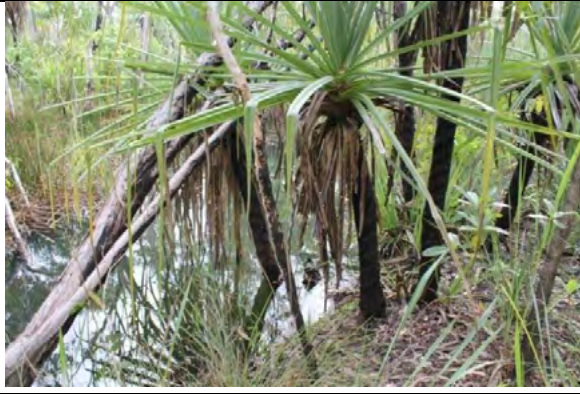
<b>FIGURE ID</b>	107	<b>Monitoring Date</b>	02/07/2014
<b>Figure Reference</b>	Figure A-3	<b>Coordinates</b>	-14.068164
<b>Location ID</b>	ER-ERT2-05		136.492279
<b>Catchment</b>	Emerald River	<b>Coordinate System</b>	Decimal degrees
<b>Drainage Feature</b>	Emerald River – Tributary 2		
<b>Relative Location</b>	Upstream of confluence with Emerald River		
<b>Physical Assessment</b>			
Valley Shape	Shallow Valley	Local Influences	None
Floodplain Width (m)	N/A	Landuse (left bank)	Native Forest
Floodplain Features	None	Landuse (right bank)	Native Forest
<b>Physical Barriers</b>			
Type of Bars	None	Large Woody Debris	<25%
Extent of Bars (%)	None	Artificial Features	None
Particle Size on Bars	N/A	Channel Modifications	None
<b>Channel Shape &amp; Banks</b>			
Bank Shape	Stepped	Bank Height (m)	1 to 3
Bank Slope	Low	Bank Width (m)	2 to 10
Factors Affecting Bank Stability	None	Bank Material	Fines over bedrock
Artificial Bank Protection	None	Substrate Composition	Fines over bedrock

<b>Water Observations</b>			
Water Level	Low	Water Surface Width (m)	1 (inflow) to 4 (pool)
Water Depth (m)	1	Turbidity (Visual)	Turbid, silt
Water Oils	None	Water Odours	None
Sediment Oils	None	Sediment Odours	None
<b>Stream Bed</b>			
Extent of Bedform Features	Pool and riffles	Bedrock Outcrops	No
Bed Compaction	Low to moderate	Sediment Angularity	Sub-Angular
Sediment Matrix	Fines over bedrock	Bed Stability Rating	Bed Stable
<b>Photographs</b>

Upstream showing defined channel with pooled water		Downstream showing defined channel with pooled water

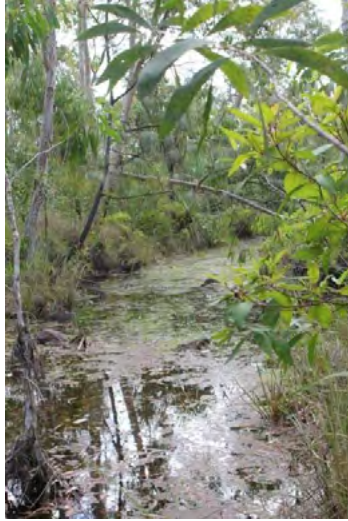
<b>FIGURE ID</b>	031	<b>Monitoring Date</b>	01/07/2014
<b>Figure Reference</b>	Figure A-2	<b>Coordinates</b>	-14.041509
<b>Location ID</b>	ER-ERT3-01		136.483409
<b>Catchment</b>	Emerald River	<b>Coordinate System</b>	Decimal degrees
<b>Drainage Feature</b>	Emerald River – Tributary 3		
<b>Relative Location</b>	Upstream of confluence with Emerald River		
<b>Physical Assessment</b>			
Valley Shape	Steep Valley	Local Influences	None
Floodplain Width (m)	N/A	Landuse (left bank)	Native Forest
Floodplain Features	None	Landuse (right bank)	Native Forest
<b>Physical Barriers</b>			
Type of Bars	None	Large Woody Debris	25%
Extent of Bars (%)	None	Artificial Features	None
Particle Size on Bars	N/A	Channel Modifications	None
<b>Channel Shape &amp; Banks</b>			
Bank Shape	Convex	Bank Height (m)	2.5
Bank Slope	Low to moderate	Bank Width (m)	3 to 4
Factors Affecting Bank Stability	None	Bank Material	Fines over bedrock

Artificial Bank Protection	None	Substrate Composition	Fines over bedrock
<b>Water Observations</b>			
Water Level	Low	Water Surface Width (m)	3
Water Depth (m)	0.1	Turbidity (Visual)	None
Water Oils	None	Water Odours	None
Sediment Oils	None	Sediment Odours	None
<b>Stream Bed</b>			
Extent of Bedform Features	Pool	Bedrock Outcrops	Yes
Bed Compaction	Low to moderate	Sediment Angularity	Angular
Sediment Matrix	Sand and gravel	Bed Stability Rating	Bed Stable
<b>Photographs</b>

Upstream showing defined channel with pooled water		Downstream showing defined channel with pooled water
