**EASTERN LEASES PROJECT**

# **BASELINE SURFACE WATER MONITORING REPORT**

for  
**South32 Pty Ltd**  
May 2015

**HANSEN BAILEY**  
215 Adelaide Street  
Brisbane QLD 4000

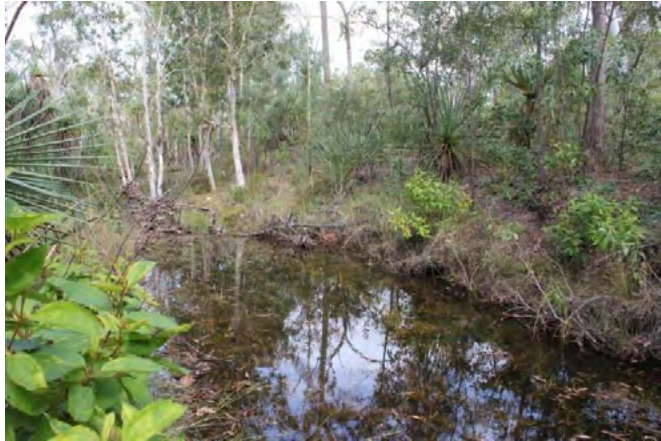
Artificial Bank Protection	None	Substrate Composition	Fines over bedrock
<b>Water Observations</b>			
Water Level	Low	Water Surface Width (m)	3
Water Depth (m)	0.1	Turbidity (Visual)	None
Water Oils	None	Water Odours	None
Sediment Oils	None	Sediment Odours	None
<b>Stream Bed</b>			
Extent of Bedform Features	Pool	Bedrock Outcrops	Yes
Bed Compaction	Low to moderate	Sediment Angularity	Angular
Sediment Matrix	Sand and gravel	Bed Stability Rating	Bed Stable
<b>Photographs</b>

Upstream showing defined channel with pooled water		Downstream showing defined channel with pooled water

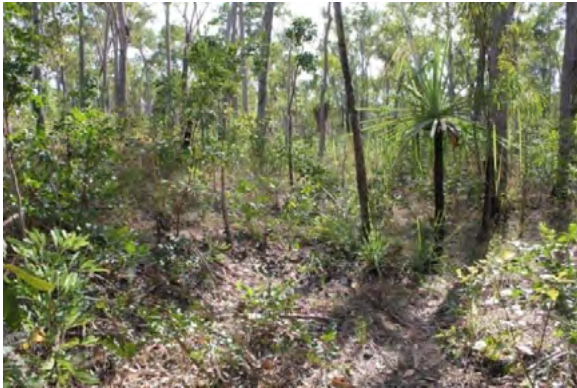
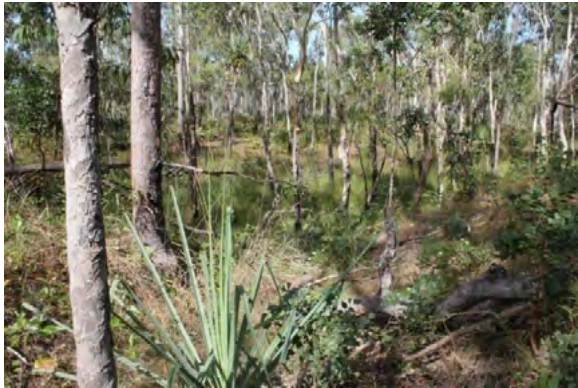
<b>FIGURE ID</b>	017	<b>Monitoring Date</b>	01/07/2014
<b>Figure Reference</b>	Figure A-2	<b>Coordinates</b>	-14.03521
<b>Location ID</b>	ER-EROB-01		136.524655
<b>Catchment</b>	Emerald River	<b>Coordinate System</b>	Decimal degrees
<b>Drainage Feature</b>	Overland flow path		
<b>Relative Location</b>	Upstream of confluence with Emerald River – Tributary 1		
<b>Physical Assessment</b>			
Valley Shape	Shallow Valley	Local Influences	None
Floodplain Width (m)	N/A	Landuse (left bank)	Native Forest
Floodplain Features	No features	Landuse (right bank)	Native Forest
<b>Physical Barriers</b>			
Type of Bars	None	Large Woody Debris	<5%
Extent of Bars (%)	None	Artificial Features	None
Particle Size on Bars	N/A	Channel Modifications	None
<b>Channel Shape &amp; Banks</b>			
Bank Shape	Convex	Bank Height (m)	2
Bank Slope	Moderate to low	Bank Width (m)	4
Factors Affecting Bank Stability	None	Bank Material	Sand and mud over bedrock

Artificial Bank Protection	None	Substrate Composition	Sand and mud over bedrock
<b>Water Observations</b>			
Water Level	No flow	Water Surface Width (m)	0
Water Depth (m)	0	Turbidity (Visual)	None
Water Oils	None	Water Odours	None
Sediment Oils	None	Sediment Odours	None
<b>Stream Bed</b>			
Extent of Bedform Features	Glide	Bedrock Outcrops	Yes
Bed Compaction	Moderate	Sediment Angularity	Sub-angular
Sediment Matrix	Sand and mud over bedrock	Bed Stability Rating	Bed stable
<b>Photographs</b>

Upstream showing overland flow path and no defined channel with in channel vegetation		Downstream showing overland flow path and no defined channel with in channel vegetation

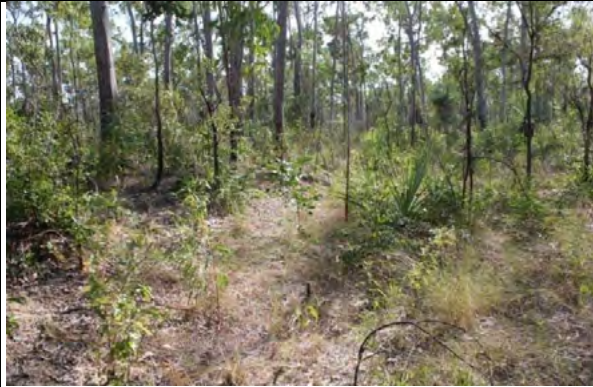
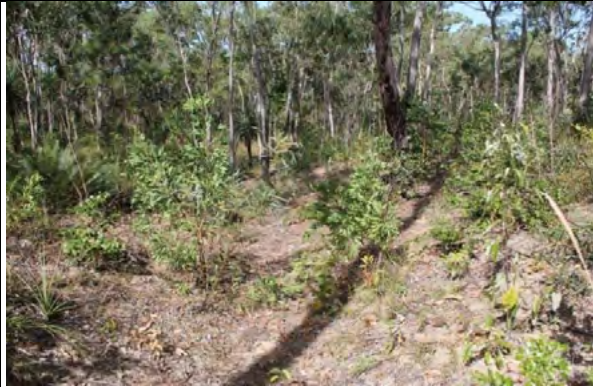
<b>FIGURE ID</b>	018	<b>Monitoring Date</b>	01/07/2014
<b>Figure Reference</b>	Figure A-2	<b>Coordinates</b>	-14.035329
<b>Location ID</b>	ER-EROB-02		136.523918
<b>Catchment</b>	Emerald River	<b>Coordinate System</b>	Decimal degrees
<b>Drainage Feature</b>	Overland flow path		
<b>Relative Location</b>	Upstream of confluence with Emerald River – Tributary 1		
<b>Physical Assessment</b>			
Valley Shape	Shallow Valley	Local Influences	None
Floodplain Width (m)	N/A	Landuse (left bank)	Native Forest
Floodplain Features	No features	Landuse (right bank)	Native Forest
<b>Physical Barriers</b>			
Type of Bars	None	Large Woody Debris	<5%
Extent of Bars (%)	None	Artificial Features	None
Particle Size on Bars	N/A	Channel Modifications	None
<b>Channel Shape &amp; Banks</b>			
Bank Shape	Convex	Bank Height (m)	1.5
Bank Slope	Moderate to low	Bank Width (m)	2
Factors Affecting Bank Stability	None	Bank Material	Sand and mud over bedrock

Artificial Bank Protection	None	Substrate Composition	Sand and mud over bedrock
<b>Water Observations</b>			
Water Level	No flow	Water Surface Width (m)	0
Water Depth (m)	0	Turbidity (Visual)	None
Water Oils	None	Water Odours	None
Sediment Oils	None	Sediment Odours	None
<b>Stream Bed</b>			
Extent of Bedform Features	Glide	Bedrock Outcrops	Yes
Bed Compaction	Moderate	Sediment Angularity	Sub-angular
Sediment Matrix	Sand and mud over bedrock	Bed Stability Rating	Bed stable
<b>Photographs</b>

Upstream showing overland flow path and no defined channel with in channel vegetation		Downstream showing overland flow path and no defined channel with in channel vegetation

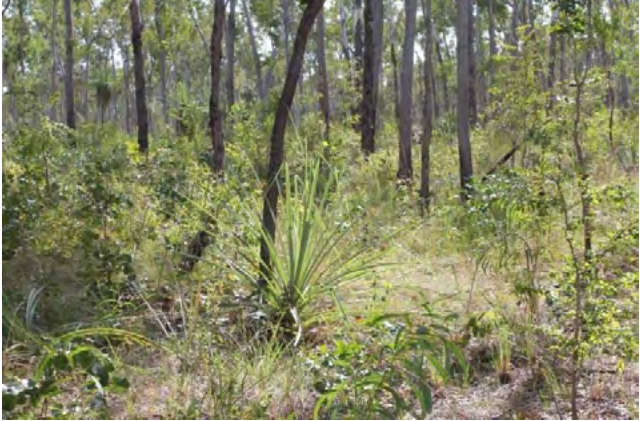
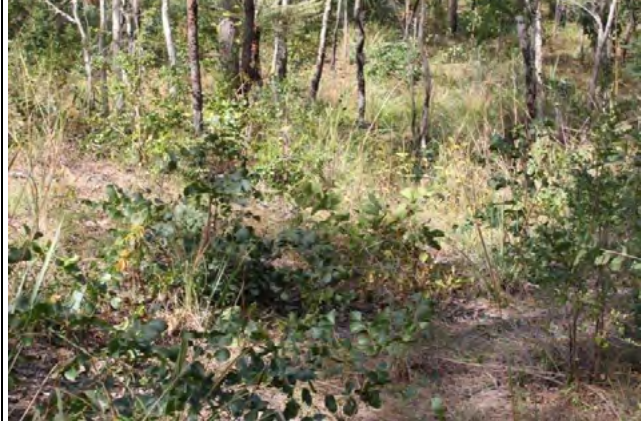
Artificial Bank Protection	None	Substrate Composition	Sand and mud over bedrock
<b>Water Observations</b>			
Water Level	No flow	Water Surface Width (m)	0
Water Depth (m)	0	Turbidity (Visual)	None
Water Oils	None	Water Odours	None
Sediment Oils	None	Sediment Odours	None
<b>Stream Bed</b>			
Extent of Bedform Features	Glide	Bedrock Outcrops	Yes
Bed Compaction	Moderate	Sediment Angularity	Sub-angular
Sediment Matrix	Sand and mud over bedrock	Bed Stability Rating	Bed stable
<b>Photographs</b>

Upstream showing overland flow path and no defined channel		Downstream showing overland flow path and no defined channel

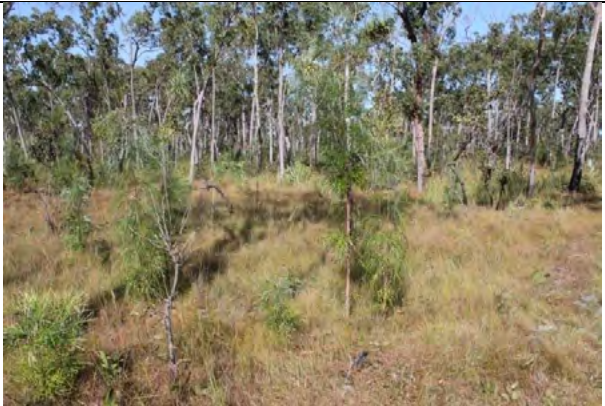
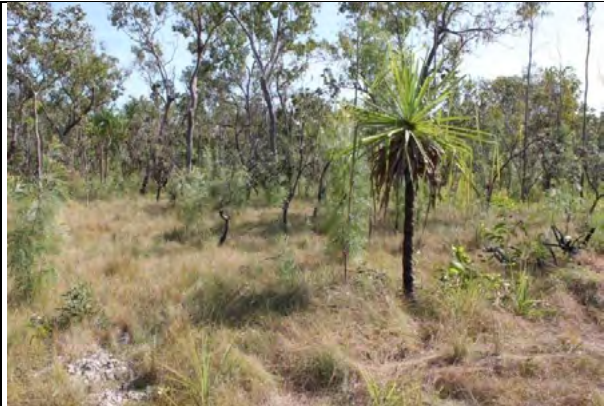
<b>Water Observations</b>			
Water Level	No flow	Water Surface Width (m)	0
Water Depth (m)	0	Turbidity (Visual)	None
Water Oils	None	Water Odours	None
Sediment Oils	None	Sediment Odours	None
<b>Stream Bed</b>			
Extent of Bedform Features	N/A	Bedrock Outcrops	N/A
Bed Compaction	Moderate	Sediment Angularity	Sub-Angular
Sediment Matrix	Sand and silt	Bed Stability Rating	Bed stable
<b>Photographs</b>

Look east showing alluvial fan flowpaths		Look west showing alluvial fan flowpaths

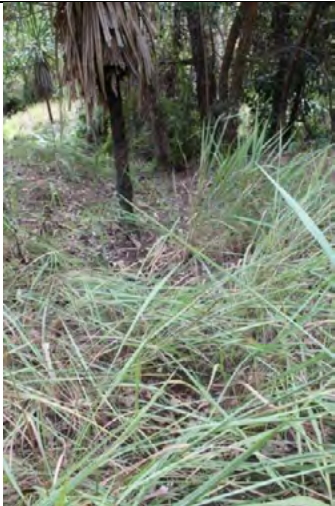
<b>FIGURE ID</b>	037	<b>Monitoring Date</b>	01/07/2014
<b>Figure Reference</b>	Figure A-3	<b>Coordinates</b>	-14.076077
<b>Location ID</b>	ER-EROB-07		136.459171
<b>Catchment</b>	Emerald River	<b>Coordinate System</b>	Decimal degrees
<b>Drainage Feature</b>	Overland flow path		
<b>Relative Location</b>	Downstream of confluence with Emerald River – Tributary 2		
<b>Physical Assessment</b>			
Valley Shape	Broad Valley	Local Influences	None
Floodplain Width (m)	N/A	Landuse (left bank)	Native Forest
Floodplain Features	No features	Landuse (right bank)	Native Forest
<b>Physical Barriers</b>			
Type of Bars	None	Large Woody Debris	<5%
Extent of Bars (%)	None	Artificial Features	None
Particle Size on Bars	N/A	Channel Modifications	None
<b>Channel Shape &amp; Banks</b>			
Bank Shape	Convex	Bank Height (m)	1
Bank Slope	Moderate	Bank Width (m)	1
Factors Affecting Bank Stability	None	Bank Material	Sand and mud over bedrock

Artificial Bank Protection	None	Substrate Composition	Sand and mud over bedrock
<b>Water Observations</b>			
Water Level	No flow	Water Surface Width (m)	0
Water Depth (m)	0	Turbidity (Visual)	None
Water Oils	None	Water Odours	None
Sediment Oils	None	Sediment Odours	None
<b>Stream Bed</b>			
Extent of Bedform Features	Glide	Bedrock Outcrops	No
Bed Compaction	Moderate	Sediment Angularity	Sub-angular
Sediment Matrix	Sand and mud	Bed Stability Rating	Bed stable
<b>Photographs</b>

Downstream showing overland flow path and no defined channel

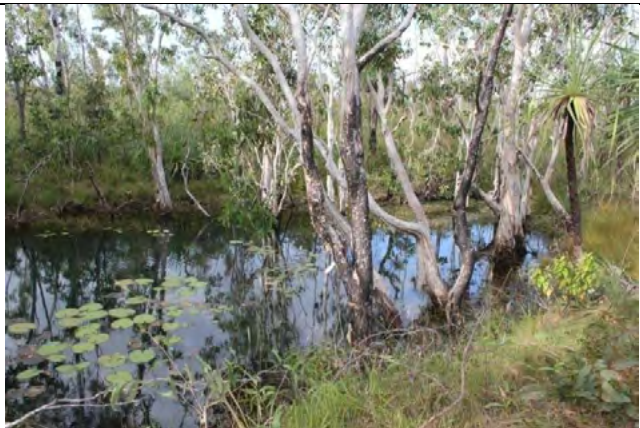
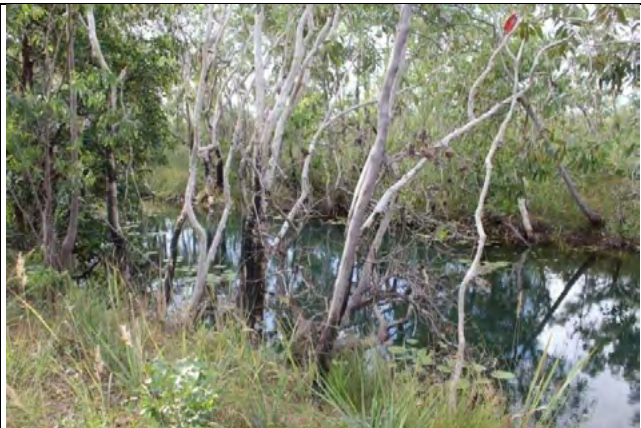
<b>Water Observations</b>			
Water Level	Low	Water Surface Width (m)	6 to 8
Water Depth (m)	0.5 to 1	Turbidity (Visual)	Plant leachate
Water Oils	None	Water Odours	Organic
Sediment Oils	None	Sediment Odours	Organic
<b>Stream Bed</b>			
Extent of Bedform Features	Pool	Bedrock Outcrops	Not observed
Bed Compaction	Low	Sediment Angularity	Sub-Angular
Sediment Matrix	Sand and silt	Bed Stability Rating	Bed Stable
<b>Photographs</b>

Upstream showing surface depression with pooled water		Downstream showing surface depression with pooled water

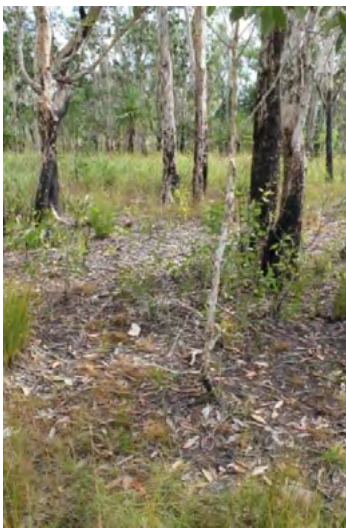
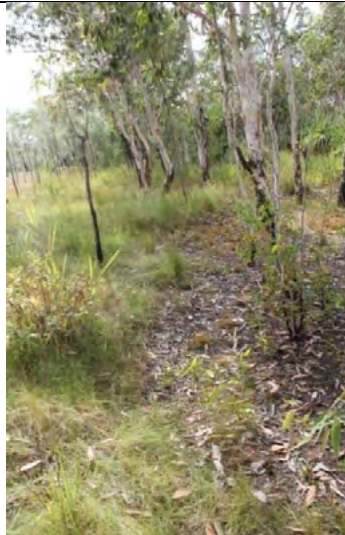
<b>FIGURE ID</b>	110	<b>Monitoring Date</b>	02/07/2014
<b>Figure Reference</b>	Figure A-3	<b>Coordinates</b>	-14.071769
<b>Location ID</b>	ER-EROB-10		136.496012
<b>Catchment</b>	Emerald River	<b>Coordinate System</b>	Decimal degrees
<b>Drainage Feature</b>	Emerald River – Tributary 2 Overbank Area		
<b>Relative Location</b>	Upstream of confluence with Emerald River		
<b>Physical Assessment</b>			
Valley Shape	Shallow Valley	Local Influences	None
Floodplain Width (m)	N/A	Landuse (left bank)	Native Forest
Floodplain Features	None	Landuse (right bank)	Native Forest
<b>Physical Barriers</b>			
Type of Bars	N/A	Large Woody Debris	N/A
Extent of Bars (%)	N/A	Artificial Features	N/A
Particle Size on Bars	N/A	Channel Modifications	N/A
<b>Channel Shape &amp; Banks</b>			
Bank Shape	N/A	Bank Height (m)	N/A
Bank Slope	N/A	Bank Width (m)	N/A
Factors Affecting Bank Stability	None	Bank Material	Fines over bedrock
Artificial Bank Protection	None	Substrate Composition	Fines over bedrock

<b>Water Observations</b>			
Water Level	No Flow	Water Surface Width (m)	0
Water Depth (m)	0	Turbidity (Visual)	None
Water Oils	None	Water Odours	None
Sediment Oils	None	Sediment Odours	None
<b>Stream Bed</b>			
Extent of Bedform Features	N/A	Bedrock Outcrops	No
Bed Compaction	Moderate	Sediment Angularity	Sub-Angular
Sediment Matrix	Mud and sand	Bed Stability Rating	Bed Stable
<b>Photographs</b>

Representative overbank vegetation and ground cover		Representative overbank vegetation and ground cover

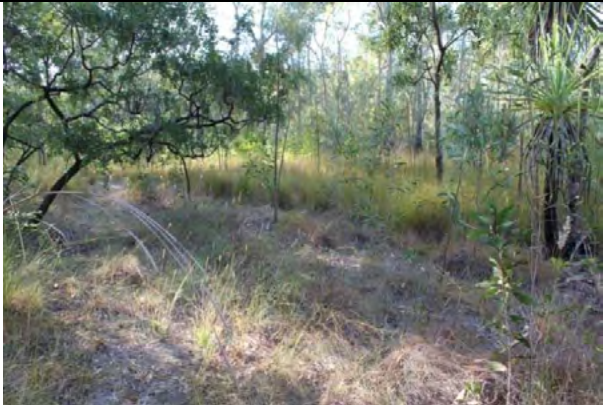
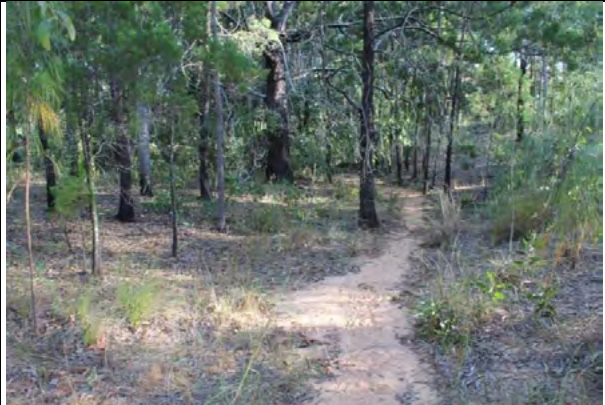
Artificial Bank Protection	None	Substrate Composition	Sand and mud over bedrock
<b>Water Observations</b>			
Water Level	No Flow	Water Surface Width (m)	0
Water Depth (m)	0	Turbidity (Visual)	None
Water Oils	None	Water Odours	None
Sediment Oils	None	Sediment Odours	None
<b>Stream Bed</b>			
Extent of Bedform Features	Riffle	Bedrock Outcrops	No
Bed Compaction	Moderate	Sediment Angularity	Sub-angular
Sediment Matrix	Sand and mud over bedrock	Bed Stability Rating	Bed stable
<b>Photographs</b>

Upstream showing overland flow path and no defined channel		Downstream showing overland flow path and no defined channel with sandy bed

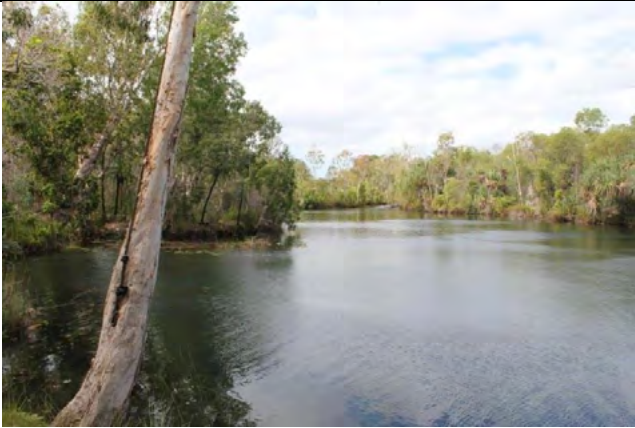
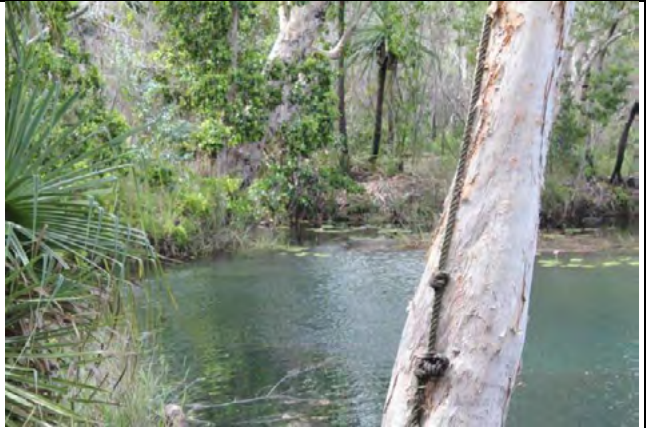
Artificial Bank Protection	None	Substrate Composition	Fines over bedrock
<b>Water Observations</b>			
Water Level	Low	Water Surface Width (m)	40+
Water Depth (m)	1 to 2	Turbidity (Visual)	Turbid, fines
Water Oils	None	Water Odours	None
Sediment Oils	None	Sediment Odours	None
<b>Stream Bed</b>			
Extent of Bedform Features	Pool and cascade sequence, backwater in tributary	Bedrock Outcrops	Yes
Bed Compaction	Low	Sediment Angularity	Not present
Sediment Matrix	Fines over bedrock	Bed Stability Rating	Bed Stable
<b>Photographs</b>

Upstream showing Amagula River on the right with Tributary 1 entering from the left		Upstream Tributary 1 at confluence with Amagula river

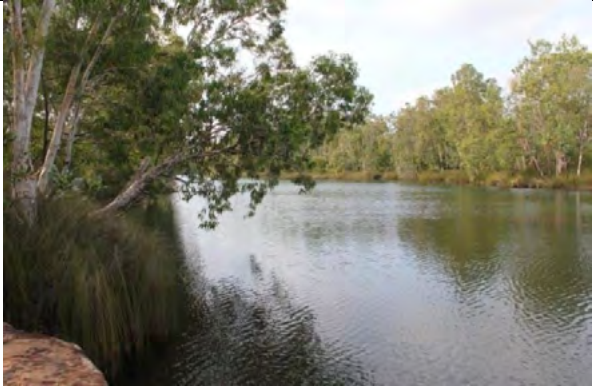
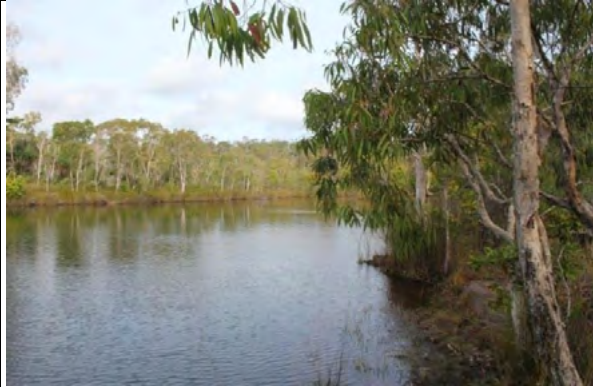
<b>FIGURE ID</b>	049	<b>Monitoring Date</b>	01/07/2014
<b>Figure Reference</b>	Figure A-4	<b>Coordinates</b>	-14.127003
<b>Location ID</b>	AR-ARMC-02		136.537476
<b>Catchment</b>	Amagula River	<b>Coordinate System</b>	Decimal degrees
<b>Drainage Feature</b>	Amagula River – Main Channel (Leske Pools)		
<b>Relative Location</b>	Downstream from Amagula River – Tributary 1		
<b>Physical Assessment</b>			
Valley Shape	Asymmetrical	Local Influences	None
Floodplain Width (m)	N/A	Landuse (left bank)	Native Forest
Floodplain Features	No features	Landuse (right bank)	Native Forest
<b>Physical Barriers</b>			
Type of Bars	None	Large Woody Debris	None
Extent of Bars (%)	None	Artificial Features	None
Particle Size on Bars	N/A	Channel Modifications	None
<b>Channel Shape &amp; Banks</b>			
Bank Shape	Stepped, convex	Bank Height (m)	2.5
Bank Slope	Steep	Bank Width (m)	2
Factors Affecting Bank Stability	None	Bank Material	Fines over bedrock

Artificial Bank Protection	None	Substrate Composition	Fines over bedrock
<b>Water Observations</b>			
Water Level	Low	Water Surface Width (m)	50+
Water Depth (m)	2	Turbidity (Visual)	Plant leachate
Water Oils	None	Water Odours	None
Sediment Oils	None	Sediment Odours	None
<b>Stream Bed</b>			
Extent of Bedform Features	Pool	Bedrock Outcrops	Uniformly rock controlled
Bed Compaction	Low	Sediment Angularity	Not present
Sediment Matrix	Bedrock	Bed Stability Rating	Bed Stable
<b>Photographs</b>

Upstream showing pooled water		Downstream showing pooled water

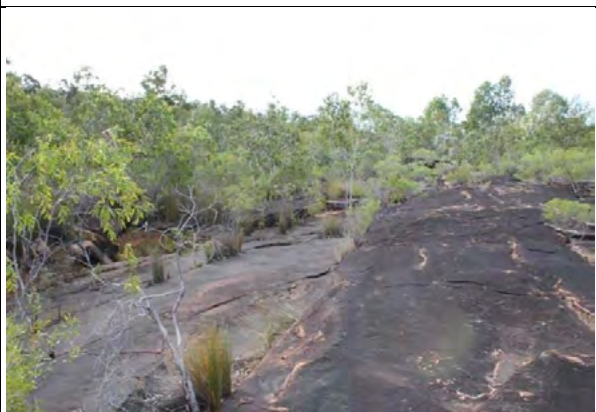
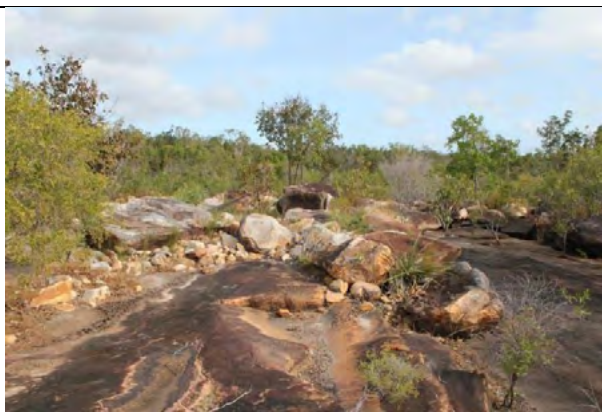
Artificial Bank Protection	None	Substrate Composition	Fines over bedrock
<b>Water Observations</b>			
Water Level	Low	Water Surface Width (m)	50+
Water Depth (m)	2 m	Turbidity (Visual)	Plant leachate
Water Oils	None	Water Odours	None
Sediment Oils	None	Sediment Odours	None
<b>Stream Bed</b>			
Extent of Bedform Features	Run	Bedrock Outcrops	Uniformly rock controlled
Bed Compaction	Low	Sediment Angularity	Not present
Sediment Matrix	Bedrock	Bed Stability Rating	Bed Stable
<b>Photographs</b>

Upstream defined channel with rock controlled bed and in channel vegetation		Downstream defined channel with rock controlled bed and in channel vegetation

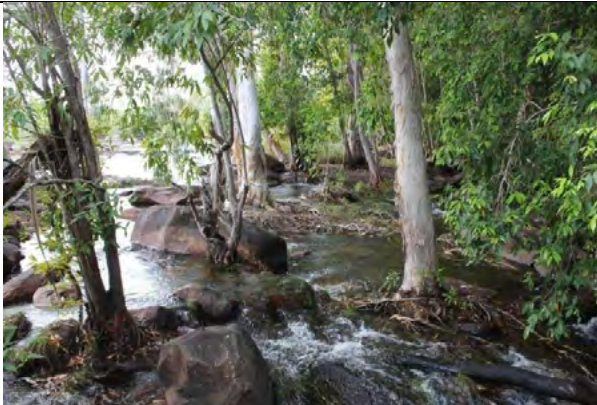
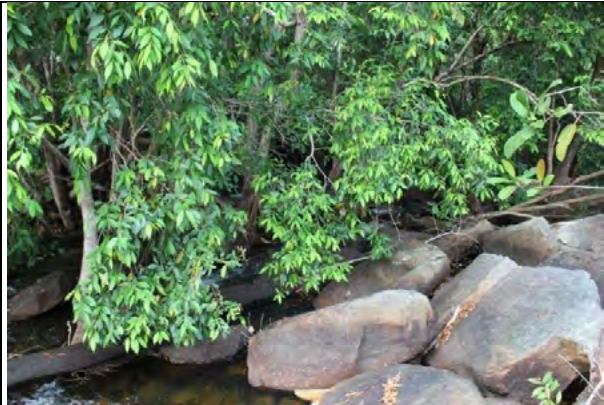
Artificial Bank Protection	None	Substrate Composition	Bedrock
<b>Water Observations</b>			
Water Level	Low	Water Surface Width (m)	2
Water Depth (m)	0.1	Turbidity (Visual)	Plant leachate
Water Oils	None	Water Odours	None
Sediment Oils	None	Sediment Odours	None
<b>Stream Bed</b>			
Extent of Bedform Features	Rapid	Bedrock Outcrops	Uniformly rock controlled
Bed Compaction	Low	Sediment Angularity	Not present
Sediment Matrix	Bedrock	Bed Stability Rating	Bed Stable
<b>Photographs</b>

Upstream showing defined channel with rock controlled bed and in channel vegetation		Downstream showing defined channel with rock controlled bed and in channel vegetation

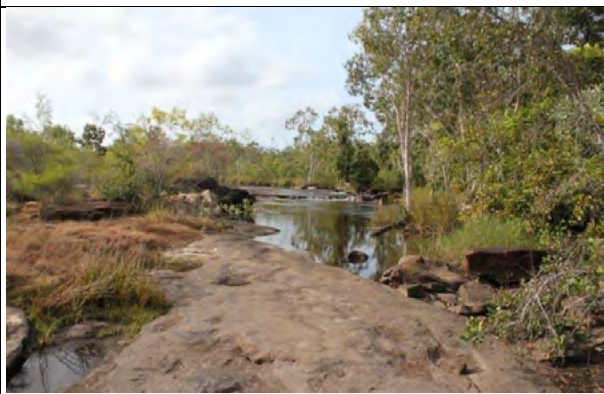
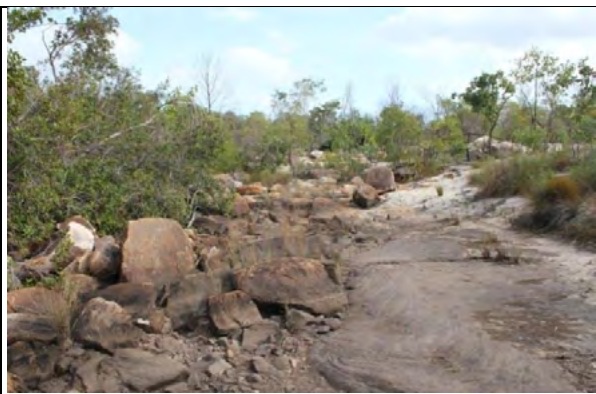
<b>FIGURE ID</b>	046	<b>Monitoring Date</b>	01/07/2014
<b>Figure Reference</b>	Figure A-4	<b>Coordinates</b>	-14.128792
<b>Location ID</b>	AR-ARMC-05		136.537647
<b>Catchment</b>	Amagula River	<b>Coordinate System</b>	Decimal degrees
<b>Drainage Feature</b>	Amagula River – Main Channel (Leske Pools)		
<b>Relative Location</b>	Downstream of confluence with Amagula River – Tributary 1		
<b>Physical Assessment</b>			
Valley Shape	Asymmetrical	Local Influences	None
Floodplain Width (m)	N/A	Landuse (left bank)	Native Forest
Floodplain Features	No features	Landuse (right bank)	Native Forest
<b>Physical Barriers</b>			
Type of Bars	None	Large Woody Debris	None
Extent of Bars (%)	None	Artificial Features	None
Particle Size on Bars	N/A	Channel Modifications	None
<b>Channel Shape &amp; Banks</b>			
Bank Shape	Concave	Bank Height (m)	1
Bank Slope	Low	Bank Width (m)	5
Factors Affecting Bank Stability	None	Bank Material	Fines over bedrock

Artificial Bank Protection	None	Substrate Composition	Fines over bedrock
<b>Water Observations</b>			
Water Level	Low	Water Surface Width (m)	3
Water Depth (m)	0.2	Turbidity (Visual)	Plant leachate
Water Oils	None	Water Odours	None
Sediment Oils	None	Sediment Odours	None
<b>Stream Bed</b>			
Extent of Bedform Features	Pond	Bedrock Outcrops	Yes
Bed Compaction	Low	Sediment Angularity	Angular
Sediment Matrix	Gravels on bedrock	Bed Stability Rating	Bed Stable
<b>Photographs</b>

Upstream showing defined channel with pooled water in rock controlled bed		Downstream showing defined channel with rock controlled bed

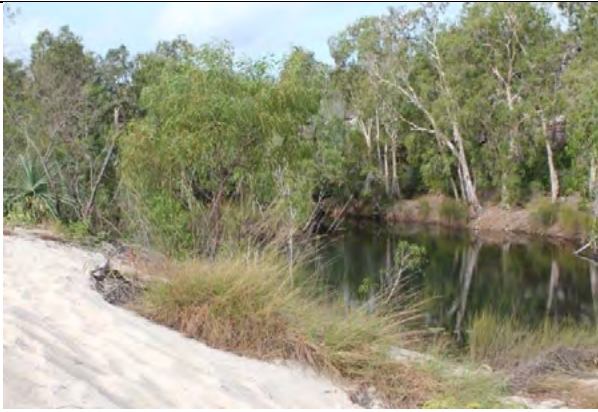
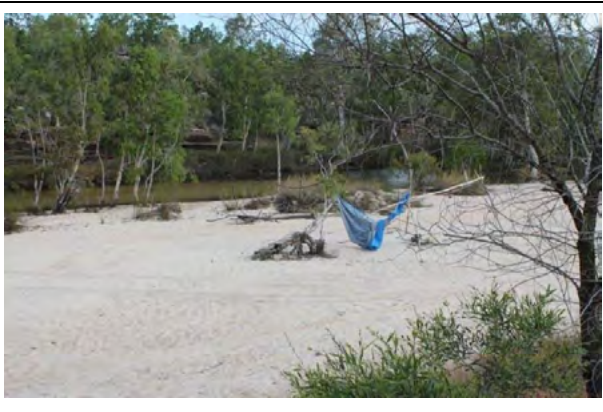
Artificial Bank Protection	None	Substrate Composition	Fines over bedrock
<b>Water Observations</b>			
Water Level	Low	Water Surface Width (m)	5
Water Depth (m)	1	Turbidity (Visual)	Plant leachate
Water Oils	None	Water Odours	None
Sediment Oils	None	Sediment Odours	None
<b>Stream Bed</b>			
Extent of Bedform Features	Pool	Bedrock Outcrops	Yes
Bed Compaction	Moderate	Sediment Angularity	Sub-angular
Sediment Matrix	Sand on bedrock	Bed Stability Rating	Moderate Deposition
<b>Photographs</b>

Upstream showing defined channel with pooled water		Downstream showing defined channel with pooled water

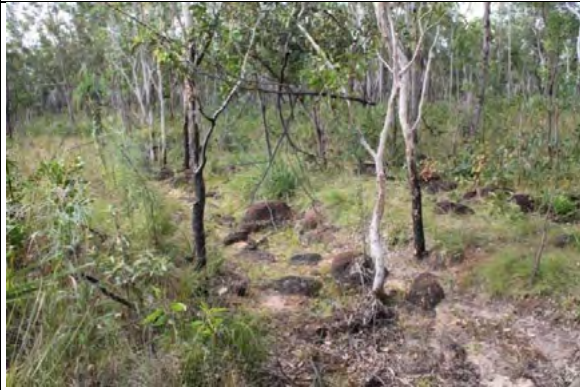
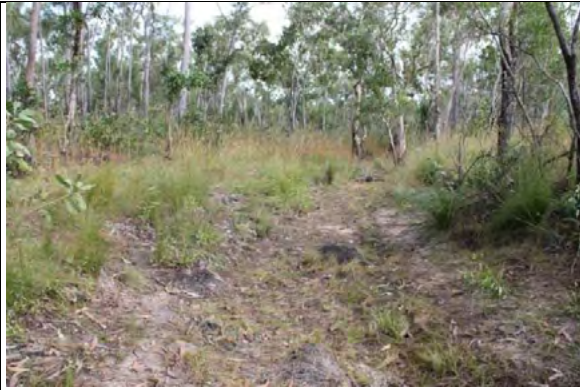
<b>FIGURE ID</b>	103	<b>Monitoring Date</b>	02/07/2014
<b>Figure Reference</b>	Figure A-4	<b>Coordinates</b>	-14.090442
<b>Location ID</b>	AR-ART1-01		136.531822
<b>Catchment</b>	Amagula River	<b>Coordinate System</b>	Decimal degrees
<b>Drainage Feature</b>	Amagula River – Tributary 1		
<b>Relative Location</b>	Upstream of confluence with Amagula River		
<b>Physical Assessment</b>			
Valley Shape	Broad	Local Influences	None
Floodplain Width (m)	N/A	Landuse (left bank)	Native Forest
Floodplain Features	No features	Landuse (right bank)	Native Forest
<b>Physical Barriers</b>			
Type of Bars	None	Large Woody Debris	<5%
Extent of Bars (%)	None	Artificial Features	None
Particle Size on Bars	N/A	Channel Modifications	None
<b>Channel Shape &amp; Banks</b>			
Bank Shape	Undefined	Bank Height (m)	Undefined
Bank Slope	Undefined	Bank Width (m)	Undefined
Factors Affecting Bank Stability	None	Bank Material	Undefined
Artificial Bank Protection	None	Substrate Composition	Fines over bedrock

<b>Water Observations</b>			
Water Level	No Flow	Water Surface Width (m)	0
Water Depth (m)	0	Turbidity (Visual)	None
Water Oils	None	Water Odours	None
Sediment Oils	None	Sediment Odours	None
<b>Stream Bed</b>			
Extent of Bedform Features	Undefined	Bedrock Outcrops	Yes
Bed Compaction	Tight	Sediment Angularity	Not present
Sediment Matrix	Soil over bedrock	Bed Stability Rating	Bed Stable
<b>Photographs</b>

Upstream showing defined channel with in stream vegetation and rock controlled bed		Downstream showing undefined channel

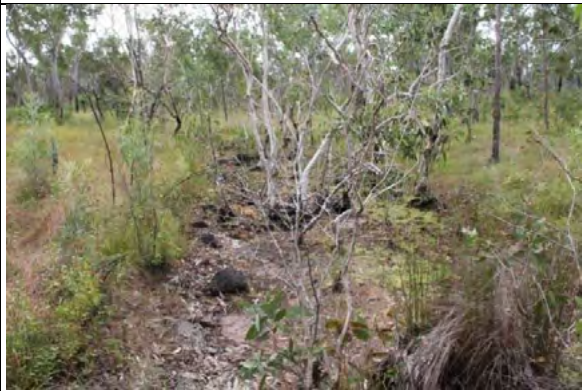
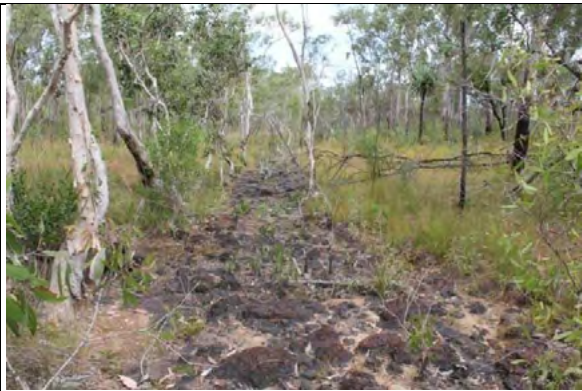
<b>FIGURE ID</b>	101	<b>Monitoring Date</b>	02/07/2014
<b>Figure Reference</b>	Figure A-4	<b>Coordinates</b>	-14.096999
<b>Location ID</b>	AR-ART1-02		136.531618
<b>Catchment</b>	Amagula River	<b>Coordinate System</b>	Decimal degrees
<b>Drainage Feature</b>	Amagula River – Tributary 1		
<b>Relative Location</b>	Upstream of confluence with Amagula River		
<b>Physical Assessment</b>			
Valley Shape	Broad	Local Influences	None
Floodplain Width (m)	N/A	Landuse (left bank)	Native Forest
Floodplain Features	No features	Landuse (right bank)	Native Forest
<b>Physical Barriers</b>			
Type of Bars	None	Large Woody Debris	<20%
Extent of Bars (%)	None	Artificial Features	None
Particle Size on Bars	N/A	Channel Modifications	None
<b>Channel Shape &amp; Banks</b>			
Bank Shape	Convex, Stepped	Bank Height (m)	1
Bank Slope	Low	Bank Width (m)	1
Factors Affecting Bank Stability	None	Bank Material	Fines over bedrock
Artificial Bank Protection	None	Substrate Composition	Fines over bedrock

<b>Water Observations</b>			
Water Level	No flow	Water Surface Width (m)	0
Water Depth (m)	0	Turbidity (Visual)	None
Water Oils	None	Water Odours	None
Sediment Oils	None	Sediment Odours	None
<b>Stream Bed</b>			
Extent of Bedform Features	Riffle	Bedrock Outcrops	Yes
Bed Compaction	Moderate	Sediment Angularity	Angular
Sediment Matrix	Bedrock, open framework	Bed Stability Rating	Bed Stable
<b>Photographs</b>

Upstream showing defined channel with in stream vegetation and rock controlled bed		Downstream showing defined channel with rock controlled bed

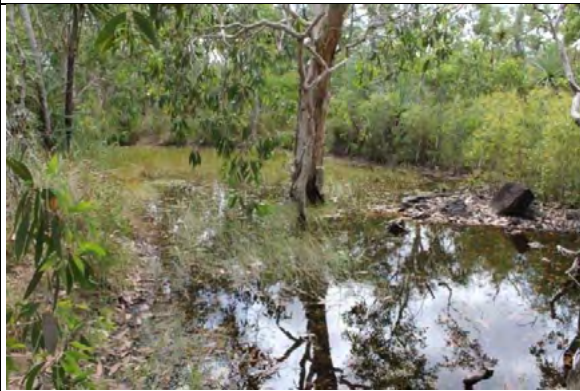
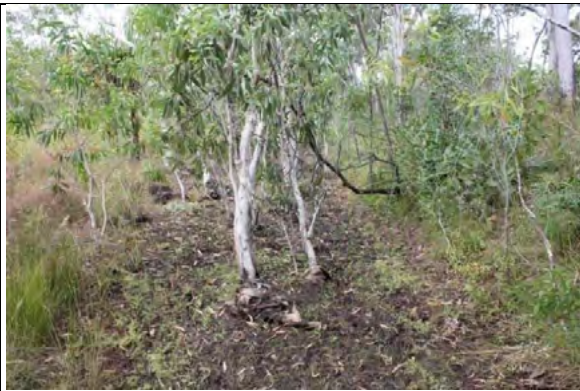
<b>FIGURE ID</b>	094	<b>Monitoring Date</b>	02/07/2014
<b>Figure Reference</b>	Figure A-4	<b>Coordinates</b>	-14.102045
<b>Location ID</b>	AR-ART1-03		136.533129
<b>Catchment</b>	Amagula River	<b>Coordinate System</b>	Decimal degrees
<b>Drainage Feature</b>	Amagula River – Tributary 1		
<b>Relative Location</b>	Upstream of confluence with Amagula River		
<b>Physical Assessment</b>			
Valley Shape	Shallow valley, asymmetrical	Local Influences	Road
Floodplain Width (m)	N/A	Landuse (left bank)	Native Forest
Floodplain Features	No features	Landuse (right bank)	Native Forest
<b>Physical Barriers</b>			
Type of Bars	None	Large Woody Debris	50%
Extent of Bars (%)	None	Artificial Features	Road
Particle Size on Bars	N/A	Channel Modifications	None
<b>Channel Shape &amp; Banks</b>			
Bank Shape	Convex, stepped	Bank Height (m)	2 m
Bank Slope	Low to moderate	Bank Width (m)	2 (east) / 20 (west)
Factors Affecting Bank Stability	None	Bank Material	Fines over bedrock

Artificial Bank Protection	None	Substrate Composition	Fines over bedrock
<b>Water Observations</b>			
Water Level	Low	Water Surface Width (m)	2.5
Water Depth (m)	0.1	Turbidity (Visual)	Plant leachate
Water Oils	None	Water Odours	None
Sediment Oils	None	Sediment Odours	None
<b>Stream Bed</b>			
Extent of Bedform Features	Pool	Bedrock Outcrops	Yes
Bed Compaction	Low	Sediment Angularity	Angular
Sediment Matrix	Fines over bedrock	Bed Stability Rating	Bed stable
<b>Photographs</b>

Upstream showing defined channel with pooled water and in channel vegetation		Downstream showing defined channel and in channel vegetation

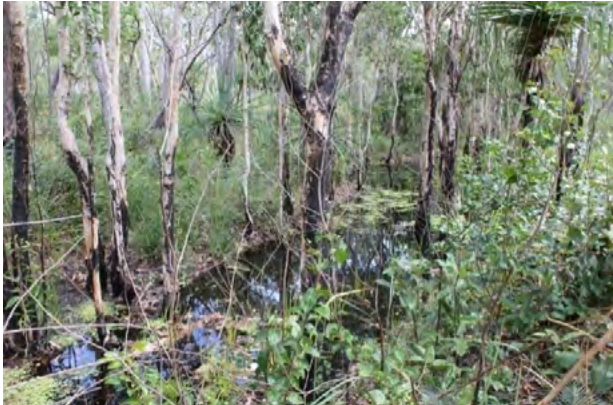
Artificial Bank Protection	None	Substrate Composition	Fines over bedrock
<b>Water Observations</b>			
Water Level	Low	Water Surface Width (m)	0.5
Water Depth (m)	0.2	Turbidity (Visual)	Plant leachate
Water Oils	None	Water Odours	None
Sediment Oils	None	Sediment Odours	None
<b>Stream Bed</b>			
Extent of Bedform Features	Pool	Bedrock Outcrops	Yes
Bed Compaction	Low	Sediment Angularity	Angular
Sediment Matrix	Fines over bedrock	Bed Stability Rating	Bed stable
<b>Photographs</b>

Upstream showing defined channel with pooled water and in channel vegetation

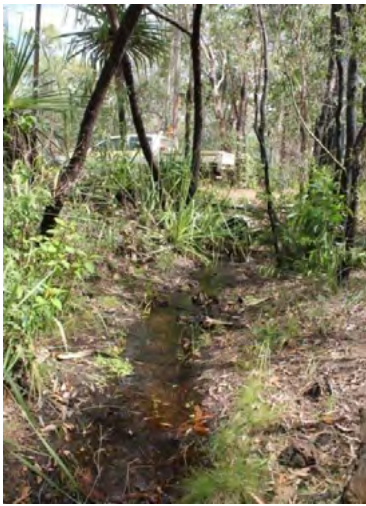
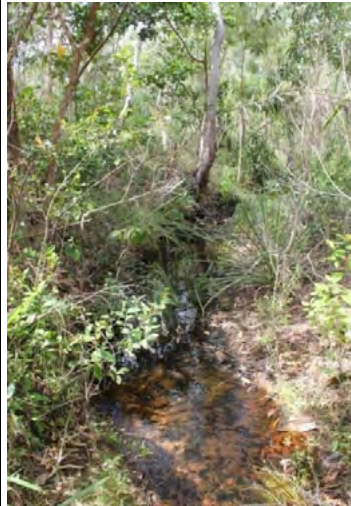
<b>FIGURE ID</b>	096	<b>Monitoring Date</b>	02/07/2014
<b>Figure Reference</b>	Figure A-4	<b>Coordinates</b>	-14.104504
<b>Location ID</b>	AR-ART1-05		136.534251
<b>Catchment</b>	Amagula River	<b>Coordinate System</b>	Decimal degrees
<b>Drainage Feature</b>	Amagula River – Tributary 1		
<b>Relative Location</b>	Upstream of confluence with Amagula River		
<b>Physical Assessment</b>			
Valley Shape	Shallow valley	Local Influences	Culvert
Floodplain Width (m)	N/A	Landuse (left bank)	Native Forest
Floodplain Features	No features	Landuse (right bank)	Native Forest
<b>Physical Barriers</b>			
Type of Bars	None	Large Woody Debris	50%
Extent of Bars (%)	None	Artificial Features	None
Particle Size on Bars	N/A	Channel Modifications	None
<b>Channel Shape &amp; Banks</b>			
Bank Shape	Concave, stepped	Bank Height (m)	1.5
Bank Slope	Low	Bank Width (m)	2
Factors Affecting Bank Stability	Culvert	Bank Material	Fines over bedrock

Artificial Bank Protection	None	Substrate Composition	Fines over bedrock
<b>Water Observations</b>			
Water Level	Low	Water Surface Width (m)	0.5
Water Depth (m)	0.2	Turbidity (Visual)	Plant leachate
Water Oils	None	Water Odours	None
Sediment Oils	None	Sediment Odours	None
<b>Stream Bed</b>			
Extent of Bedform Features	Glide	Bedrock Outcrops	Yes
Bed Compaction	Low	Sediment Angularity	Angular
Sediment Matrix	Fines over bedrock	Bed Stability Rating	Bed Stable
<b>Photographs</b>

Upstream defined channel with culvert		Upstream defined channel with pooled water

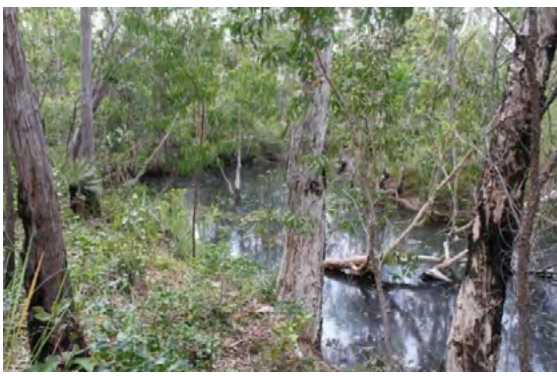
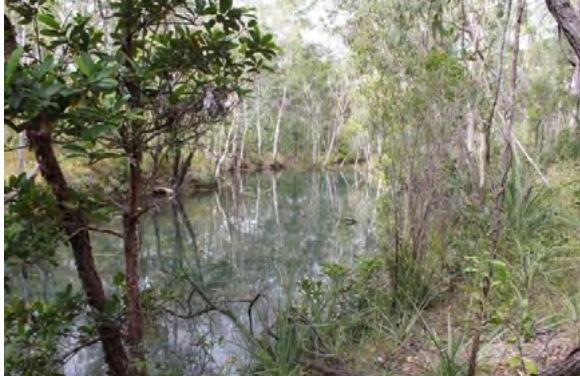
<b>FIGURE ID</b>	097	<b>Monitoring Date</b>	02/07/2014
<b>Figure Reference</b>	Figure A-4	<b>Coordinates</b>	-14.106376
<b>Location ID</b>	AR-ART1-06		136.53641
<b>Catchment</b>	Amagula River	<b>Coordinate System</b>	Decimal degrees
<b>Drainage Feature</b>	Amagula River – Tributary 1		
<b>Relative Location</b>	Upstream of confluence with Amagula River		
<b>Physical Assessment</b>			
Valley Shape	Shallow valley	Local Influences	None
Floodplain Width (m)	N/A	Landuse (left bank)	Native Forest
Floodplain Features	No features	Landuse (right bank)	Native Forest
<b>Physical Barriers</b>			
Type of Bars	None	Large Woody Debris	Large floating and fixed debris
Extent of Bars (%)	None	Artificial Features	None
Particle Size on Bars	N/A	Channel Modifications	None
<b>Channel Shape &amp; Banks</b>			
Bank Shape	Convex	Bank Height (m)	4
Bank Slope	Moderate	Bank Width (m)	10
Factors Affecting Bank Stability	None	Bank Material	Fines over bedrock

Artificial Bank Protection	None	Substrate Composition	Fines over bedrock
<b>Water Observations</b>			
Water Level	Low	Water Surface Width (m)	5-10
Water Depth (m)	1	Turbidity (Visual)	Plant leachate
Water Oils	None	Water Odours	None
Sediment Oils	None	Sediment Odours	None
<b>Stream Bed</b>			
Extent of Bedform Features	Pool and riffle sequence	Bedrock Outcrops	Yes
Bed Compaction	Low	Sediment Angularity	Sub-angular
Sediment Matrix	Fines over bedrock	Bed Stability Rating	Bed Stable
<b>Photographs</b>

Upstream showing defined channel with pooled water		Downstream showing defined channel with pooled water

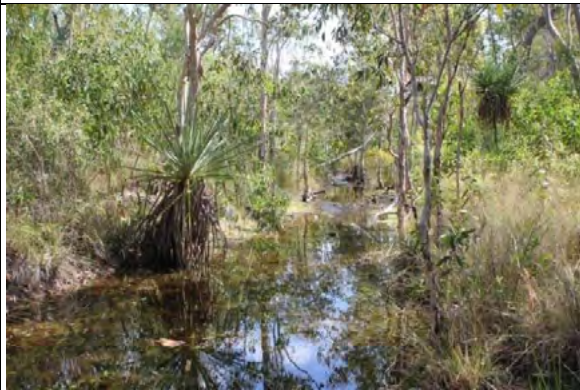
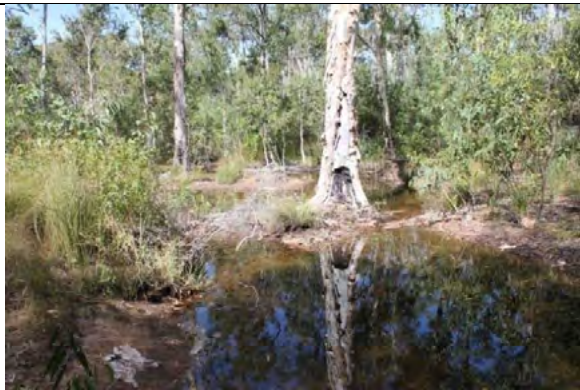
<b>FIGURE ID</b>	090	<b>Monitoring Date</b>	02/07/2014
<b>Figure Reference</b>	Figure A-4	<b>Coordinates</b>	-14.087413
<b>Location ID</b>	AR-ART2-01		136.566443
<b>Catchment</b>	Amagula River	<b>Coordinate System</b>	Decimal degrees
<b>Drainage Feature</b>	Amagula River – Tributary 2 (Main Channel)		
<b>Relative Location</b>	Upstream of confluence with Amagula River		
<b>Physical Assessment</b>			
Valley Shape	Shallow valley	Local Influences	None
Floodplain Width (m)	N/A	Landuse (left bank)	Native Forest
Floodplain Features	No features	Landuse (right bank)	Native Forest
<b>Physical Barriers</b>			
Type of Bars	None	Large Woody Debris	40%
Extent of Bars (%)	None	Artificial Features	None
Particle Size on Bars	N/A	Channel Modifications	None
<b>Channel Shape &amp; Banks</b>			
Bank Shape	Concave, stepped	Bank Height (m)	1.5
Bank Slope	Low	Bank Width (m)	2
Factors Affecting Bank Stability	None	Bank Material	Fines over bedrock

Artificial Bank Protection	None	Substrate Composition	Fines over bedrock
<b>Water Observations</b>			
Water Level	Low	Water Surface Width (m)	3 to 5
Water Depth (m)	0.3	Turbidity (Visual)	Clear
Water Oils	None	Water Odours	None
Sediment Oils	None	Sediment Odours	None
<b>Stream Bed</b>			
Extent of Bedform Features	Pool and glide	Bedrock Outcrops	Yes
Bed Compaction	Moderate	Sediment Angularity	Sub-Angular
Sediment Matrix	Fines over bedrock	Bed Stability Rating	Bed Stable
<b>Photographs</b>

Upstream showing defined channel with pooled water		Downstream showing defined channel with pooled water and in channel vegetation

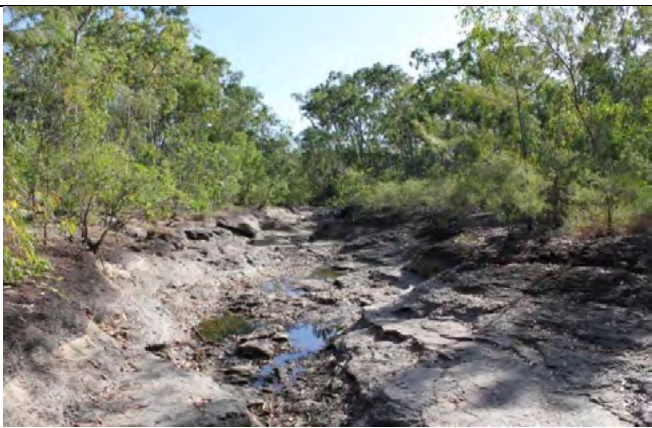
<b>Water Observations</b>			
Water Level	No Flow	Water Surface Width (m)	0
Water Depth (m)	0	Turbidity (Visual)	None
Water Oils	None	Water Odours	None
Sediment Oils	None	Sediment Odours	None
<b>Stream Bed</b>			
Extent of Bedform Features	Riffle and glide	Bedrock Outcrops	Yes
Bed Compaction	Low	Sediment Angularity	Angular
Sediment Matrix	Bedrock, open	Bed Stability Rating	Bed stable
<b>Photographs</b>

Downstream showing defined channel with residual water and rock controlled bed

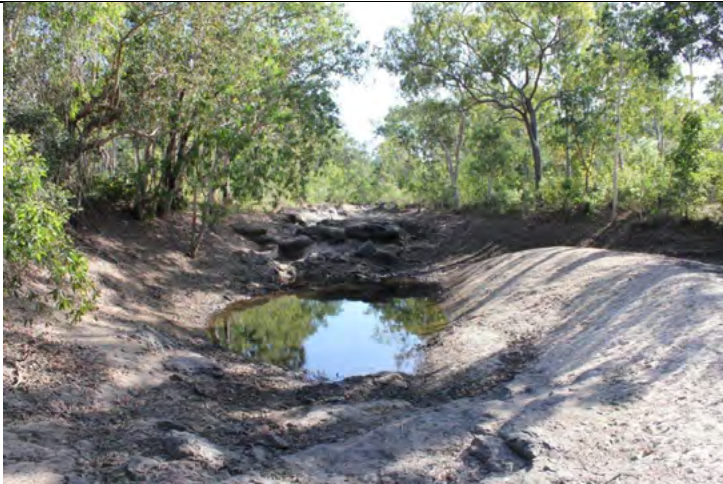
Artificial Bank Protection	None	Substrate Composition	Fines over bedrock
<b>Water Observations</b>			
Water Level	No flow	Water Surface Width (m)	1.2
Water Depth (m)	0.5	Turbidity (Visual)	Turbid
Water Oils	None	Water Odours	None
Sediment Oils	None	Sediment Odours	None
<b>Stream Bed</b>			
Extent of Bedform Features	Pool	Bedrock Outcrops	Yes
Bed Compaction	Moderate	Sediment Angularity	Sub-Angular
Sediment Matrix	Sand and silt	Bed Stability Rating	Bed Stable
<b>Photographs</b>

Upstream showing defined channel with pooled water

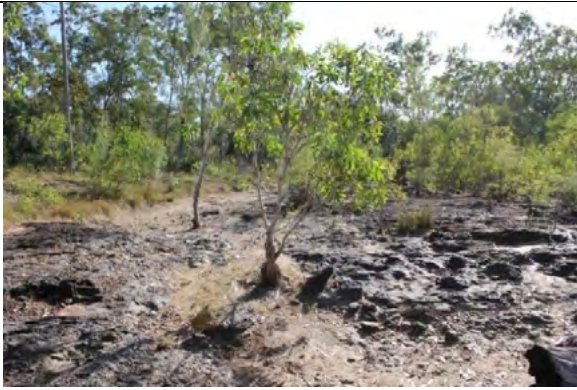
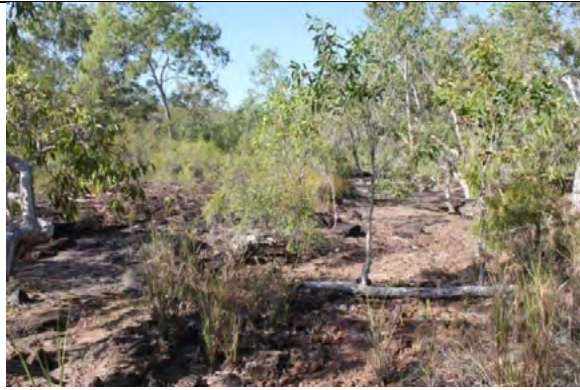
<b>FIGURE ID</b>	076	<b>Monitoring Date</b>	02/07/2014
<b>Figure Reference</b>	Figure A-4	<b>Coordinates</b>	-14.099264
<b>Location ID</b>	AR-ART2-04		136.562268
<b>Catchment</b>	Amagula River	<b>Coordinate System</b>	Decimal degrees
<b>Drainage Feature</b>	Amagula River – Tributary 2		
<b>Relative Location</b>	Upstream of confluence with Amagula River		
<b>Physical Assessment</b>			
Valley Shape	Shallow, asymmetrical	Local Influences	None
Floodplain Width (m)	N/A	Landuse (left bank)	Native Forest
Floodplain Features	No features	Landuse (right bank)	Native Forest
<b>Physical Barriers</b>			
Type of Bars	None	Large Woody Debris	<5%
Extent of Bars (%)	None	Artificial Features	None
Particle Size on Bars	N/A	Channel Modifications	None
<b>Channel Shape &amp; Banks</b>			
Bank Shape	Concave, stepped	Bank Height (m)	1.5
Bank Slope	Low	Bank Width (m)	7
Factors Affecting Bank Stability	None	Bank Material	Fines over bedrock

Artificial Bank Protection	None	Substrate Composition	Fines over bedrock
<b>Water Observations</b>			
Water Level	No Flow	Water Surface Width (m)	0
Water Depth (m)	0	Turbidity (Visual)	None
Water Oils	None	Water Odours	None
Sediment Oils	None	Sediment Odours	None
<b>Stream Bed</b>			
Extent of Bedform Features	Riffle and glide	Bedrock Outcrops	Yes
Bed Compaction	Low	Sediment Angularity	Angular
Sediment Matrix	Fines over bedrock	Bed Stability Rating	Bed stable
<b>Photographs</b>

Upstream showing defined channel with rock controlled bed and in channel vegetation		Downstream showing defined channel with rock controlled bed and in channel vegetation

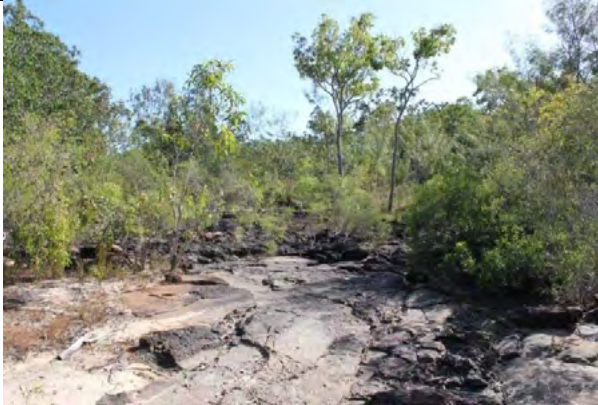
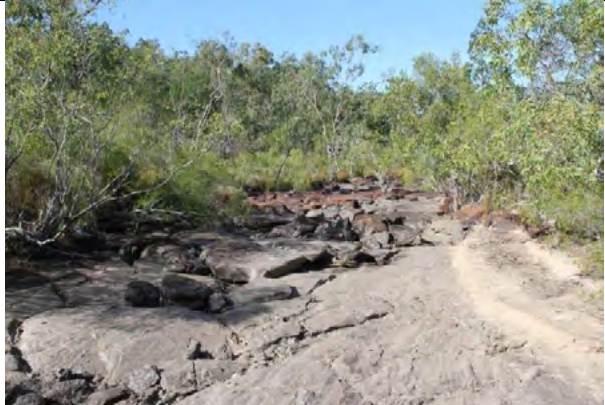
Artificial Bank Protection	None	Substrate Composition	Fines over bedrock
<b>Water Observations</b>			
Water Level	No Flow	Water Surface Width (m)	0
Water Depth (m)	0	Turbidity (Visual)	None
Water Oils	None	Water Odours	None
Sediment Oils	None	Sediment Odours	None
<b>Stream Bed</b>			
Extent of Bedform Features	Riffle and glide	Bedrock Outcrops	Yes
Bed Compaction	Low	Sediment Angularity	Angular
Sediment Matrix	Fines over bedrock	Bed Stability Rating	Bed stable
<b>Photographs</b>

Upstream showing defined channel with rock controlled bed		Downstream showing defined channel with rock controlled bed

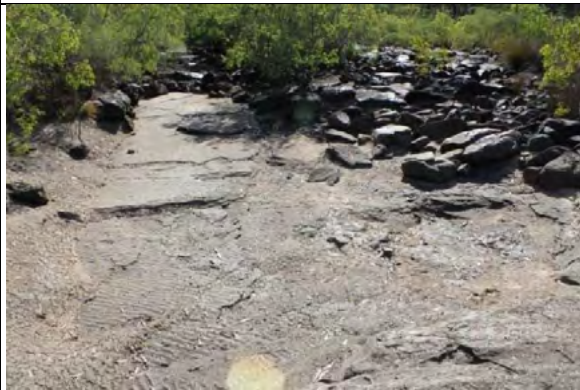
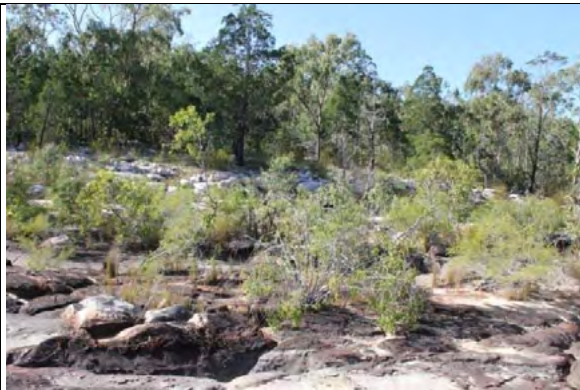
<b>FIGURE ID</b>	080	<b>Monitoring Date</b>	02/07/2014
<b>Figure Reference</b>	Figure A-4	<b>Coordinates</b>	-14.101839
<b>Location ID</b>	AR-ART2-06		136.56256
<b>Catchment</b>	Amagula River	<b>Coordinate System</b>	Decimal degrees
<b>Drainage Feature</b>	Amagula – Tributary 2		
<b>Relative Location</b>	Upstream of confluence with Amagula River		
<b>Physical Assessment</b>			
Valley Shape	Shallow, asymmetrical	Local Influences	None
Floodplain Width (m)	N/A	Landuse (left bank)	Native Forest
Floodplain Features	No features	Landuse (right bank)	Native Forest
<b>Physical Barriers</b>			
Type of Bars	None	Large Woody Debris	<5%
Extent of Bars (%)	None	Artificial Features	None
Particle Size on Bars	N/A	Channel Modifications	None
<b>Channel Shape &amp; Banks</b>			
Bank Shape	Concave, stepped	Bank Height (m)	2 to 3
Bank Slope	Low	Bank Width (m)	40
Factors Affecting Bank Stability	None	Bank Material	Fines over bedrock

Artificial Bank Protection	None	Substrate Composition	Fines over bedrock
<b>Water Observations</b>			
Water Level	No Flow	Water Surface Width (m)	0
Water Depth (m)	0	Turbidity (Visual)	None
Water Oils	None	Water Odours	None
Sediment Oils	None	Sediment Odours	None
<b>Stream Bed</b>			
Extent of Bedform Features	Riffle and pool	Bedrock Outcrops	Yes
Bed Compaction	Low	Sediment Angularity	Angular
Sediment Matrix	Gravel and bedrock	Bed Stability Rating	Bed stable
<b>Photographs</b>

Upstream showing defined channel with rock controlled bed.		Downstream showing defined channel with rock controlled bed and in stream vegetation

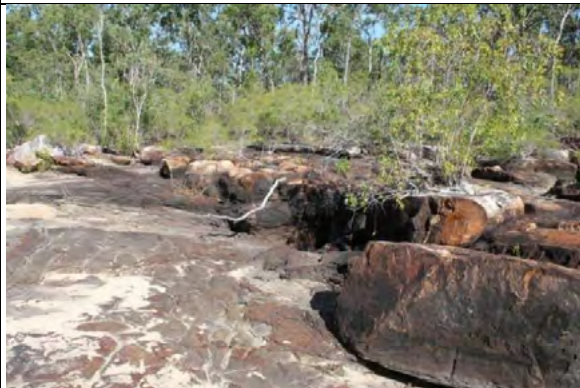
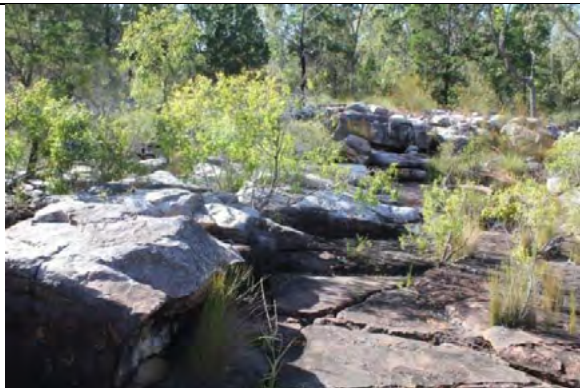
<b>FIGURE ID</b>	081	<b>Monitoring Date</b>	02/07/2014
<b>Figure Reference</b>	Figure A-4	<b>Coordinates</b>	-14.102451
<b>Location ID</b>	AR-ART2-07		136.562387
<b>Catchment</b>	Amagula River	<b>Coordinate System</b>	Decimal degrees
<b>Drainage Feature</b>	Amagula – Tributary 2 (typical bank elevation change)		
<b>Relative Location</b>	Upstream of confluence with Amagula River		
<b>Physical Assessment</b>			
Valley Shape	Shallow, asymmetrical	Local Influences	None
Floodplain Width (m)	N/A	Landuse (left bank)	Native Forest
Floodplain Features	No features	Landuse (right bank)	Native Forest
<b>Physical Barriers</b>			
Type of Bars	None	Large Woody Debris	<5%
Extent of Bars (%)	None	Artificial Features	None
Particle Size on Bars	N/A	Channel Modifications	None
<b>Channel Shape &amp; Banks</b>			
Bank Shape	Concave, stepped	Bank Height (m)	2 to 3
Bank Slope	Low	Bank Width (m)	40
Factors Affecting Bank Stability	None	Bank Material	Fines over bedrock

Artificial Bank Protection	None	Substrate Composition	Fines over bedrock
<b>Water Observations</b>			
Water Level	No Flow	Water Surface Width (m)	0
Water Depth (m)	0	Turbidity (Visual)	None
Water Oils	None	Water Odours	None
Sediment Oils	None	Sediment Odours	None
<b>Stream Bed</b>			
Extent of Bedform Features	Riffle and pool	Bedrock Outcrops	Yes
Bed Compaction	Low	Sediment Angularity	Angular
Sediment Matrix	Gravel and bedrock	Bed Stability Rating	Bed stable
<b>Photographs</b>

Western View - Tributary flows from right to left (north to south)		Eastern View – Tributary flows left to right (north to south)

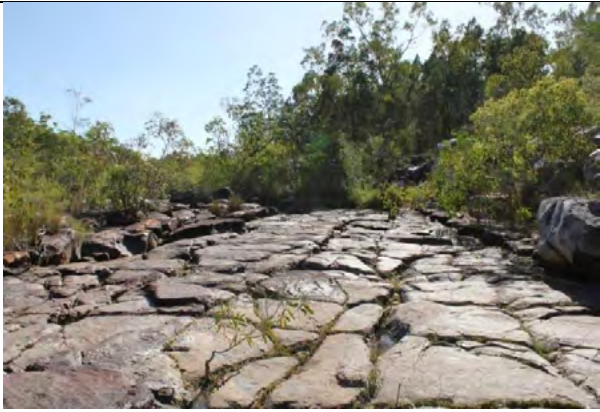
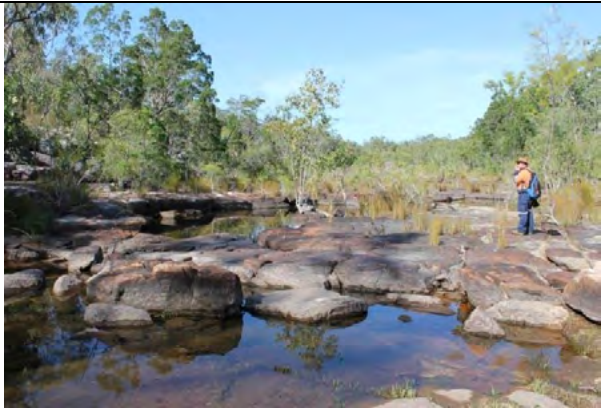
Artificial Bank Protection	None	Substrate Composition	Fines over bedrock
<b>Water Observations</b>			
Water Level	Low	Water Surface Width (m)	6
Water Depth (m)	0.3	Turbidity (Visual)	Clear
Water Oils	None	Water Odours	None
Sediment Oils	None	Sediment Odours	None
<b>Stream Bed</b>			
Extent of Bedform Features	Riffle and pool	Bedrock Outcrops	Yes
Bed Compaction	Low	Sediment Angularity	Angular
Sediment Matrix	Gravel and bedrock	Bed Stability Rating	Bed stable
<b>Photographs</b>

Upstream showing defined channel with controlled bed		Downstream showing defined channel with pooled water and rock controlled bed

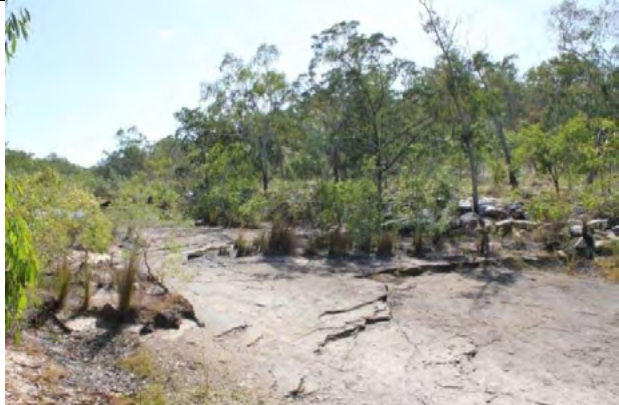
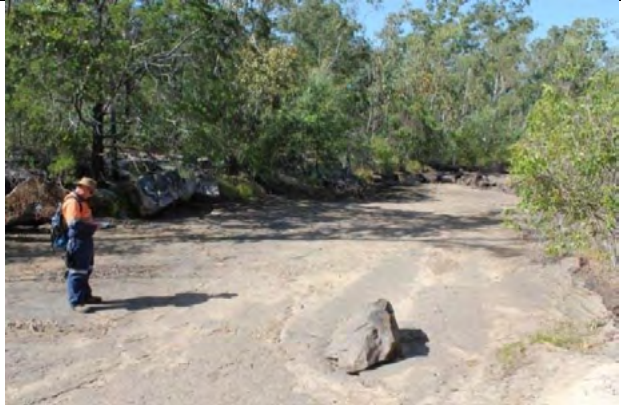
Artificial Bank Protection	None	Substrate Composition	Fines over bedrock
<b>Water Observations</b>			
Water Level	No Flow	Water Surface Width (m)	0
Water Depth (m)	0	Turbidity (Visual)	None
Water Oils	None	Water Odours	None
Sediment Oils	None	Sediment Odours	None
<b>Stream Bed</b>			
Extent of Bedform Features	Glide and pool	Bedrock Outcrops	Yes
Bed Compaction	Low	Sediment Angularity	Angular
Sediment Matrix	Gravel and bedrock	Bed Stability Rating	Bed stable
<b>Photographs</b>

Upstream showing defined channel with rock controlled bed		Downstream showing defined channel with rock controlled bed
