**EASTERN LEASES PROJECT**

# **BASELINE SURFACE WATER MONITORING REPORT**

for  
**South32 Pty Ltd**  
May 2015

**HANSEN BAILEY**  
215 Adelaide Street  
Brisbane QLD 4000

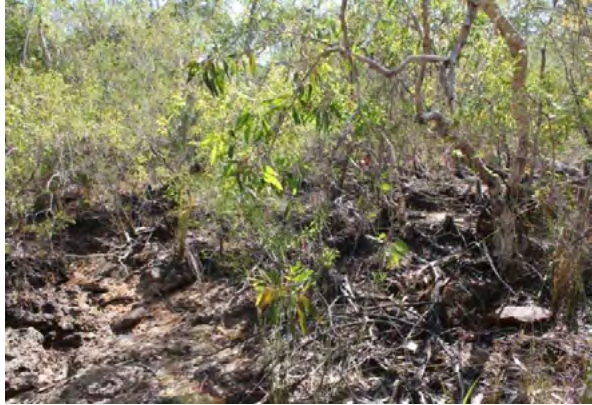
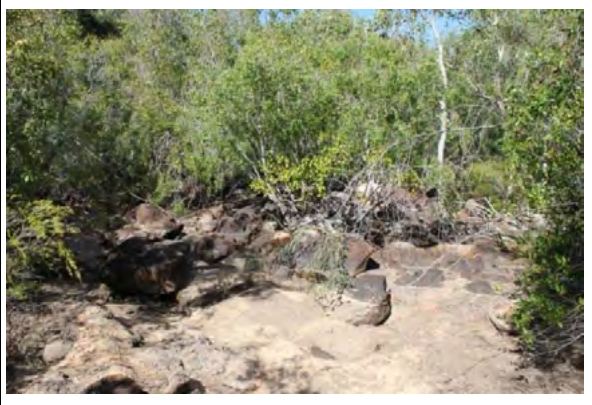
<b>FIGURE ID</b>	087	<b>Monitoring Date</b>	02/07/2014
<b>Figure Reference</b>	Figure A-4	<b>Coordinates</b>	-14.104894
<b>Location ID</b>	AR-ART2-10		136.561999
<b>Catchment</b>	Amagula River	<b>Coordinate System</b>	Decimal degrees
<b>Drainage Feature</b>	Amagula – Tributary 2 (High Flow Channel)		
<b>Relative Location</b>	Upstream of confluence with Amagula River		
<b>Physical Assessment</b>			
Valley Shape	Shallow, asymmetrical	Local Influences	None
Floodplain Width (m)	N/A	Landuse (left bank)	Native Forest
Floodplain Features	No features	Landuse (right bank)	Native Forest
<b>Physical Barriers</b>			
Type of Bars	None	Large Woody Debris	None
Extent of Bars (%)	None	Artificial Features	None
Particle Size on Bars	N/A	Channel Modifications	None
<b>Channel Shape &amp; Banks</b>			
Bank Shape	Stepped	Bank Height (m)	1
Bank Slope	Low	Bank Width (m)	1
Factors Affecting Bank Stability	None	Bank Material	Fines over bedrock

Artificial Bank Protection	None	Substrate Composition	Fines over bedrock
<b>Water Observations</b>			
Water Level	No Flow	Water Surface Width (m)	0
Water Depth (m)	0	Turbidity (Visual)	None
Water Oils	None	Water Odours	None
Sediment Oils	None	Sediment Odours	None
<b>Stream Bed</b>			
Extent of Bedform Features	Riffle	Bedrock Outcrops	Yes
Bed Compaction	Low	Sediment Angularity	Sub-Angular
Sediment Matrix	Gravel and bedrock	Bed Stability Rating	Bed Stable
<b>Photographs</b>

Upstream showing defined channel with rock controlled bed and in channel vegetation		Downstream showing defined channel with rock controlled bed

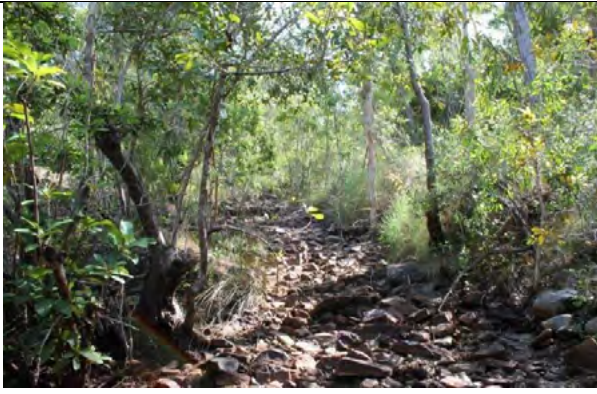
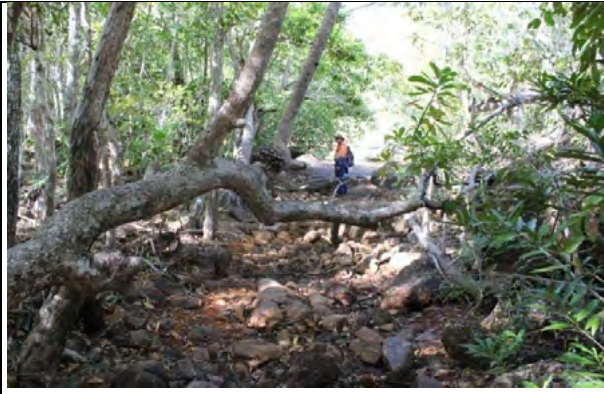
<b>FIGURE ID</b>	083	<b>Monitoring Date</b>	02/07/2014
<b>Figure Reference</b>	Figure A-4	<b>Coordinates</b>	-14.10525
<b>Location ID</b>	AR-ART2-11		136.561449
<b>Catchment</b>	Amagula River	<b>Coordinate System</b>	Decimal degrees
<b>Drainage Feature</b>	Amagula – Tributary 2		
<b>Relative Location</b>	Upstream of confluence with Amagula River		
<b>Physical Assessment</b>			
Valley Shape	Shallow, asymmetrical	Local Influences	None
Floodplain Width (m)	N/A	Landuse (left bank)	Native Forest
Floodplain Features	No features	Landuse (right bank)	Native Forest
<b>Physical Barriers</b>			
Type of Bars	None	Large Woody Debris	<10%
Extent of Bars (%)	None	Artificial Features	None
Particle Size on Bars	N/A	Channel Modifications	None
<b>Channel Shape &amp; Banks</b>			
Bank Shape	Concave, stepped	Bank Height (m)	2
Bank Slope	Moderate	Bank Width (m)	2
Factors Affecting Bank Stability	None	Bank Material	Fines over bedrock

Artificial Bank Protection	None	Substrate Composition	Fines over bedrock
<b>Water Observations</b>			
Water Level	No Flow	Water Surface Width (m)	0
Water Depth (m)	0	Turbidity (Visual)	None
Water Oils	None	Water Odours	None
Sediment Oils	None	Sediment Odours	None
<b>Stream Bed</b>			
Extent of Bedform Features	Riffle and glide	Bedrock Outcrops	Yes
Bed Compaction	Low	Sediment Angularity	Angular
Sediment Matrix	Fines over bedrock	Bed Stability Rating	Bed stable
<b>Photographs</b>

Upstream showing defined channel with rock controlled bed		Downstream showing defined channel with rock controlled bed

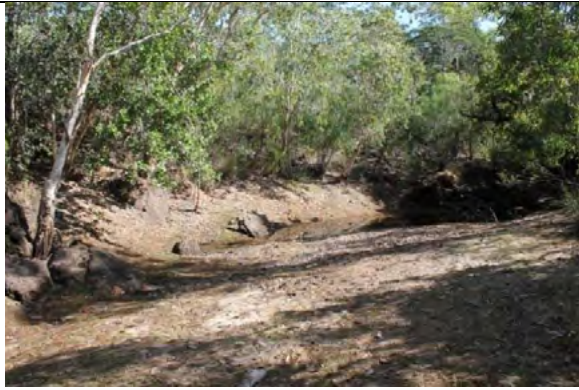
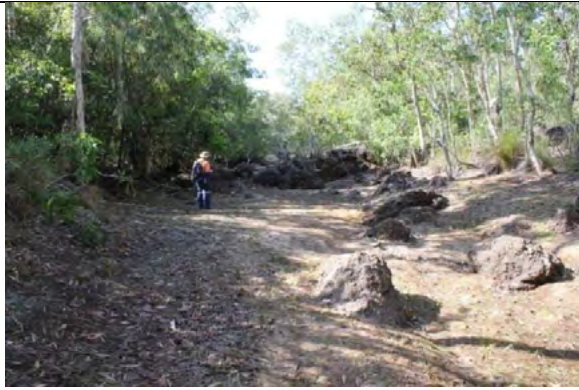
<b>FIGURE ID</b>	084	<b>Monitoring Date</b>	02/07/2014
<b>Figure Reference</b>	Figure A-4	<b>Coordinates</b>	-14.105445
<b>Location ID</b>	AR-ART2-12		136.561547
<b>Catchment</b>	Amagula River	<b>Coordinate System</b>	Decimal degrees
<b>Drainage Feature</b>	Amagula – Tributary 2 Anabranh		
<b>Relative Location</b>	Upstream of confluence with Amagula River		
<b>Physical Assessment</b>			
Valley Shape	Shallow, asymmetrical	Local Influences	None
Floodplain Width (m)	N/A	Landuse (left bank)	Native Forest
Floodplain Features	No features	Landuse (right bank)	Native Forest
<b>Physical Barriers</b>			
Type of Bars	Point, unvegetated	Large Woody Debris	None
Extent of Bars (%)	40	Artificial Features	None
Particle Size on Bars	Sand, minor silt	Channel Modifications	None
<b>Channel Shape &amp; Banks</b>			
Bank Shape	Undercut, concave	Bank Height (m)	3
Bank Slope	Moderate	Bank Width (m)	2
Factors Affecting Bank Stability	Bedrock depression	Bank Material	Fines over bedrock

Artificial Bank Protection	None	Substrate Composition	Fines over bedrock
<b>Water Observations</b>			
Water Level	No flow	Water Surface Width (m)	0
Water Depth (m)	0	Turbidity (Visual)	None
Water Oils	None	Water Odours	None
Sediment Oils	None	Sediment Odours	None
<b>Stream Bed</b>			
Extent of Bedform Features	Riffle and pool	Bedrock Outcrops	Yes
Bed Compaction	Moderate	Sediment Angularity	Sub-Angular
Sediment Matrix	Sand and bedrock	Bed Stability Rating	Bed Stable
<b>Photographs</b>

Upstream showing defined channel with pooled water and sediment		Downstream showing defined channel

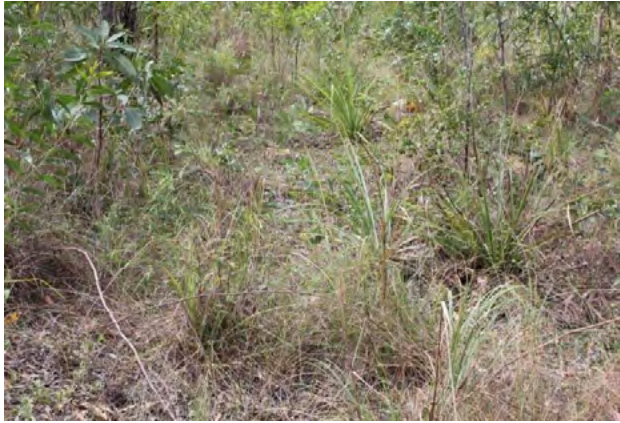
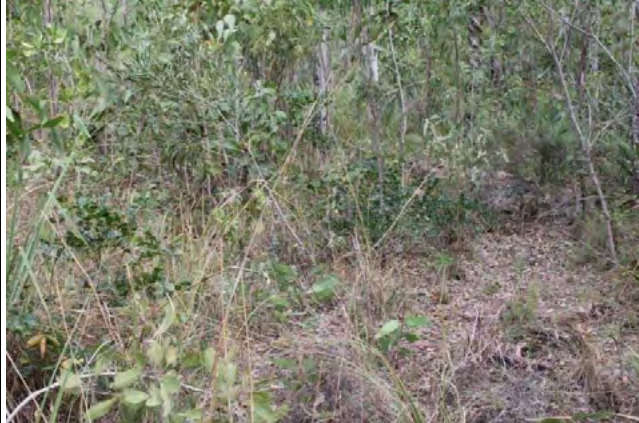
Artificial Bank Protection	None	Substrate Composition	Fines over bedrock
<b>Water Observations</b>			
Water Level	No flow	Water Surface Width (m)	0
Water Depth (m)	0	Turbidity (Visual)	None
Water Oils	None	Water Odours	None
Sediment Oils	None	Sediment Odours	None
<b>Stream Bed</b>			
Extent of Bedform Features	Undefined	Bedrock Outcrops	Yes
Bed Compaction	Tight	Sediment Angularity	Angular
Sediment Matrix	Soil over bedrock	Bed Stability Rating	Bed Stable
<b>Photographs</b>

Upstream showing overland flow path and no defined channel		Downstream showing overland flow path and no defined channel

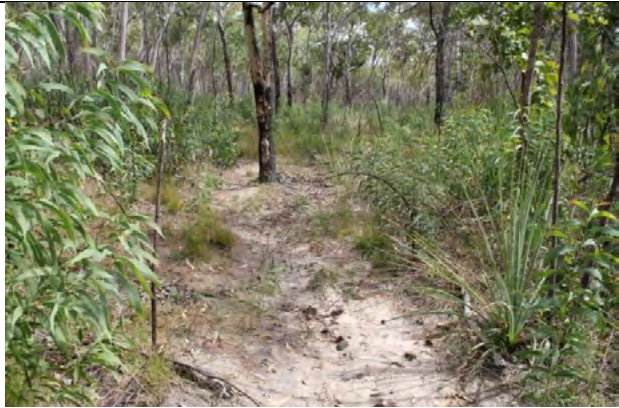
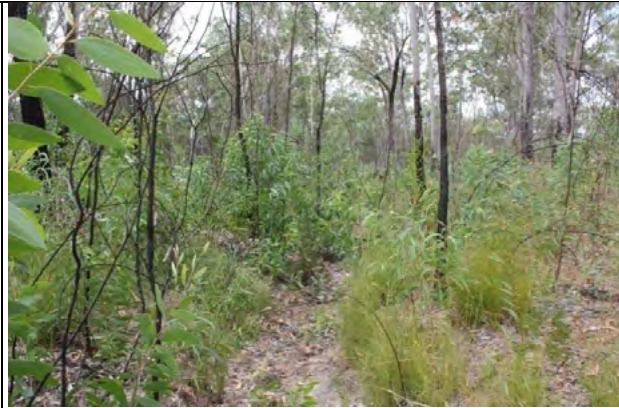
Artificial Bank Protection	None	Substrate Composition	Fines/sand over bedrock
<b>Water Observations</b>			
Water Level	No flow	Water Surface Width (m)	0
Water Depth (m)	0	Turbidity (Visual)	None
Water Oils	None	Water Odours	None
Sediment Oils	None	Sediment Odours	None
<b>Stream Bed</b>			
Extent of Bedform Features	Undefined	Bedrock Outcrops	Yes
Bed Compaction	Low	Sediment Angularity	Angular
Sediment Matrix	Fines/sand over bedrock	Bed Stability Rating	Bed Stable
<b>Photographs</b>

Upstream showing undefined channel with sandy bed		Downstream showing undefined channel with sandy bed and in stream vegetation.

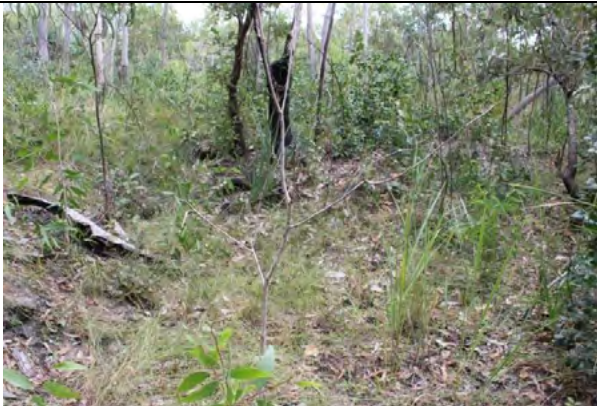
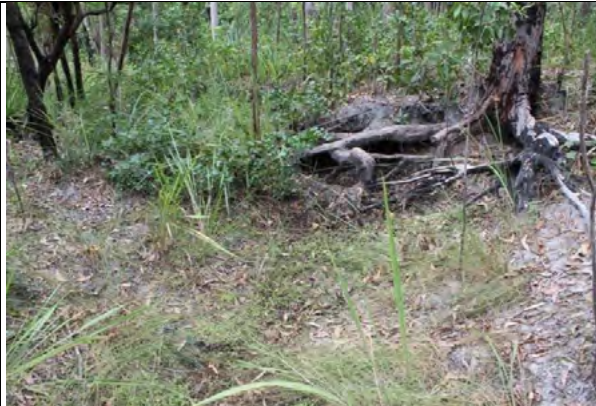
Upstream showing undefined channel with in stream vegetation		Downstream showing undefined channel with in stream vegetation.
